## Roof Inspection Report

Barkisland Mill

21<sup>st</sup> September 2023

## Drone Inspection Report - Summary of Findings

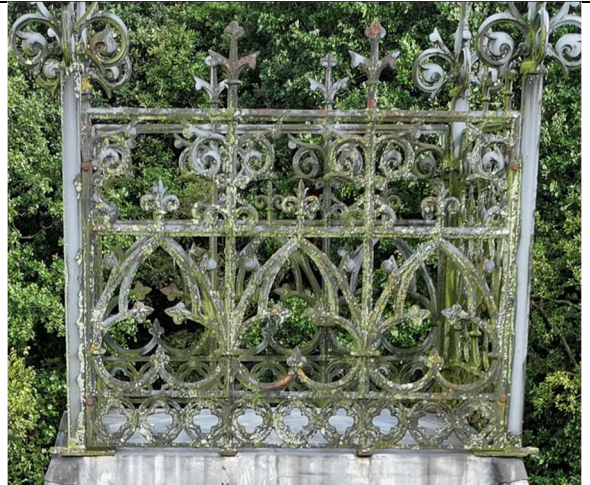
General comment, all towers – the ferrous metalwork needs to be suitably prepared and re-decorated.

There are corrosion stains on the slates and lead details below.

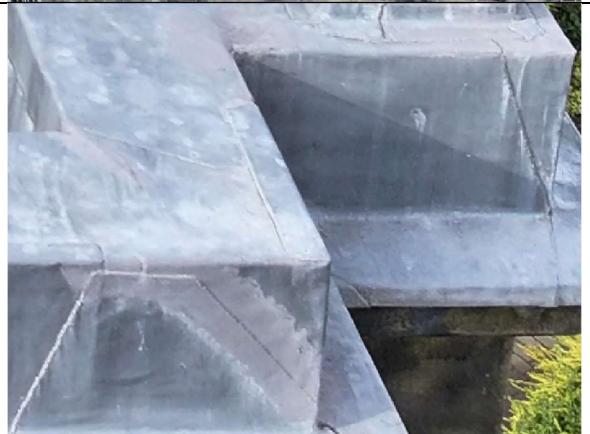
General comment, all towers – areas of lead have been coated with waterproofing-type paint. This is not an appropriate long-term solution and if there are defects with the leadwork, these should be appropriately patch-repaired or bossed.

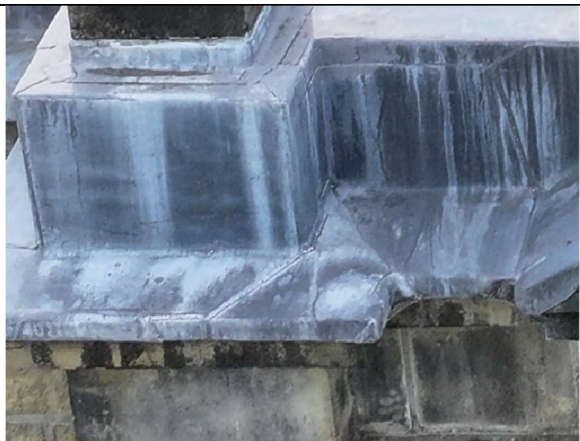
General comment, all towers – there are areas of lead that are oxidising as patination oil has not been applied to the surface of the lead.

We recommend the surface is suitably prepared and patination oil is applied next time high-level works are undertaken.

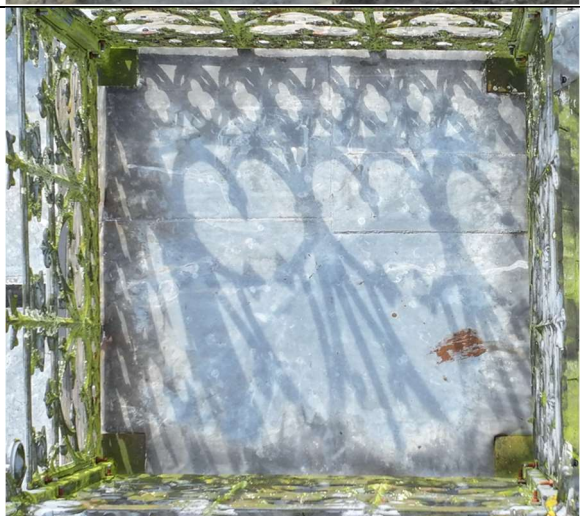
General comment – all flat roof areas – these areas have been incorrectly detailed with several pieces of lead that have been bossed (welded) together.

These should have been detailed with two or more sheets joined with a mop stick detail.

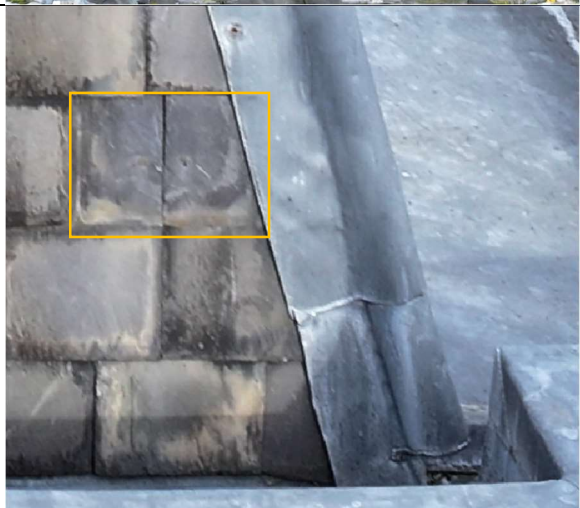
Right-hand pitch – the missing slate should be replaced in the short-term.

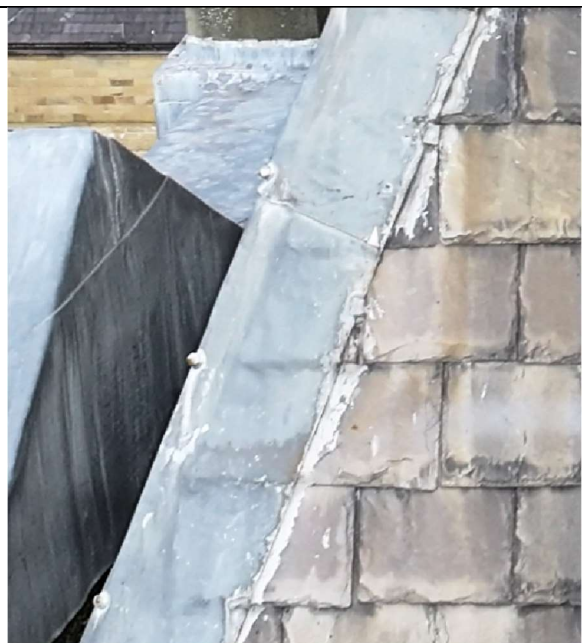
The lead hip detail has been stuck down to the slates with a mastic-type product. This is inappropriate and a lead restraint strap detail should have been used.

Consideration should be given to adding a restraint strap to the hip details.

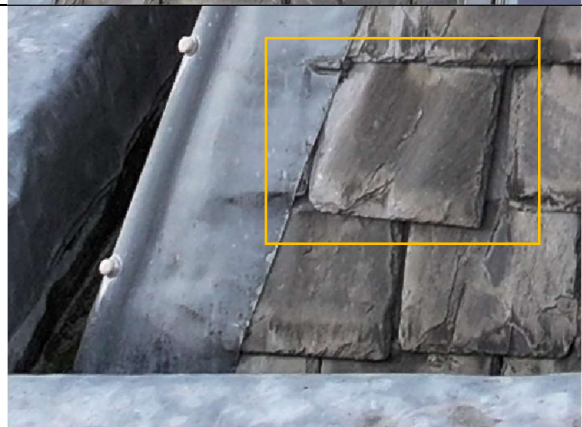
Rear pitch – the slipping slate should be re-affixed in the short-term.

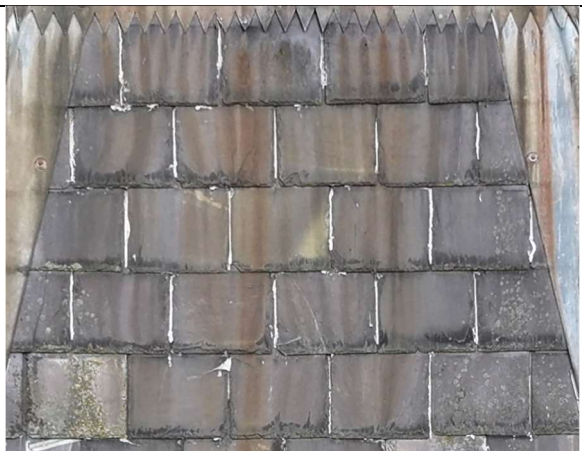
General comment – many of the slates have been bedded in/sealed with a mastic-type product.

This is inappropriate and these areas should be monitored for failure going forward.

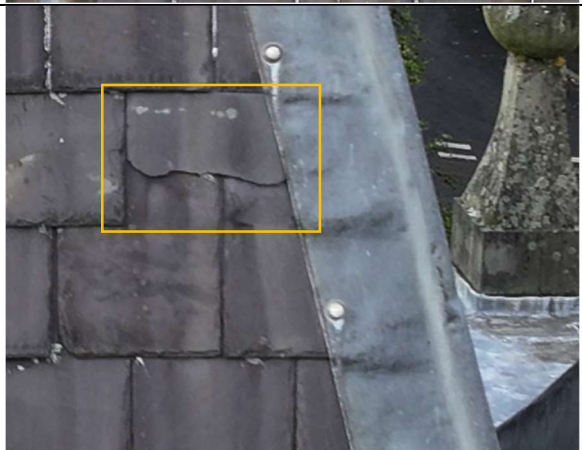
Rear pitch – the cracked slate should be replaced in the short term.

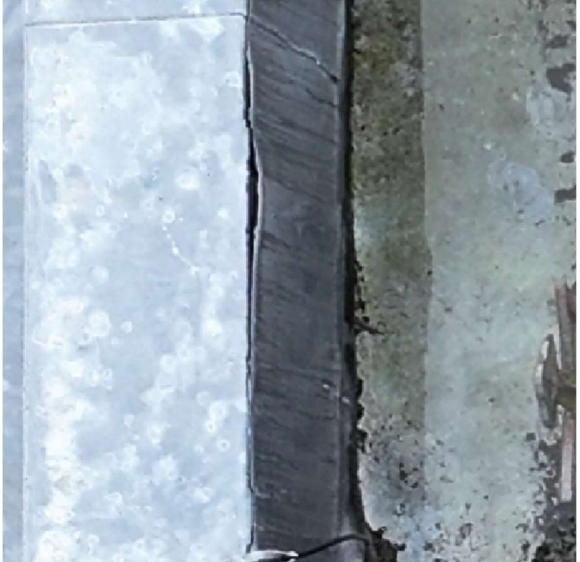
| <p>Parapet wall, rear elevation – the lead has split.</p> <p>We recommend that this is repaired as soon as possible.</p> | |

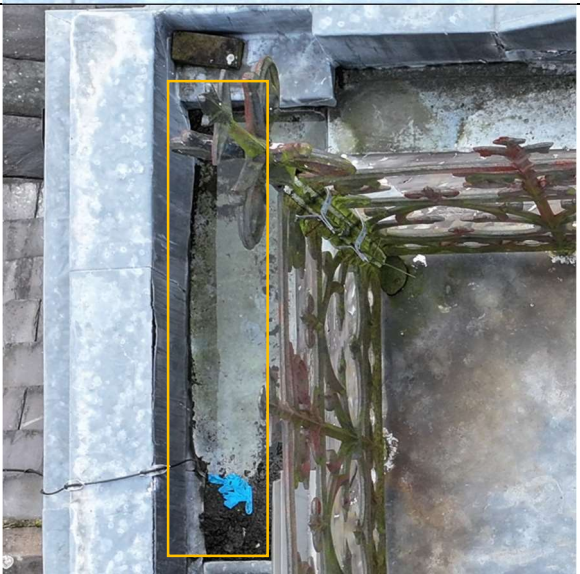
| <p>Box guttering – there is ponding near the outlet. This should be checked for debris and emptied.</p> | |

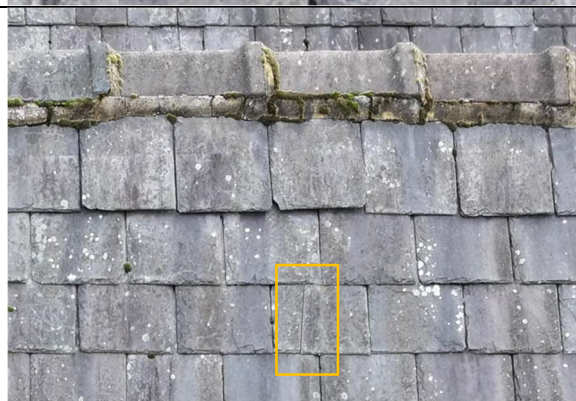
Pitch, left-hand section – the cracked slate should be replaced in the short-term.

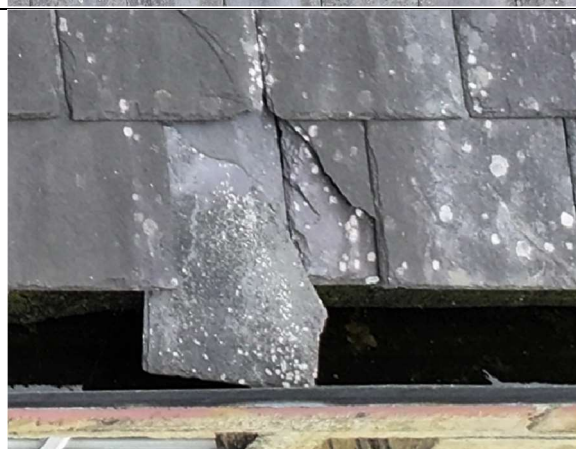
Eaves, left-hand section – the broken tile should be replaced in the short-term.

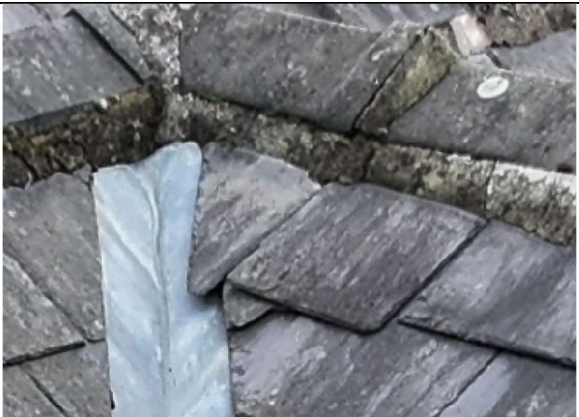
| <p>Left-hand section, tower section – the slipping slates should be re-affixed in the short-term.</p> | |

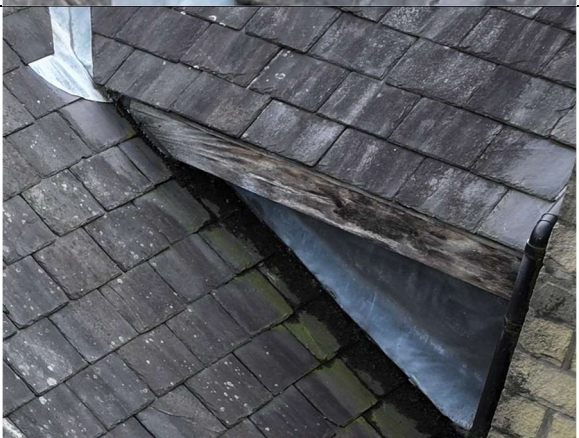
| <p>Left-hand section, tower section – there is no guttering at the eaves of this section. This may be acceptable if the slates projected further, however, they do not.</p> <p>There is not a particularly easy way to address this, a lead detail is likely the most economical option.</p> | |

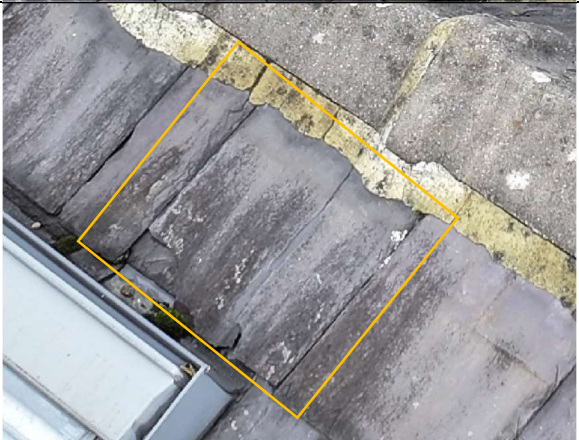
| <p>Centre left section, tower section – the cracked and damaged slate should be replaced in the short-term.</p> | |

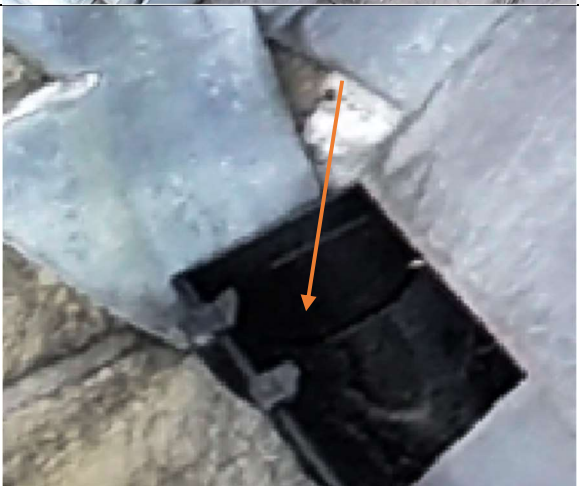
| <p>Centre left section, tower section – the soaker detail should be directed into the end of the guttering.</p> | |

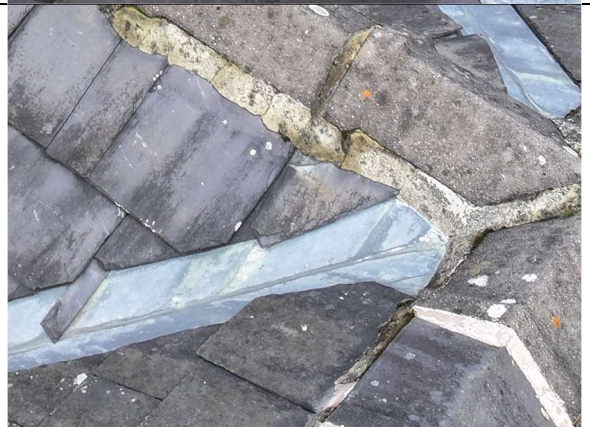
Centre left section, tower valley – the slipped slate should be re-affixed in the short-term.

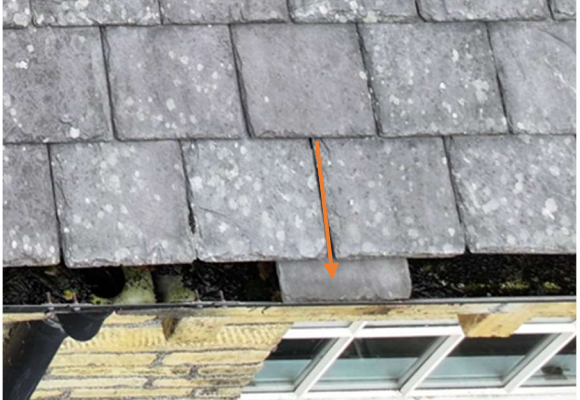
| <p>Centre left section – the slipping slate at the eaves should be re-affixed as soon as possible.</p> | |

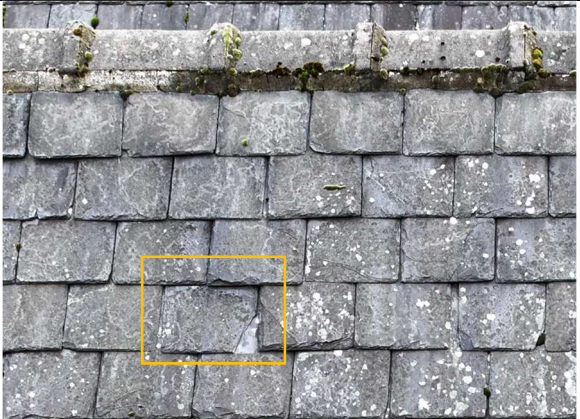
| <p>Centre left section – the chipped slate should be replaced in the short-term.</p> | |

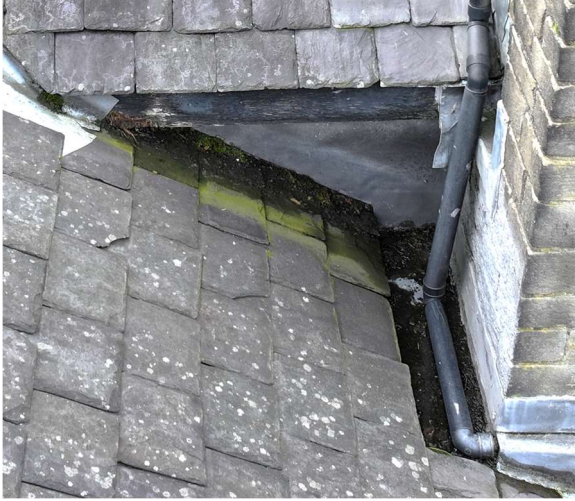
| <p>Centre left, tower section – the fascia is decaying and a plan should be made to replace it.</p> <p>The detritus around the wall head and box guttering should be cleared away in the short term.</p> <p>The lead valley is torn at the bottom and should be replaced/repaired.</p> <p>The fall pipes do not form part of this instruction, however, we noted that there was only one pipe clip holding on all of the sections of the fall pipe here. We recommend additional pipe clips be added in the short term.</p> | |

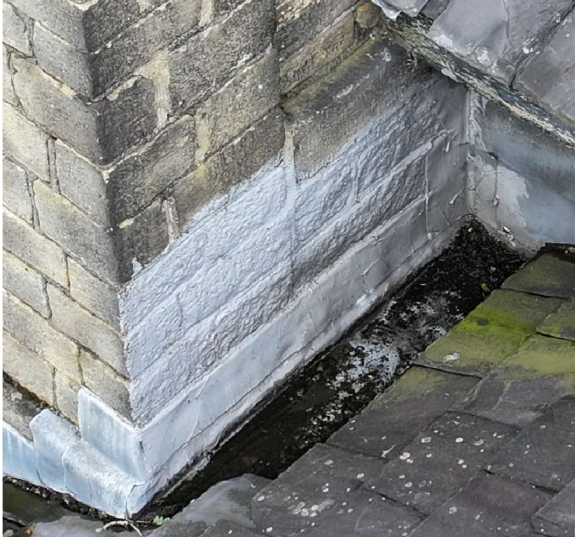
| <p>Centre-right, tower section – the walls do not form part of this instruction, however, painting them with waterproofing paint is wholly inappropriate and will likely cause accelerated decay of the stone below.</p> <p>The eaves detail above should be suitably re-designed to correctly discharge rainwater to the main gutters.</p> | |

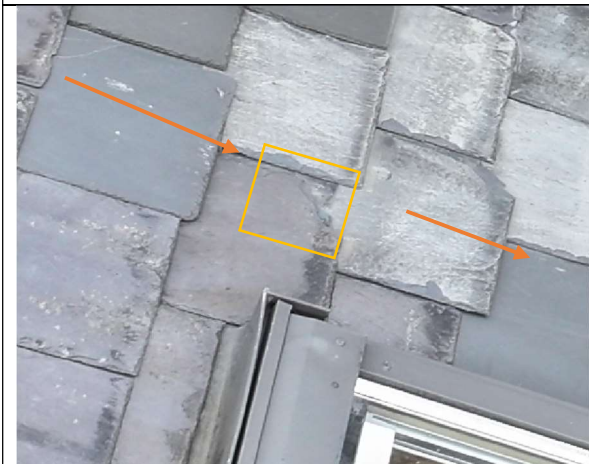
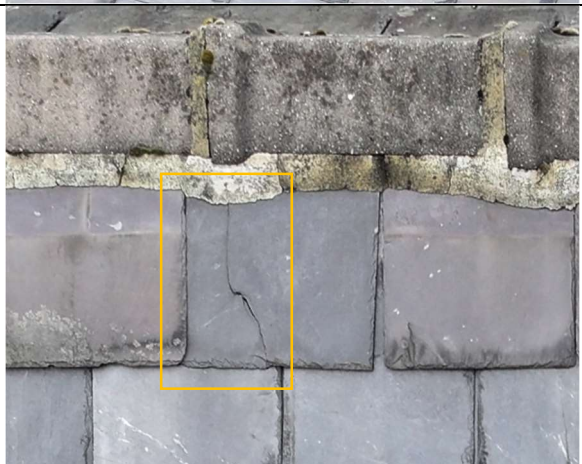
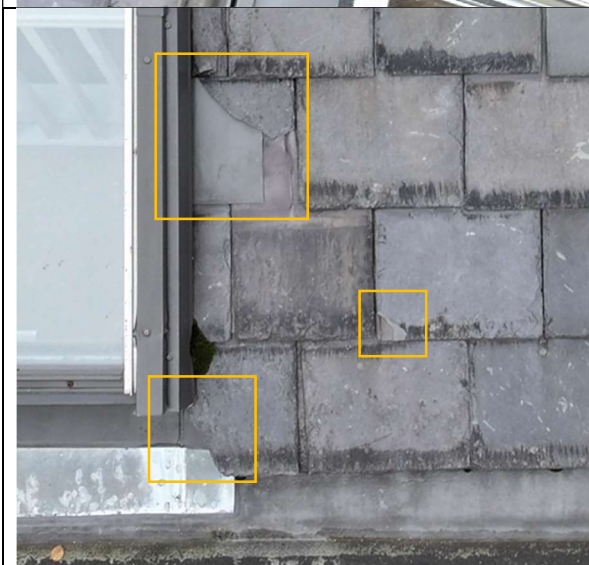
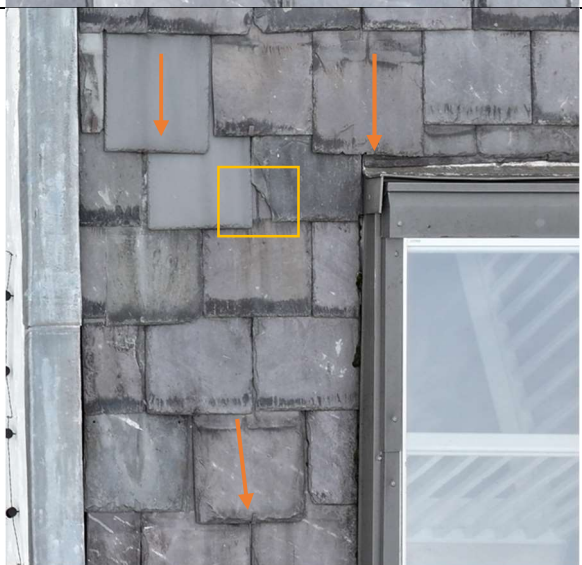
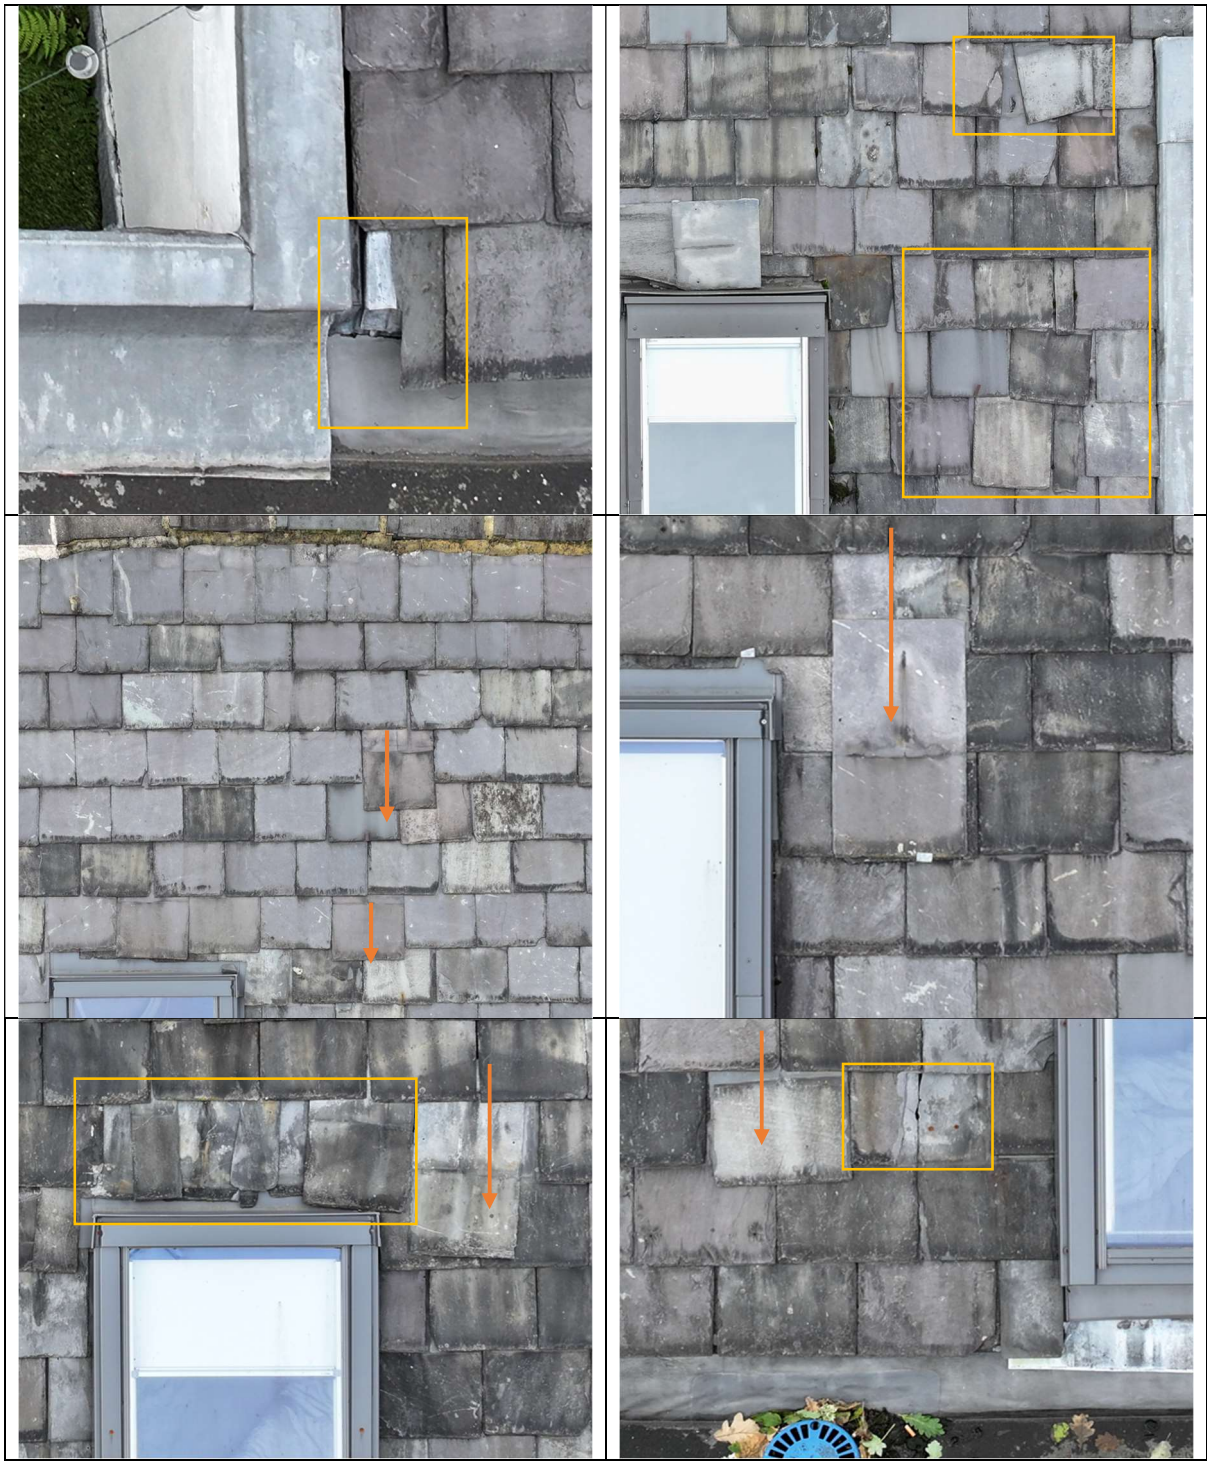
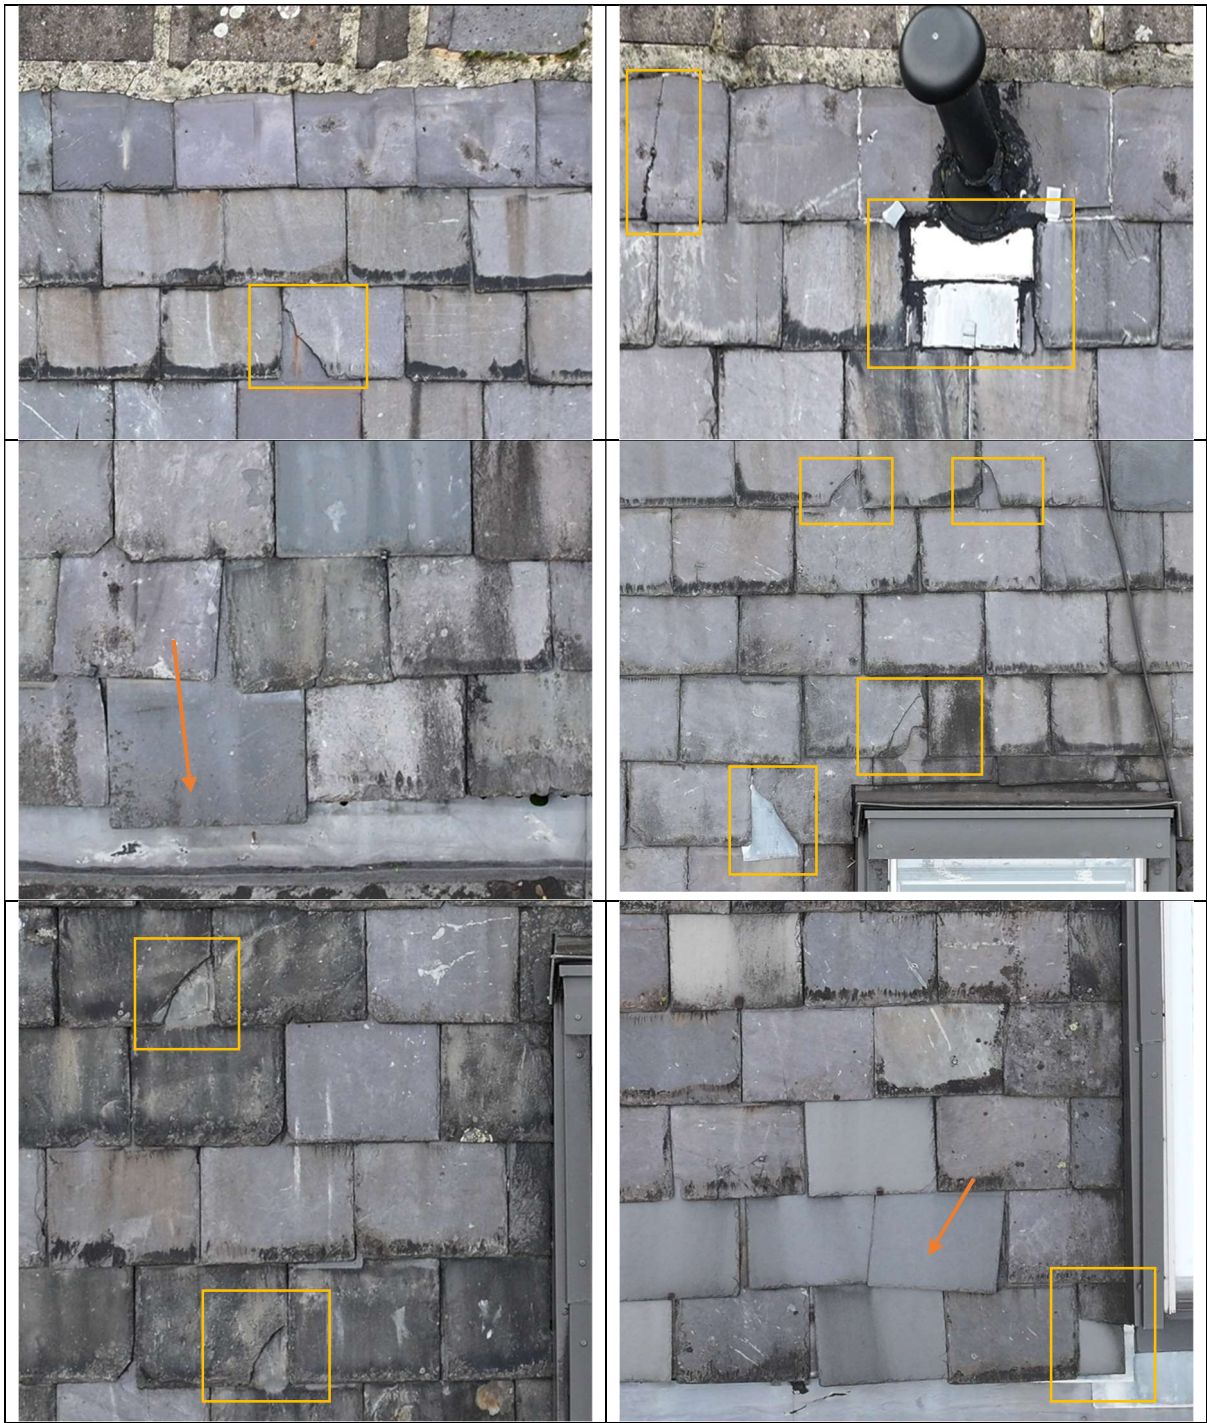
The damaged and slipping slates should be replaced in the short term. We have included photos of the areas of concern below. The photos run left to right and we have marked damaged slates in yellow boxes and slipped slates with an orange arrow.

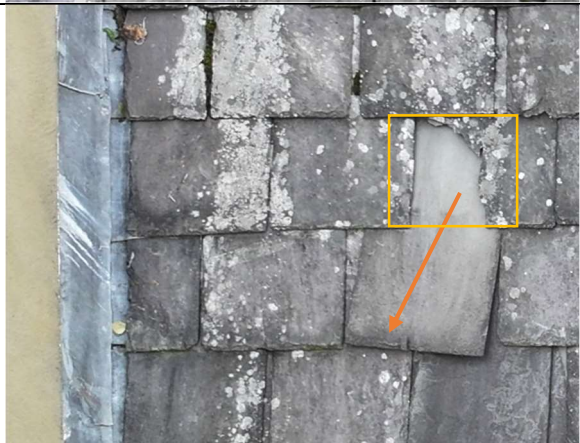
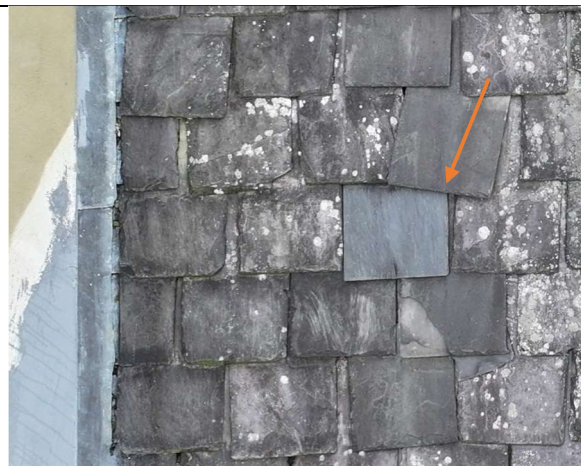
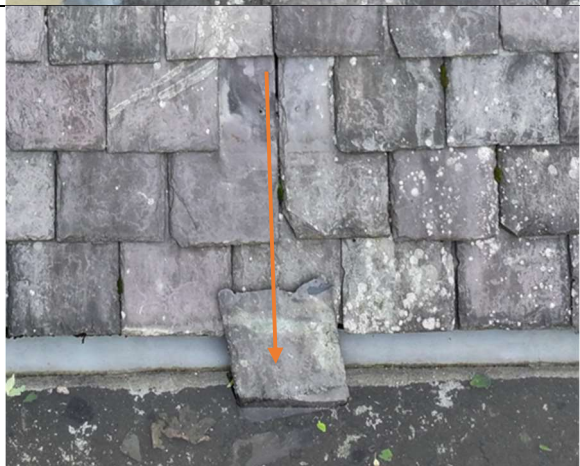
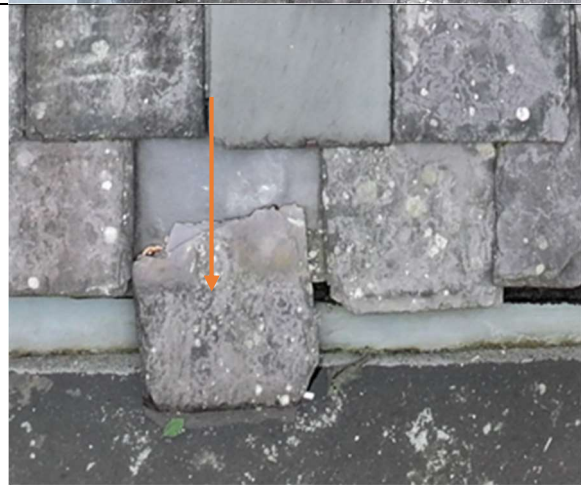
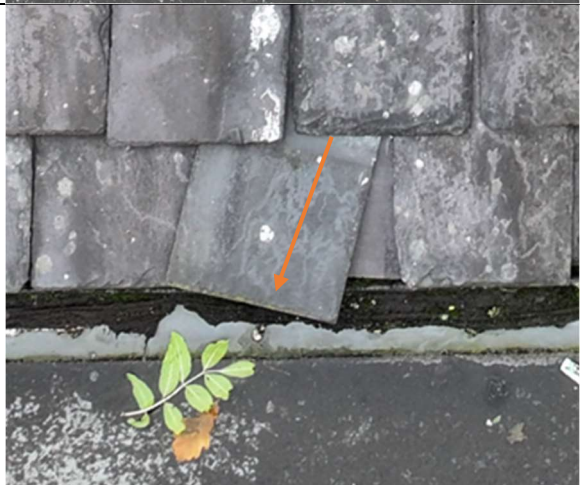
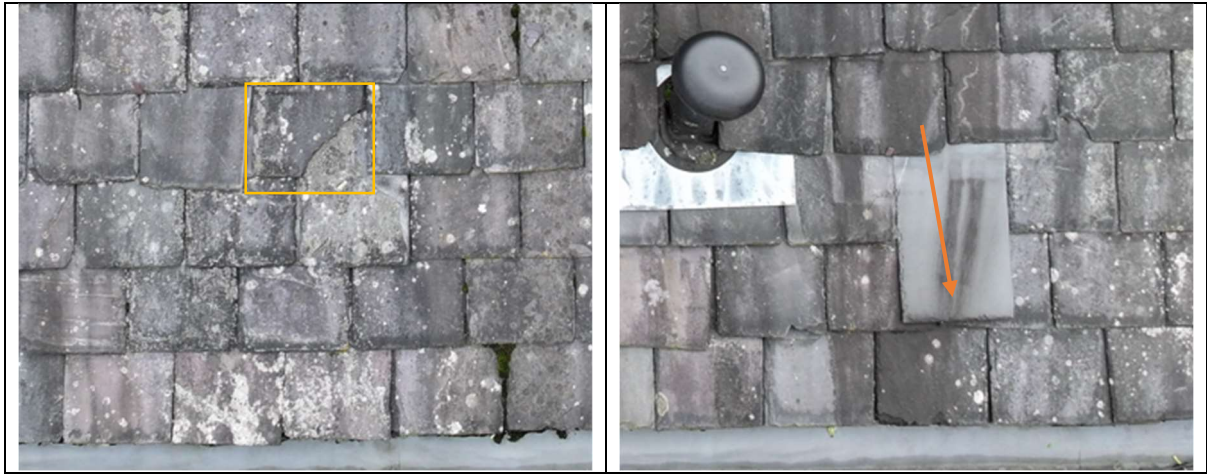
The ridge pointing is in poor condition and will likely need to be raked out and repointed in the next year.

All of the damaged, chipped, slipped and missing slates should be replaced in the short term. Matching slates should be used.

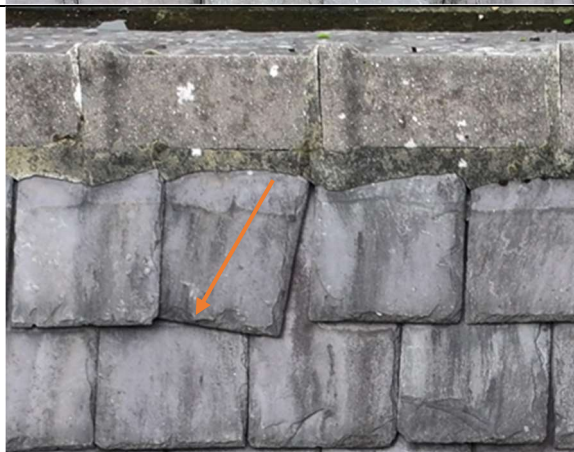
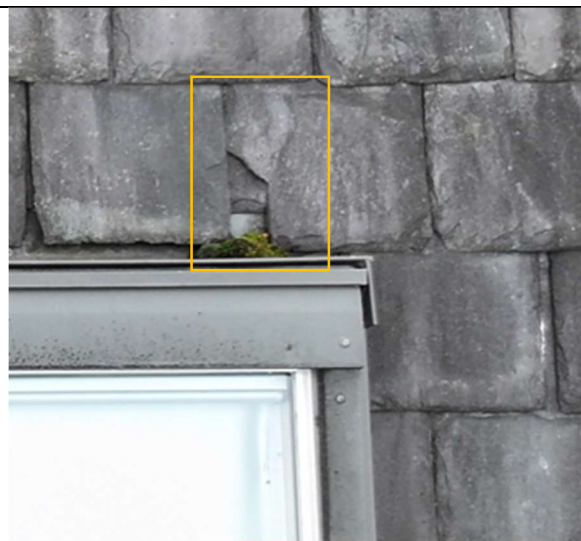
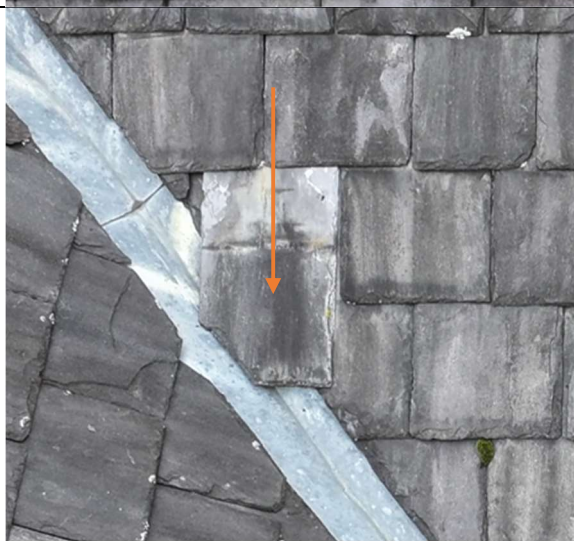
The ridge pointing is in poor condition and will likely need raking out and repointing in the next year.

All of the damaged, chipped, slipped and missing slates should be replaced in the short term. Matching slates should be used.

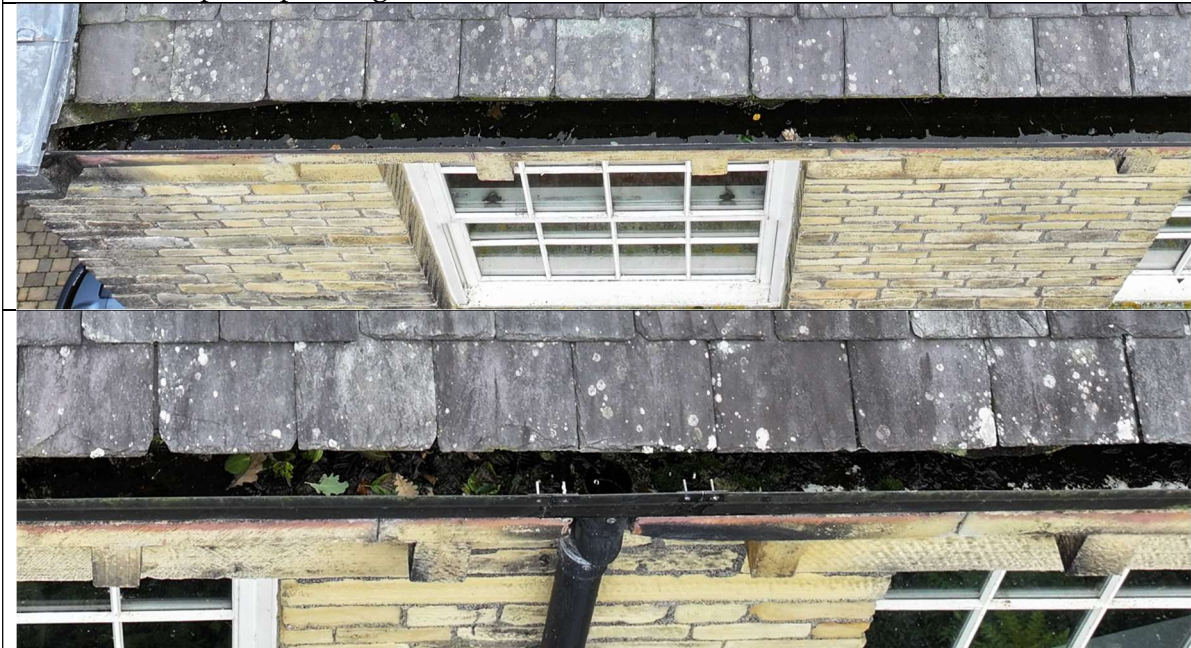
| General comment – there is ponding along the guttering runs. The debris should be cleared and the fall checked and adjusted if needed. There are some example photos of the debris build-up and ponding below. | |

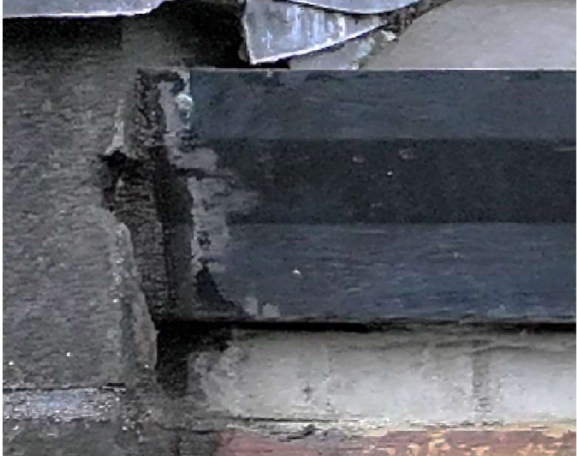
| <p>Left-hand stop-end – there is moisture staining around the stop-end. This suggests that the stop end is leaking and should be re-sealed as soon as possible.</p> | |

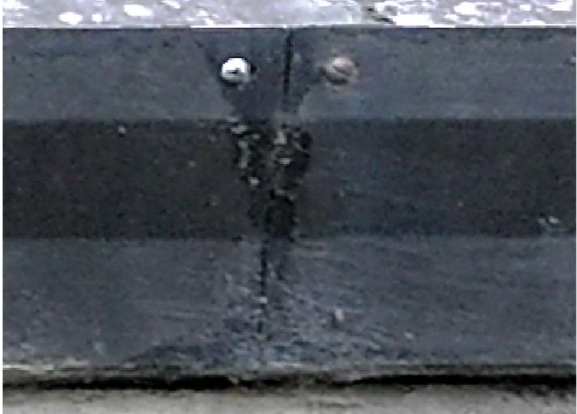
| <p>Second union from the left – the right-hand fixing is corroding and there is a small area of moisture staining and failed paint.</p> <p>This union should also be checked for leaks and repaired as required. The corroded fixing should be replaced</p> | |

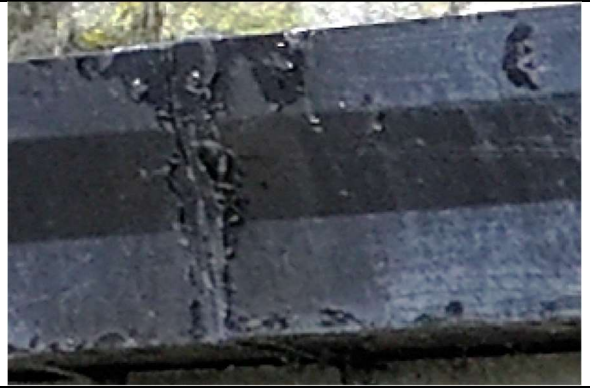
Left-hand tower – there are areas of damaged paint along the run and it looks like some sections have been previously redecorated.

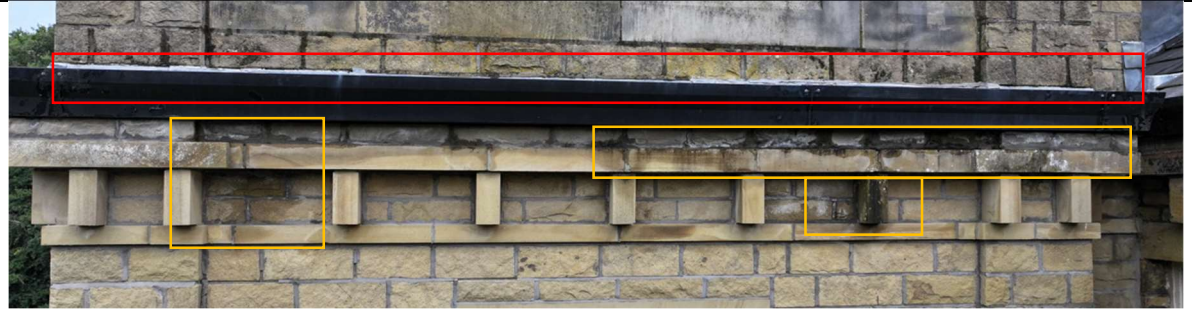
Left-hand tower – red box – sections of the guttering and cover flashing are poorly detailed to the elevation...

Orange boxes – ... this is allowing rainwater to escape down the rear side – this will likely cause premature failure of the guttering run, accelerated decay of the stone and problems with penetrating moisture.

The cover flashing detail should be better detailed in the short-term.

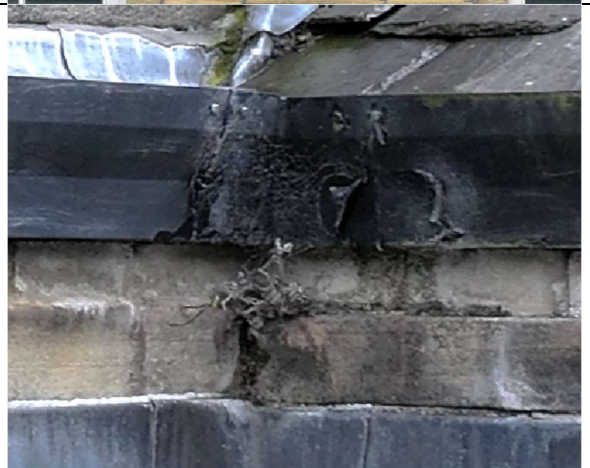
Centre tower, right-hand abutment – there are areas of moisture staining on the gutter and wall below.

The guttering should be repaired as soon as possible.

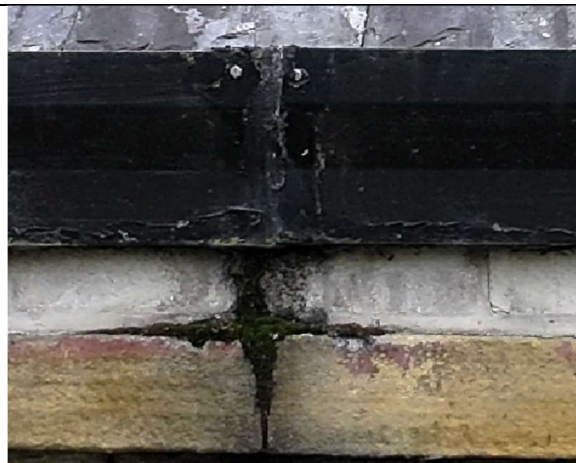
Centre right-hand section, first union from the left – moss is growing immediately below the union, this suggests the union is weeping and should be repaired.

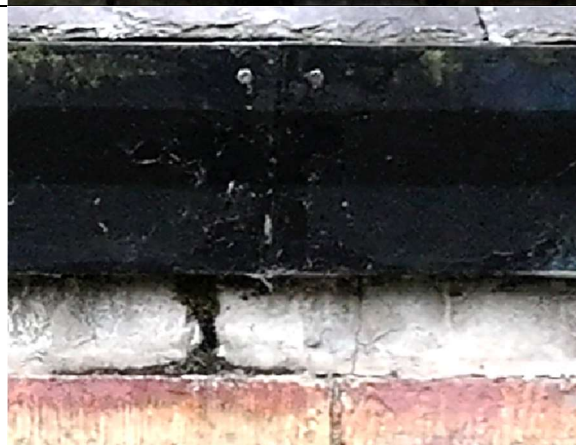
Centre right-hand section, union to the right-hand side of the outlet – moss is growing immediately below the union, this suggests the union is weeping and should be repaired.

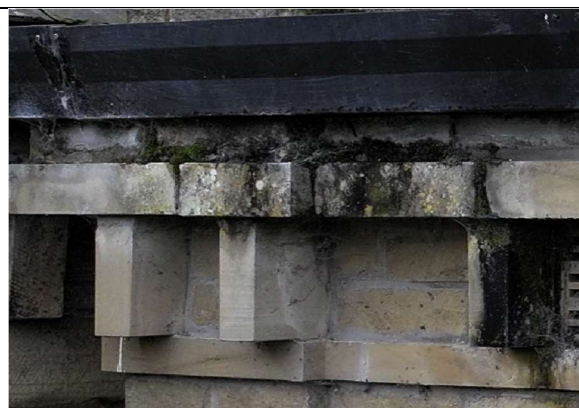
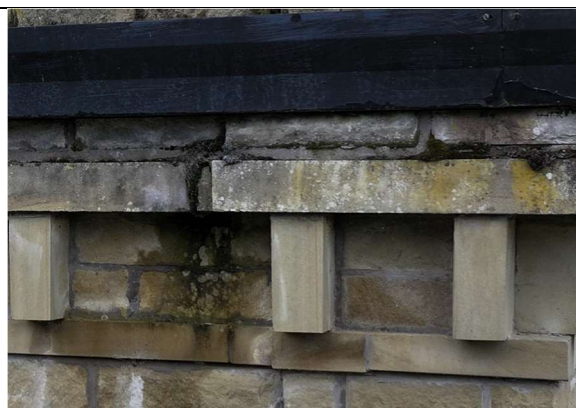
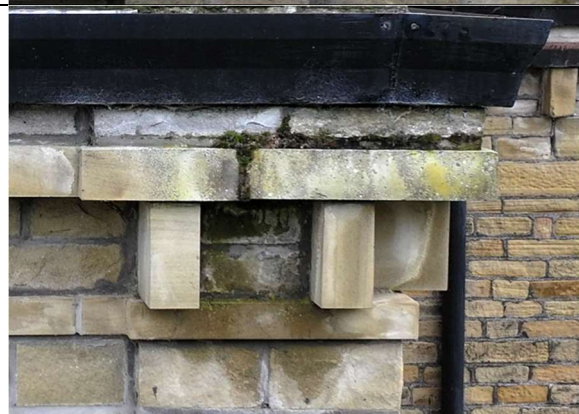
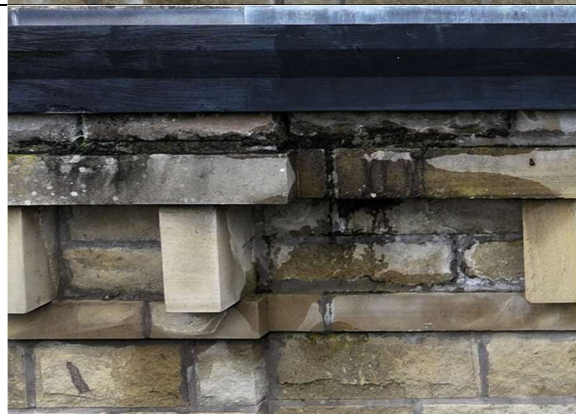
Right-hand tower, all elevations – there is moss building up under the guttering runs. The areas should be checked for leaks and repaired as required.

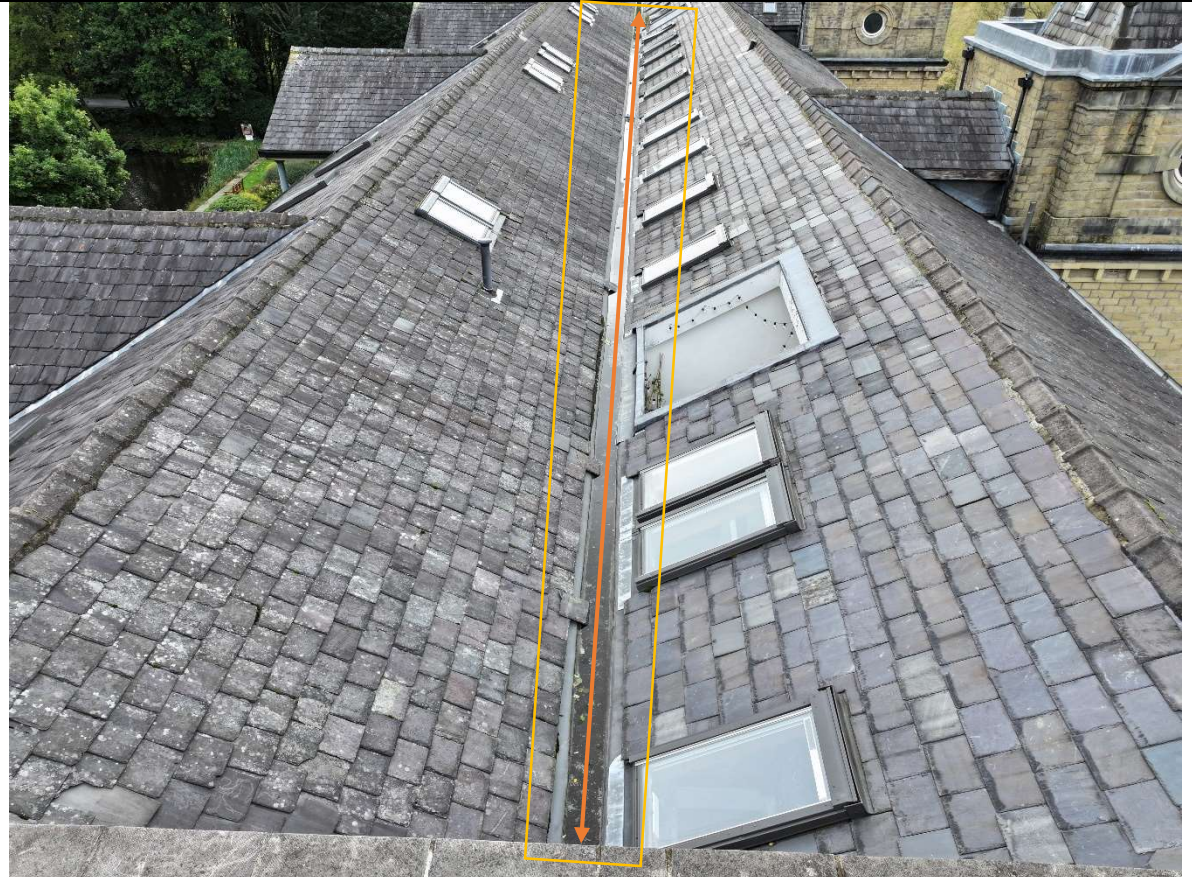
There is ponding along most of the length of the valley gutter – this needs to be cleared out straight away and the fall checked.

We recommend that this is cleared out at least each Spring.

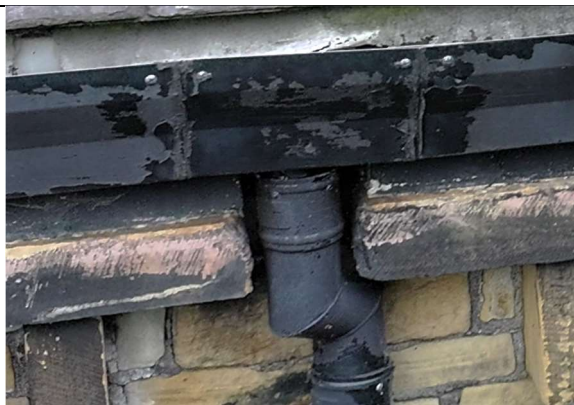
General comment – the guttering looks like it has been over-painted/the top coat is failing. It should be suitably prepared and redecorated according to the manufacturer's technical specifications.

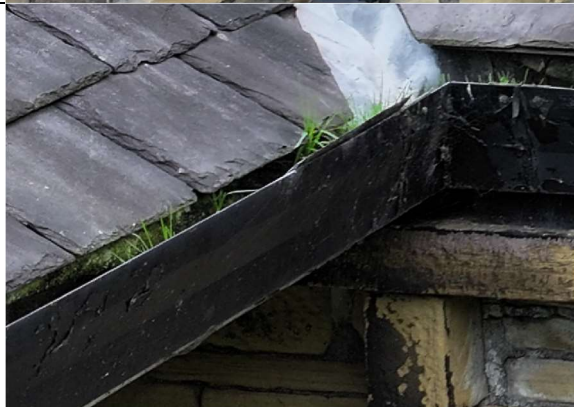
General comment – there is vegetation growing in the guttering. This should be cleared out in the short-term.

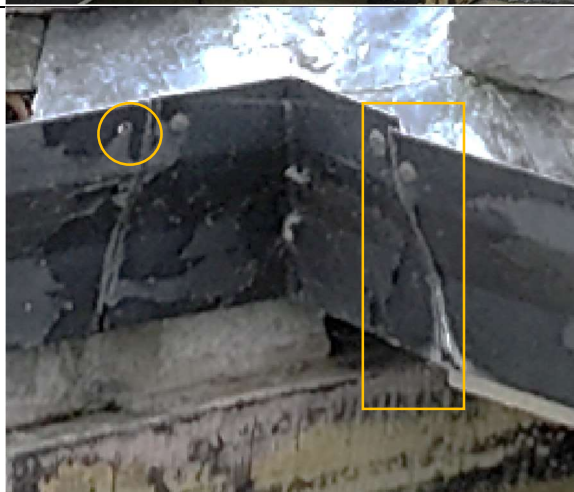
The corner of dormer 8 – one fixing is missing and the corner and run are displaced.

This should be repaired in the short-term.

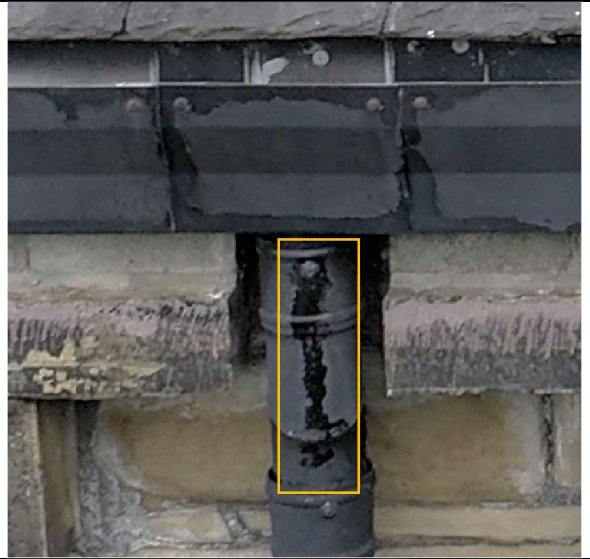
8 – 9 run – the fall pipes are outside the scope of this instruction, however, we noted that there appears to be a leak in this section.

It should be repaired in the short term.

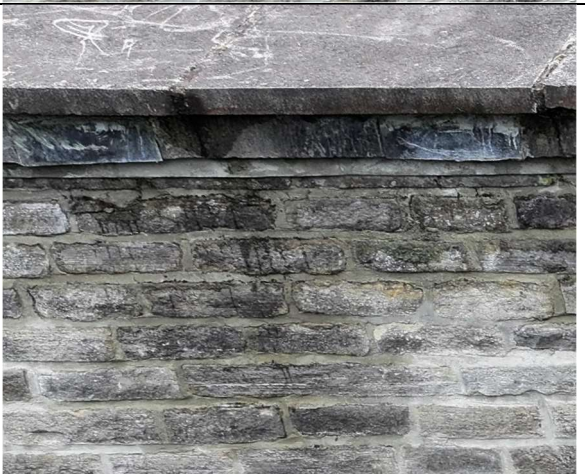
| <p>Coping stones – the wall heads are saturated in places, likely as a result of incorrect detailing (see Section 1.5 below) and missing/inadequate throating (drip grooves) on the underside of the stones.</p> <p>These should be checked next time high-level works are undertaken and cut/amended as necessary.</p> | |
