## Roof Inspection Report

Barkisland Mill

21<sup>st</sup> September 2023

## Drone Inspection Report - Summary of Findings

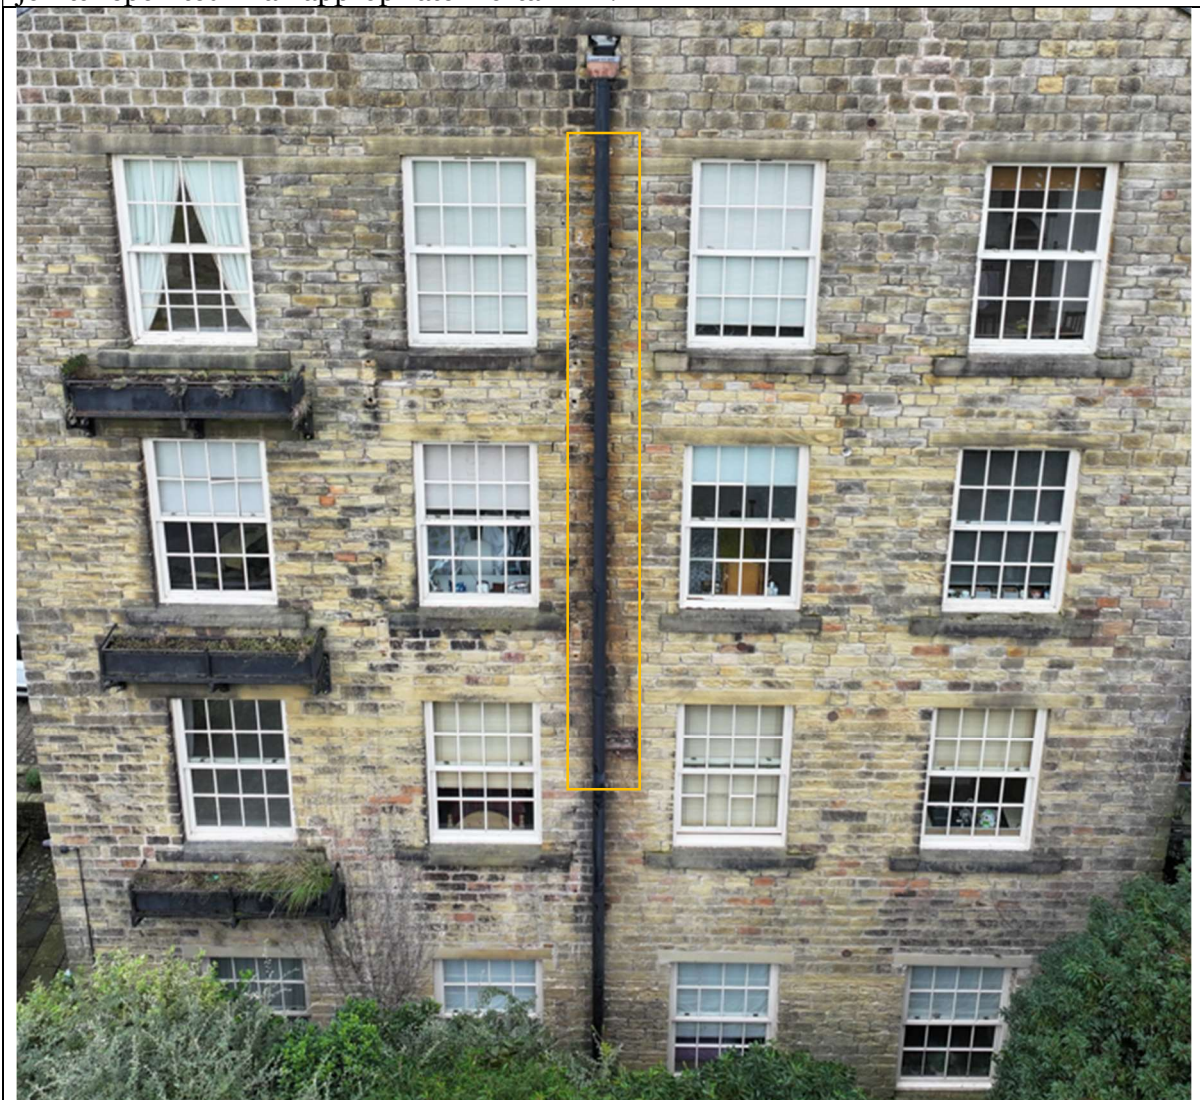
The pointing and detailing on this elevation are not the best. There are several areas where the pointing is missing and needs to be replaced, the detailing around the windows is generally incorrect and there are holes in the stone from historic fixings etc. We recommend a Schedule of Works is prepared in the short term so the works can be properly tendered and undertaken during the 'lime season' (generally, April/May to September/October). This work will require a suitably engineered and wrapped scaffold.

The wall around the fall pipe is stained and mortar has washed out of the joints. This looks to be historic, however, it should be checked during and following rain to ensure the fall pipe is not leaking.

Once this has been addressed, the stonework should be appropriately cleaned and the joints repointed in an appropriate mortar mix.

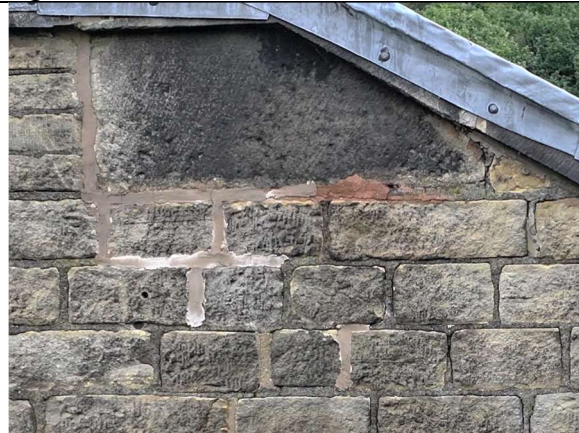
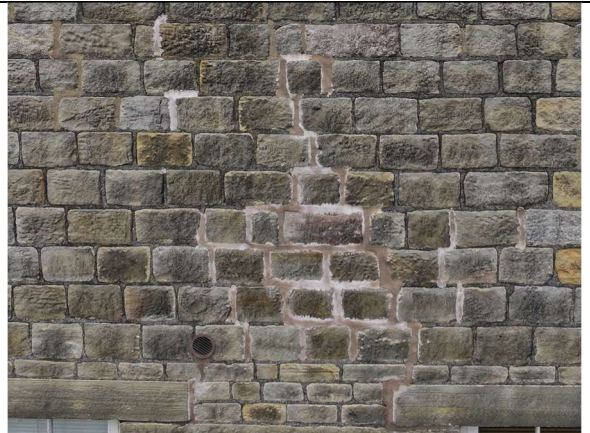
Rear spandrel – the areas of repointing on this section of the wall have been undertaken to a poor standard.

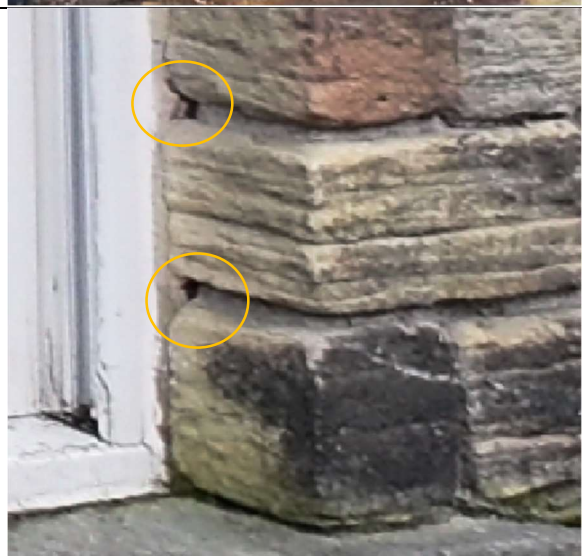
An example photo of where there are gaps in the detailing around the window reveals.

Note: the timber windows are not part of this instruction, however, on the photos taken, these look like they are in need of localised repair, appropriate preparation and redecoration – see our comments above on paints as this looks to be the primary cause of accelerated decay here.

The mortar should be raked out, the stone joints repointed and the abutments detailed in burnt sand mastic.

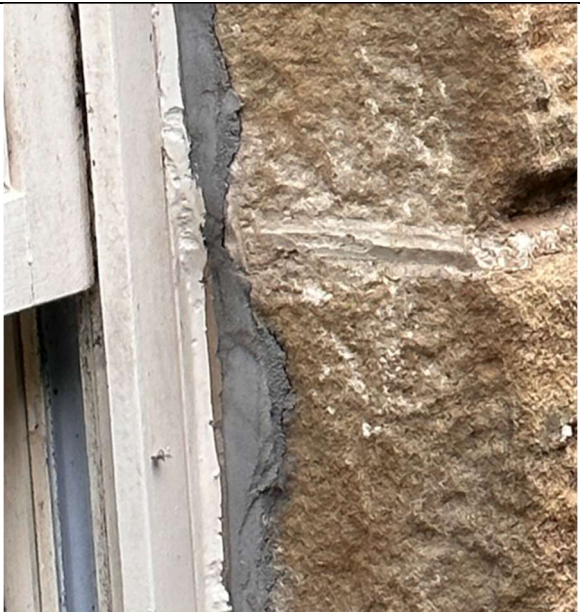
| <p>An example photo of incorrect detailing around the window reveals.</p> <p>The mortar should be raked out, the stone joints repointed in an appropriate mortar mix and the abutments detailed in burnt sand mastic.</p> | |

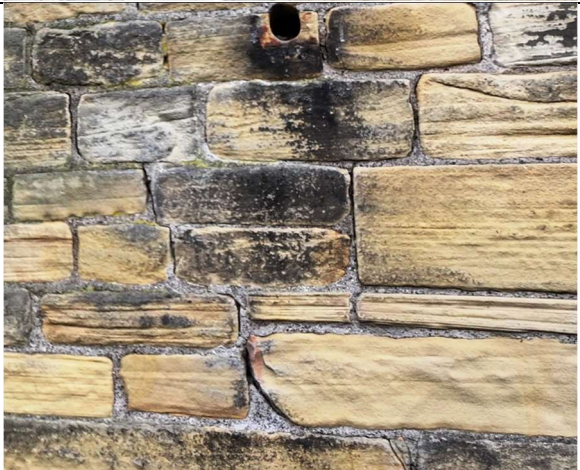
| <p>There are several areas where there has been a little movement in the structure and the mortar joints have opened up.</p> <p>These joints should be raked out and re-pointed.</p> <p>See our comments above on mortar.</p> | |

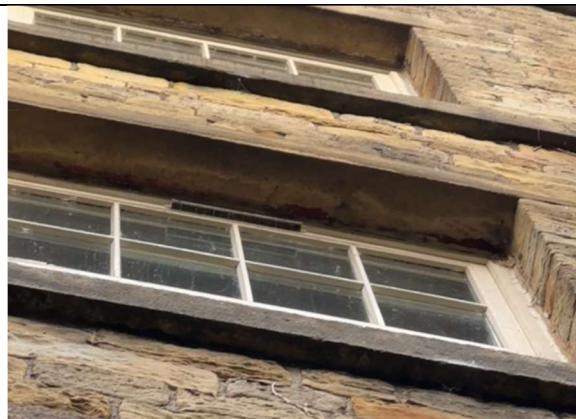
Windowsills – there does not appear to be any throating on the windowsills.

Consideration should be given to cutting throating into the underside of all of the windowsills.
