Roof Inspection Report

5 Baldwin Terrace

Halifax

8th November 2023

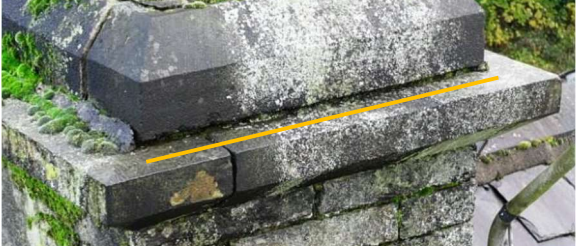
Right-hand side – the front centre corbelling stone is not sat square and the pointing is missing from the joint. Rainwater will likely be entering the stack and flue via this joint.

The stone should be re-set and the joints repointed.

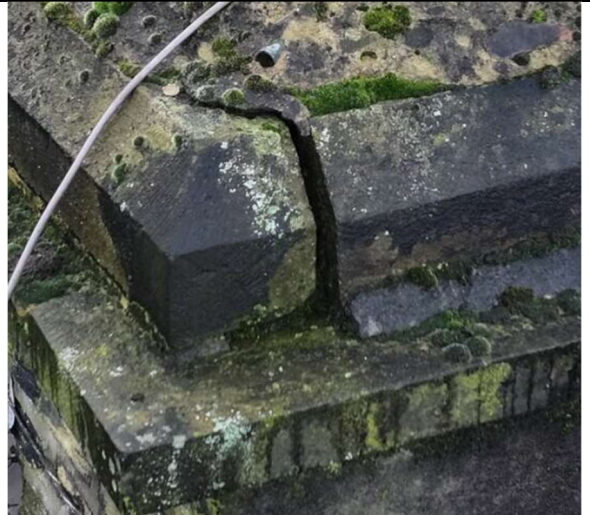
The damaged corbelling stone should be repaired next time high-level works are undertaken.

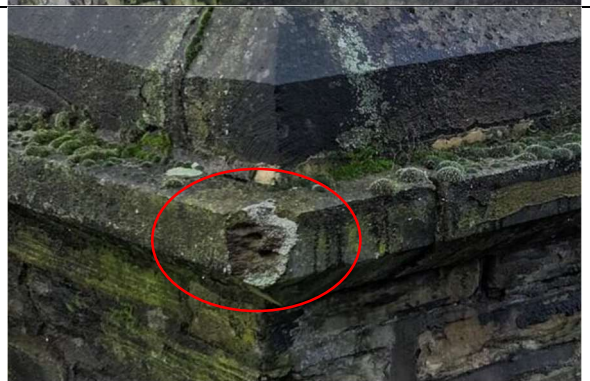
Parts of the stack have been repointed. Based on the colour of the mortar, this looks like a cementitious mix which is inappropriate for a stone stack. See our comments above on mortars.

Areas of stonework are decaying and these should be defrased.

Consideration should be given to raking out and repointing the stack in the short-medium term.

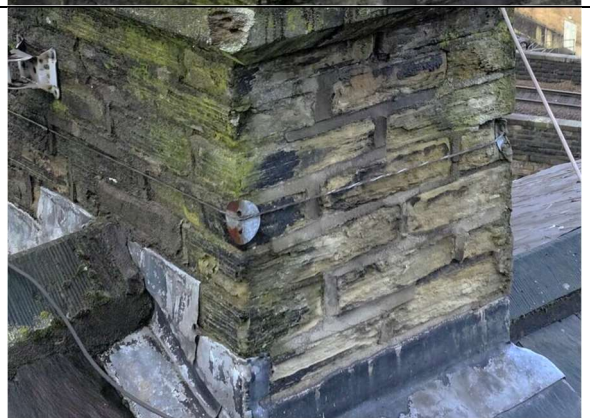
Saddle pieces are missing on both sides of the stack where it meets the ridge. These should be added next time high-level works are undertaken.

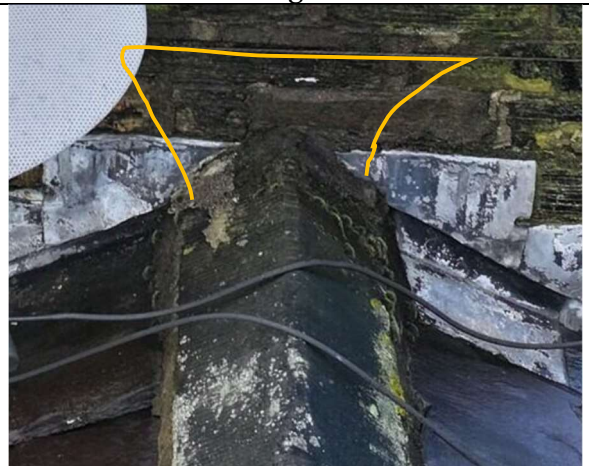
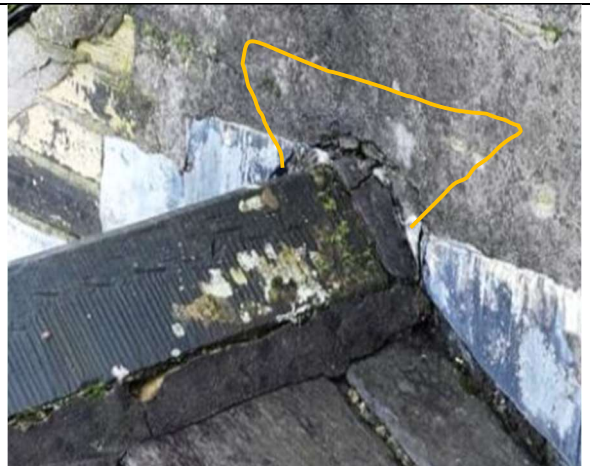
The restraint straps are missing on the front apron on the front of the property

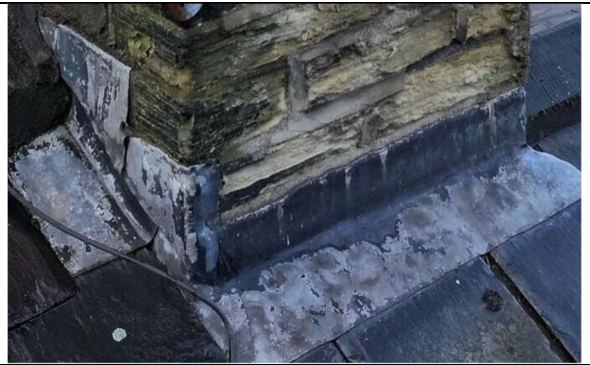
The front apron on the back of the stack has been poorly detailed and should be replaced with a correctly detailed front apron and restraint straps in the next couple of months.

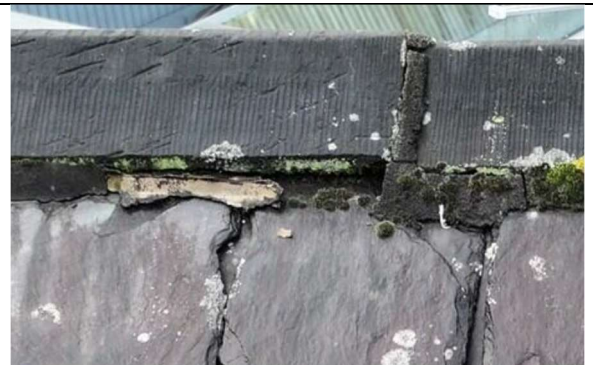
The areas of missing and damaged pointing around the ridge tiles should be raked out and the ridge repointed in the next couple of months.

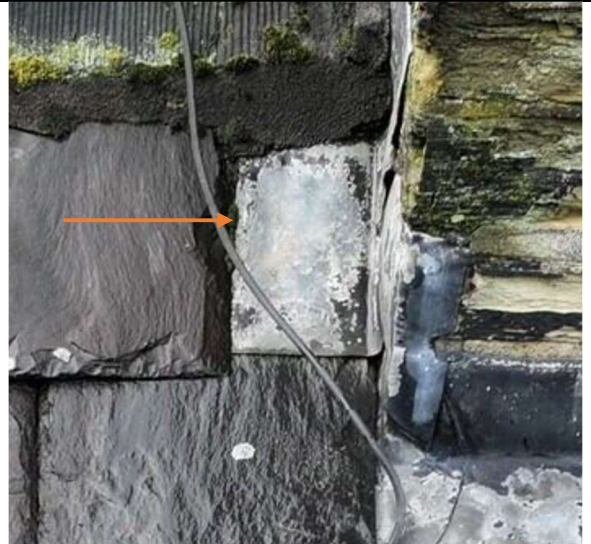
The missing slate at the ridge/chimney abutment should be replaced next time high-level works are undertaken.

Note that a lead soaker is not an appropriate replacement for a slate.

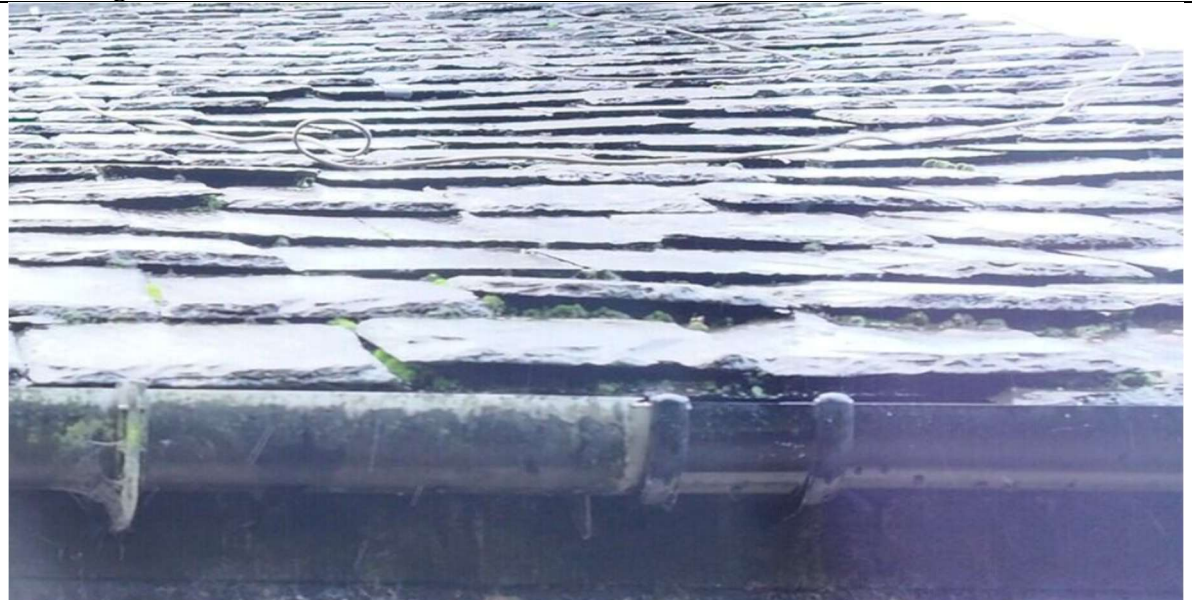
The slates do not all sit flat to the pitch, particularly on the lower portion of the roof. This could be allowing wind-driven rain into the roofspace, particularly around the eaves. We recommend that this is investigated further when it is dry and the slates reaffixed so they sit flat against each other.

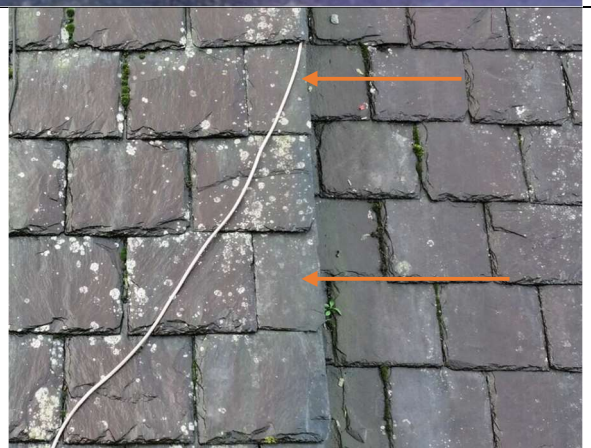
The verge detail is incorrect – the slates here run:
Half-slate
Slate
Half-slate
Slate etc.

They should run:
Slate
Slate and a half
Slate
Slate and a half, etc.

There is no way of economically correcting this.

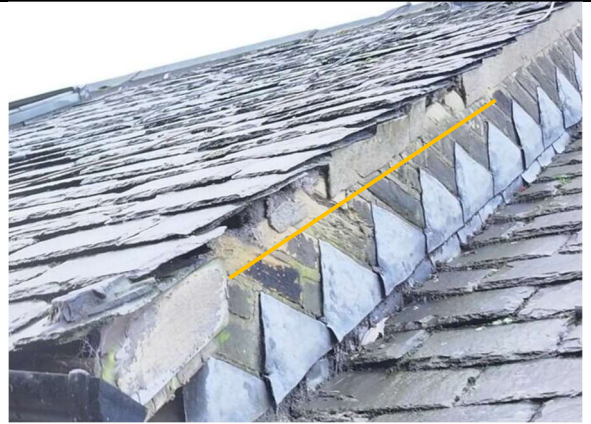
Verge – there is an inadequate projection of the slates over the verge, they should project at least 50 mm to shed rainwater clear of the elevation.

There are also several sections of pointing that are cracked and/or missing. Rainwater could be entering the wallhead and the roofspace here.

We recommend that the ridge be repointed in the next couple of months. See our comments above on mortars.

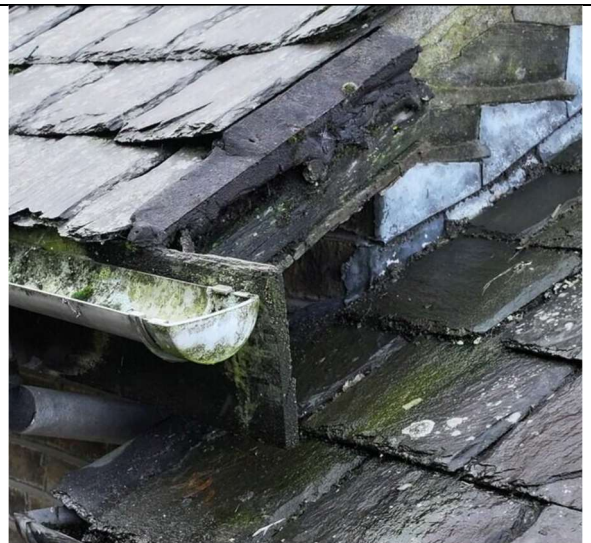
Where the verge meets the eaves, the detailing is poor.

This area of the roof should be redesigned when the weather is dry.

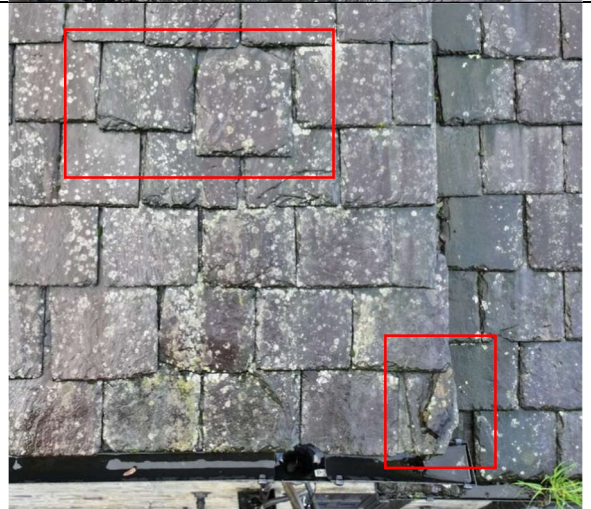
The slipping and slipped slates should be reaffixed as soon as possible as they may be allowing rainwater to penetrate the roof.

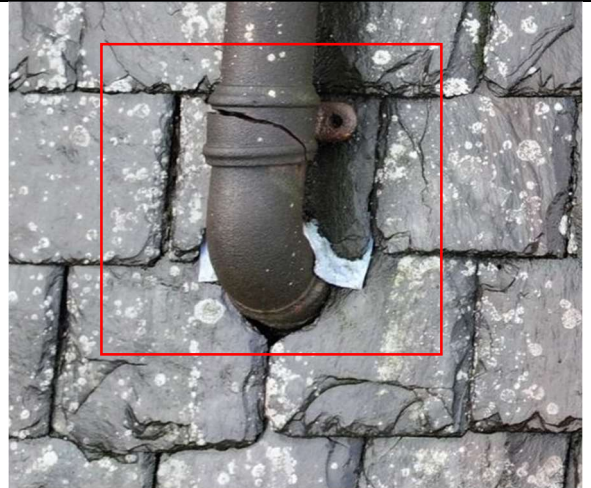
Soil vent pipe – there is a crack straight through the pipe. This should be made safe as soon as possible and then repaired/replaced.

It is unclear how this penetration through the covering has been weather-sealed. It should be inspected close-up to ensure it is weathertight.

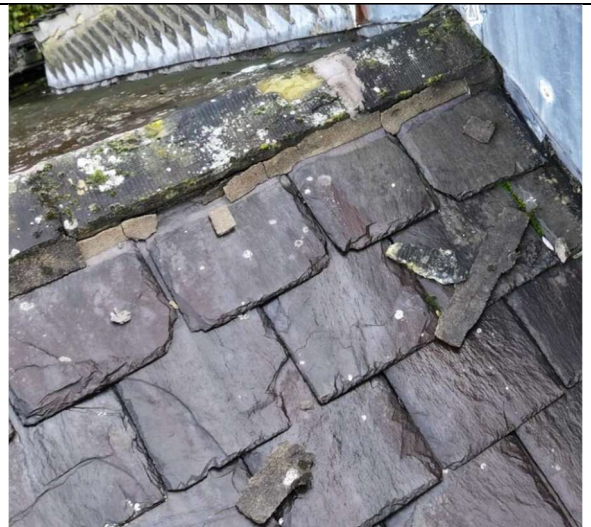
The damaged ridge pointing should be removed and the ridge repointed. We recommend that this work is undertaken in the next couple of months.

The debris should be cleared off the pitch.

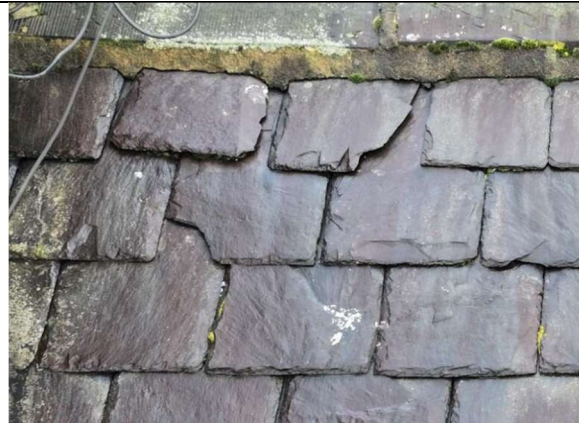
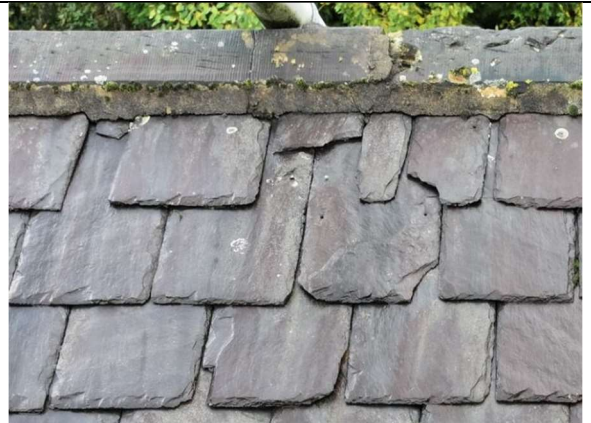
The missing and damaged slated under the ridge should be replaced in the next couple of months.

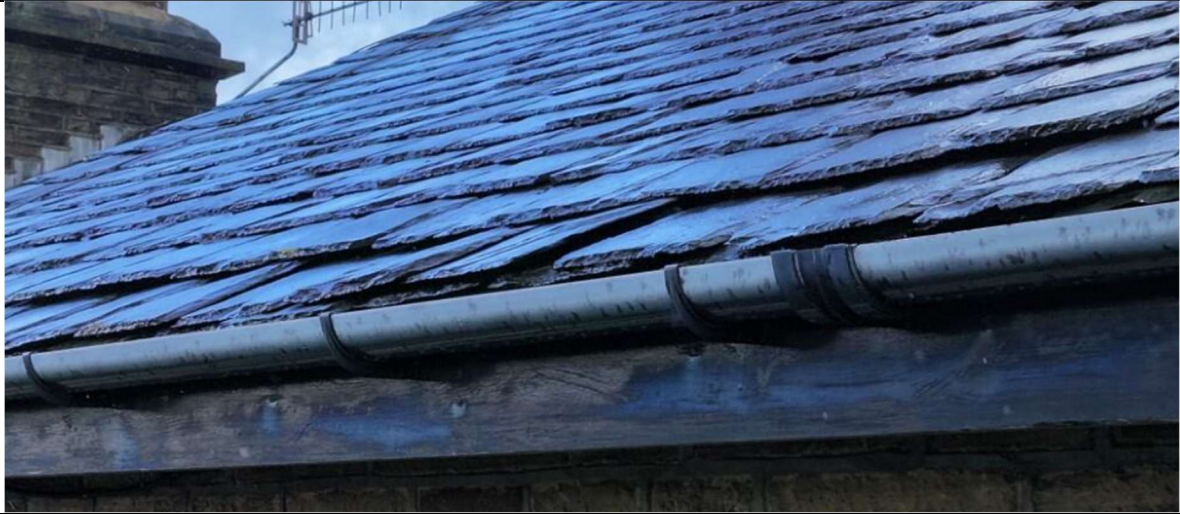
The slates do not all sit flat to the pitch on the lower portion of the roof. This could be allowing wind-driven rain into the roofspace, particularly around the eaves. We recommend that this is investigated further when it is dry and the slates reattached so they sit flat against each other.

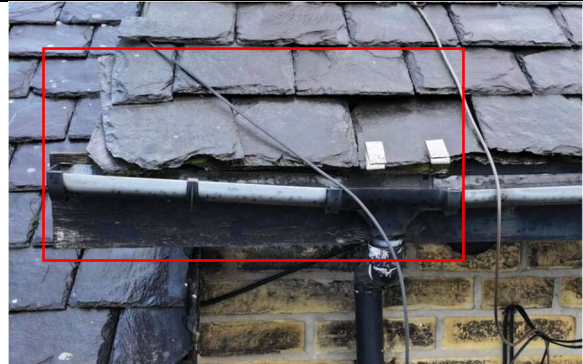
The detailing around the verge/eaves is not particularly good.

With some thought, this could be improved to better discharge rainwater into the guttering...

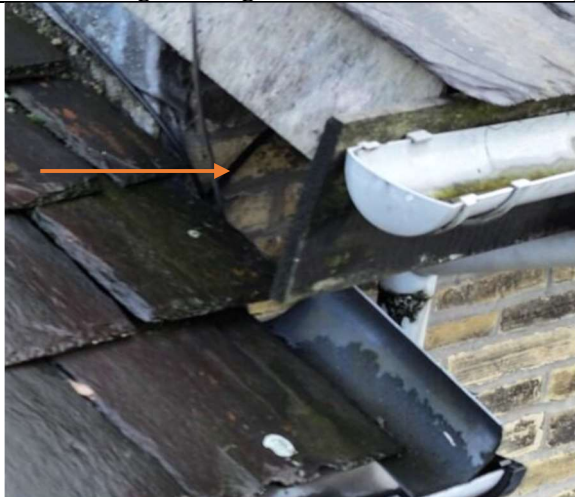
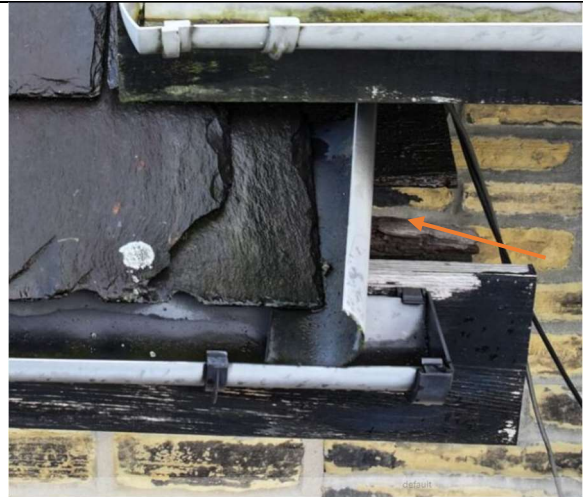
... Rainwater is likely escaping off the verge here and saturating the wall head below. The section of guttering on its side is not an adequate solution to address this.

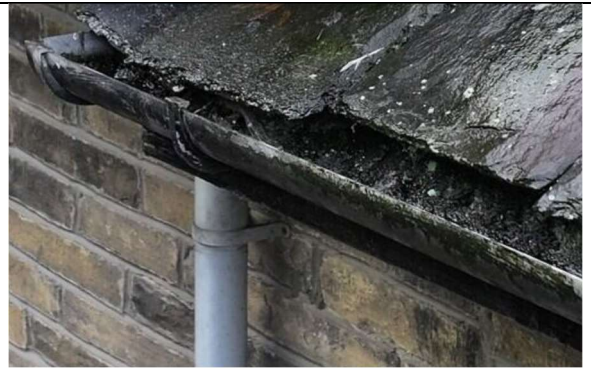
The debris in the guttering runs should be cleared in the next couple of months and should be kept on top of going forward.

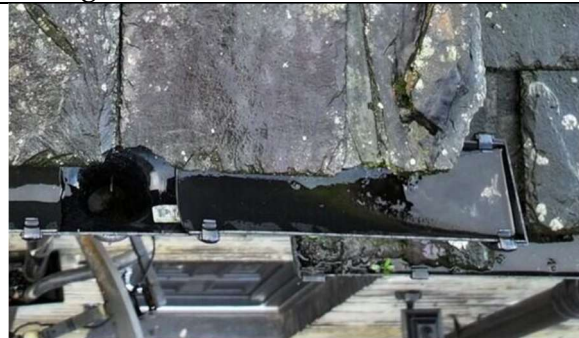
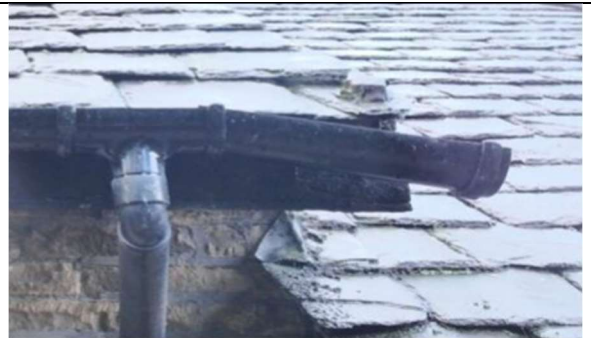
Front elevation, right-hand side – the end section is only being supported on the outlet joint. A bracket needs to be affixed soon as the section is full of water and will likely damage the outlet.
