External Roof Survey Report

**Daisy Bank
109 Duckworth Lane,
Bradford,
West Yorkshire,
BD9 6RL**

**JNR Contracting Limited
Authored by: Jamie Robson MAPM AIC
Aerial Drone Footage provided by: Rotorgraph**

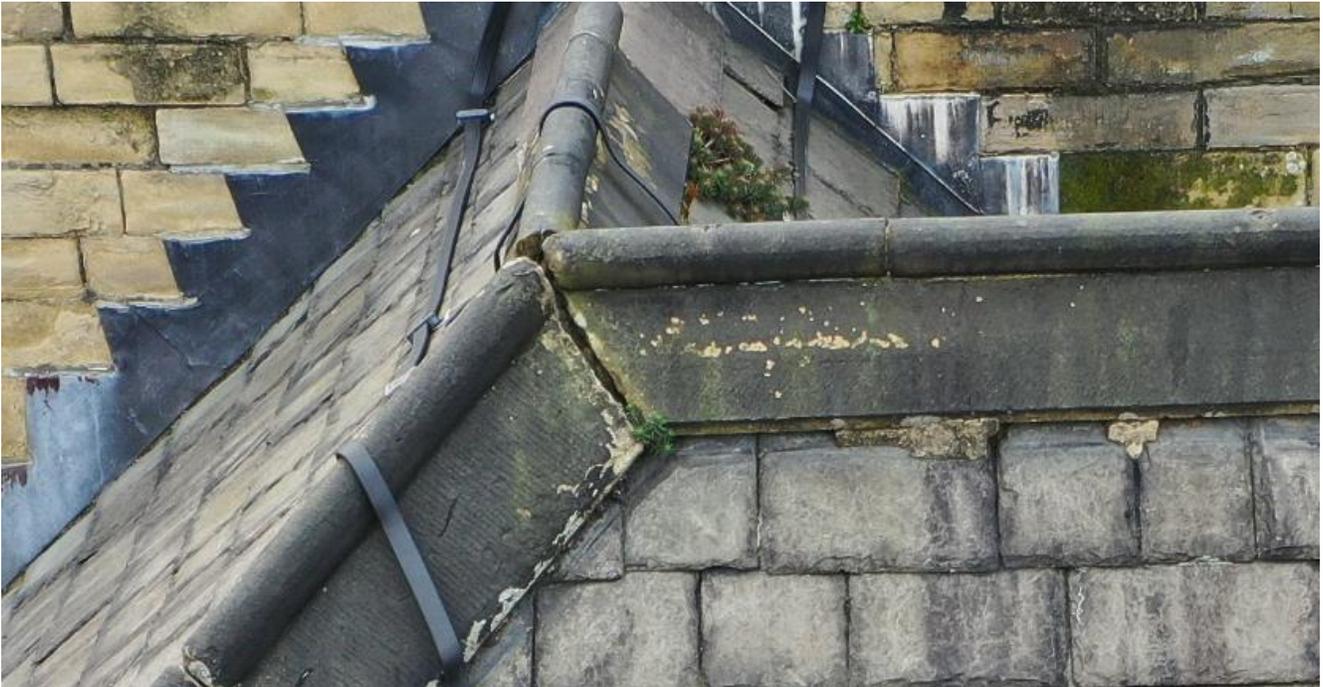
Where the roll top ridges meet, this area should have cement pointing in the crown in the middle. It has completely eroded, and there is almost no pointing holding the ridges on. This leaves them prone to leaking and blowing off in strong winds.

- Repoint all ridges throughout the roof structures
- Rebed ridges where required
- Replace ridges where required
- It is questionable whether the incorrect concrete ridges should be replaced, they are not correct for this building but that is more a matter of heritage and preservation.
- All loose slates should be refitted
- Any broken slates should be replaced
- The lead verges should be removed and replaced with appropriate heritage roll top ridges.
- The lightning conductor will have to be temporarily moved to allow these works
- Any timber sections of verge should be replaced where rotten and recapped in lead to match the rest of the site.

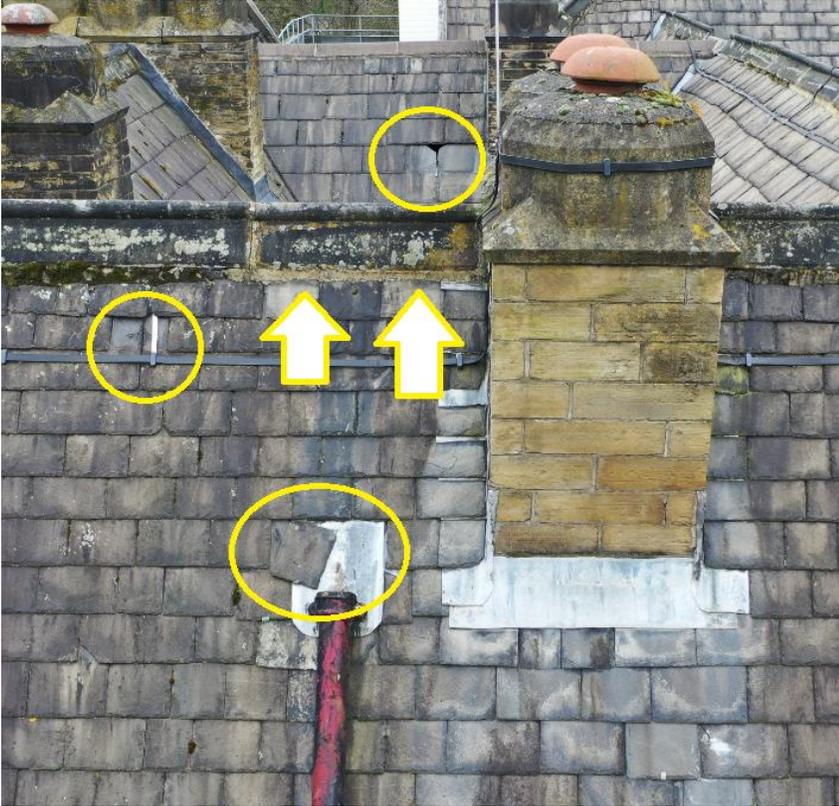
In the picture below, this highlights a typical section of the roof. A slipped slate has revealed a hole which goes straight through the roof – we would refer to this as a leaker. The ridge pointing is almost completely eroded and the ridges debonded.

A slipped slate is evident in the foreground revealing another leak. The cast iron soil stack is also severely eroded and may be barely functional.

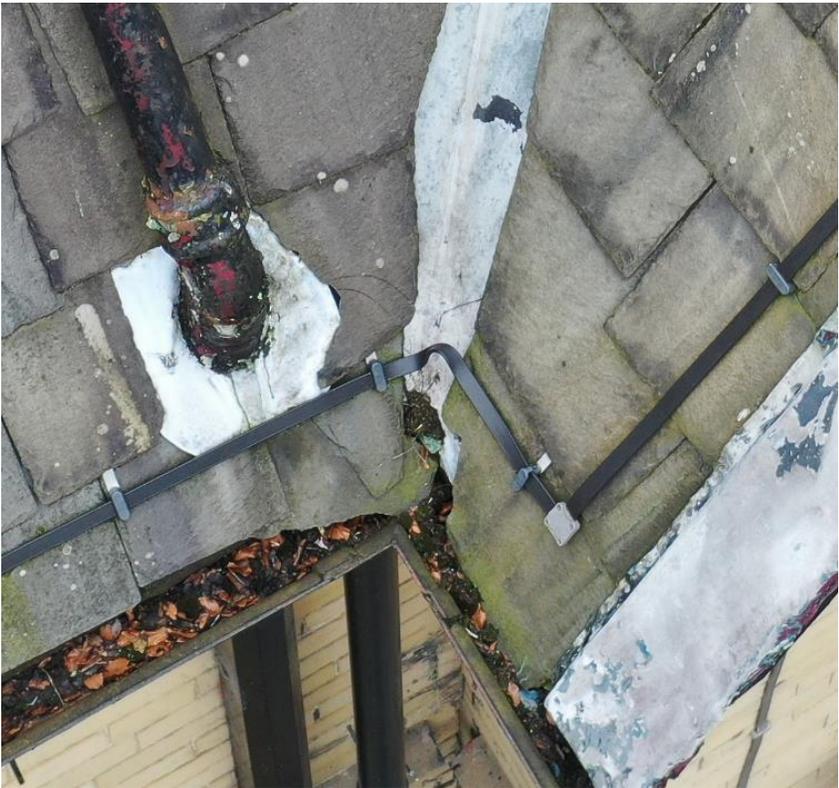
Below, the slates are broken around the lead collar on the soil pipe revealing another leaker. Another slate has slipped into the gutter corner reducing its functionality.

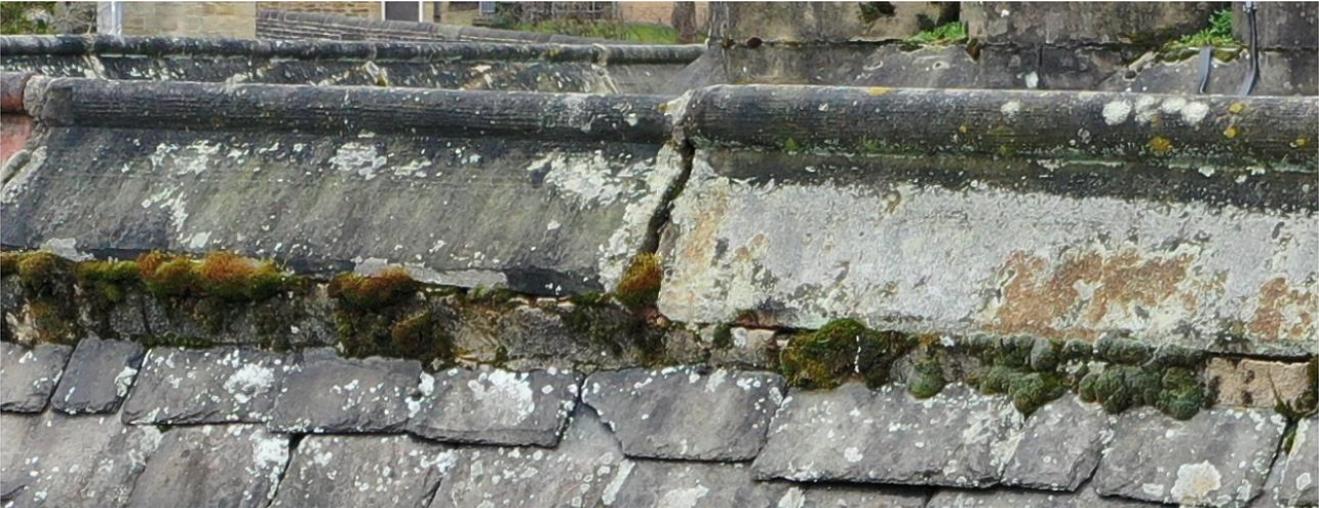
Below, a further example of severely eroded ridge pointing. There should be cement lapping between the joints and below, but it almost gone.

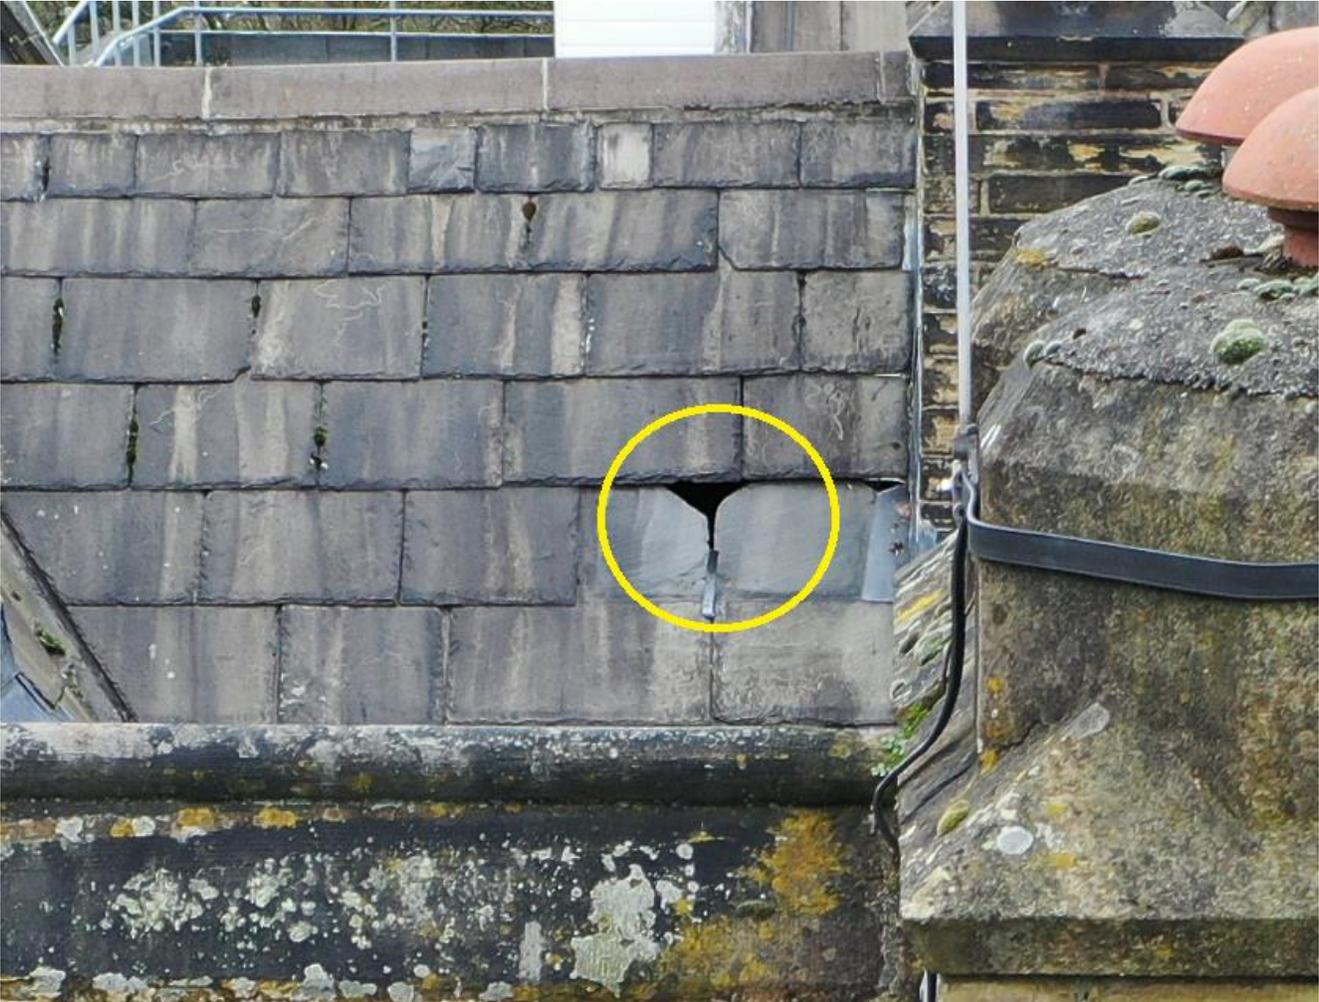
Below, an example of a large missing slate that has caused an open hole in the roof. At the top of this peak the ridges have been replaced with the wrong ridge tile.

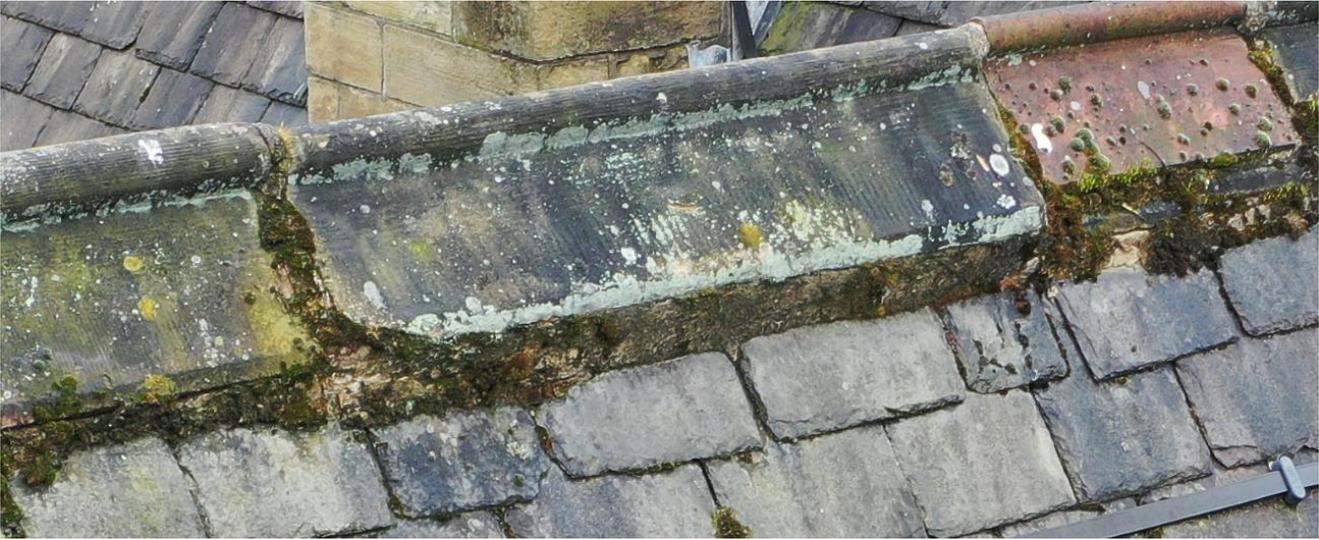
Below – Further examples of poor ridge pointing

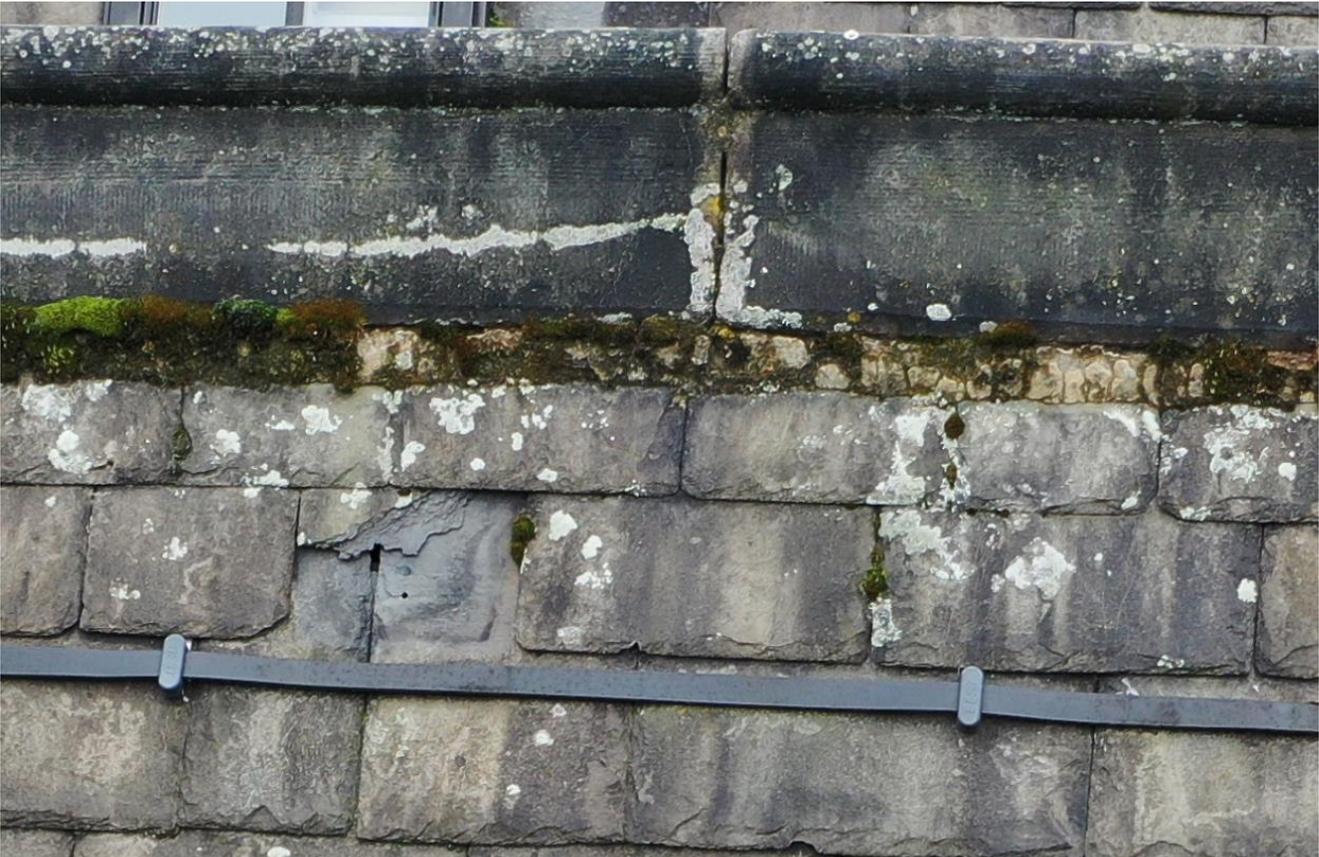
Below – a broken, eroded slate that sits under the ridge line. To get to this the top ridge will need debonding, the slate replacing then rebedding.

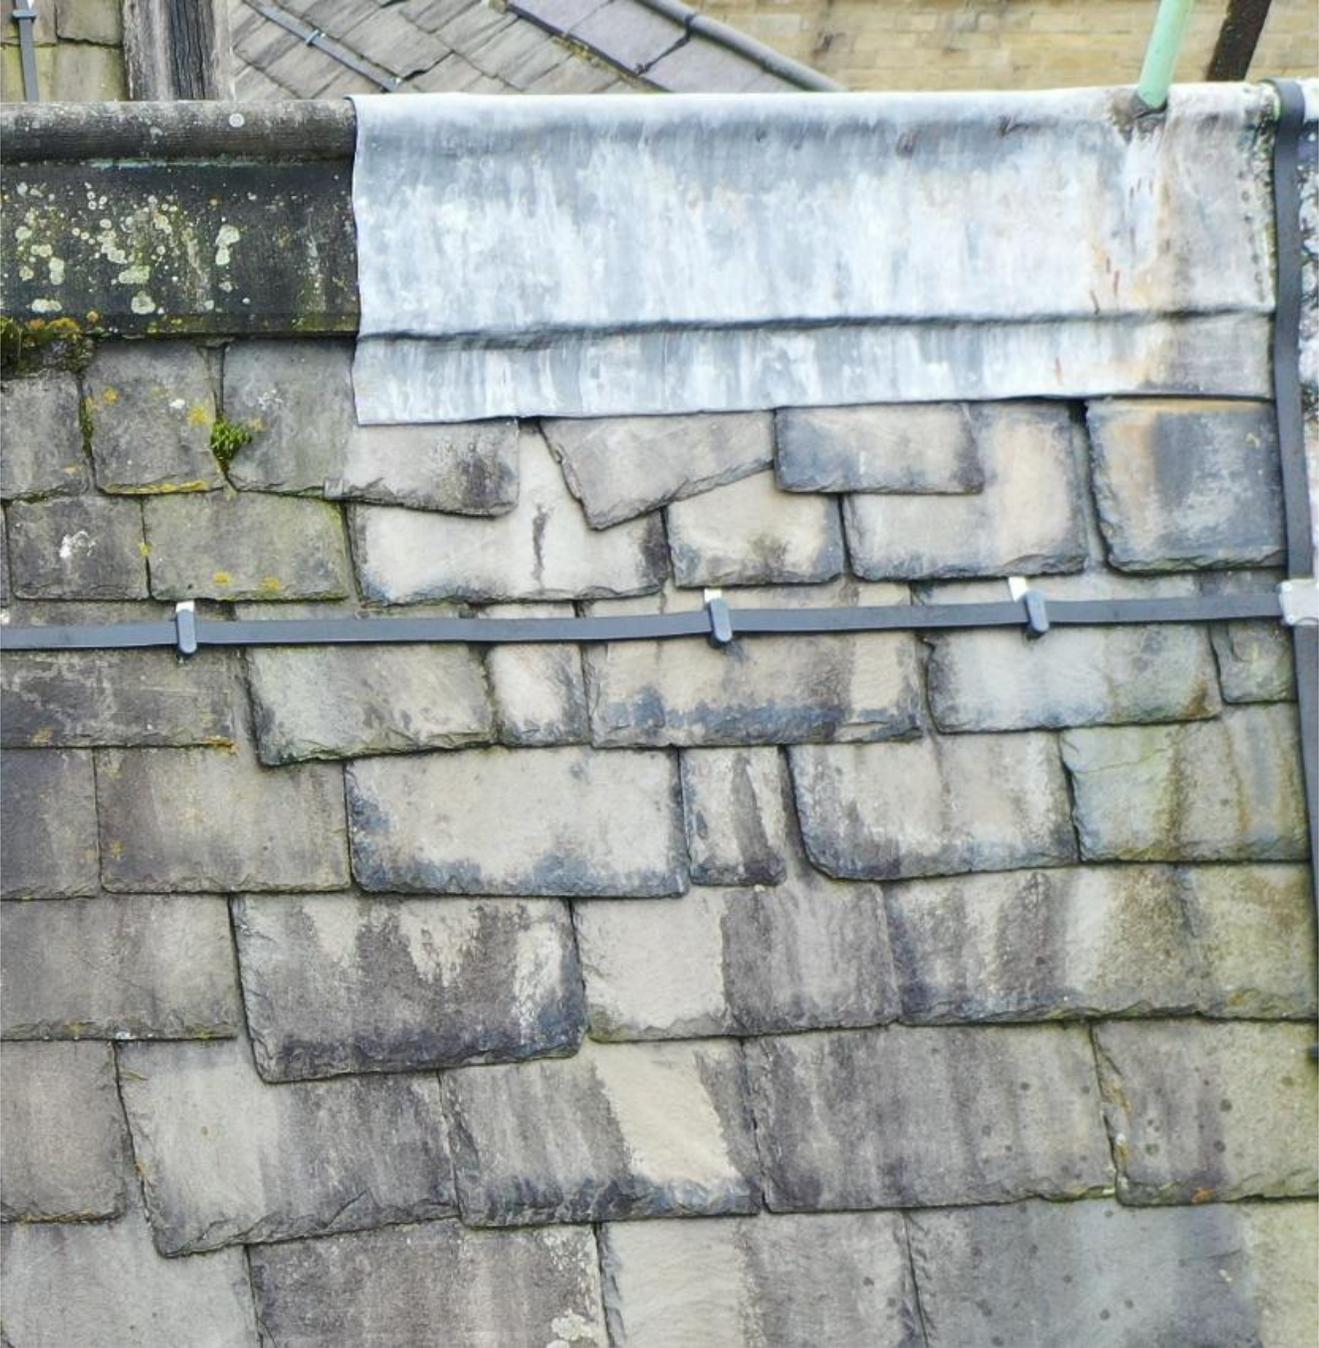
Possibly due to works relating to the lightning conductor (the cable) the ends of the peaks have been poorly cloaked in lead. When this has been carried out, it's completely debonded the slates below which all need stripping and refixing in place.

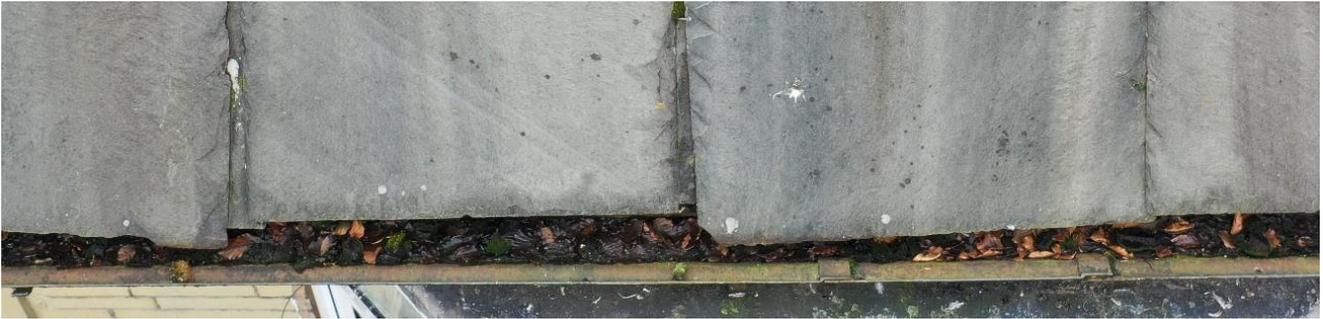
Below – The bottom slates have slipped into the gutter, a sign of nail erosion due to age. This is reducing the functionality of the gutter system

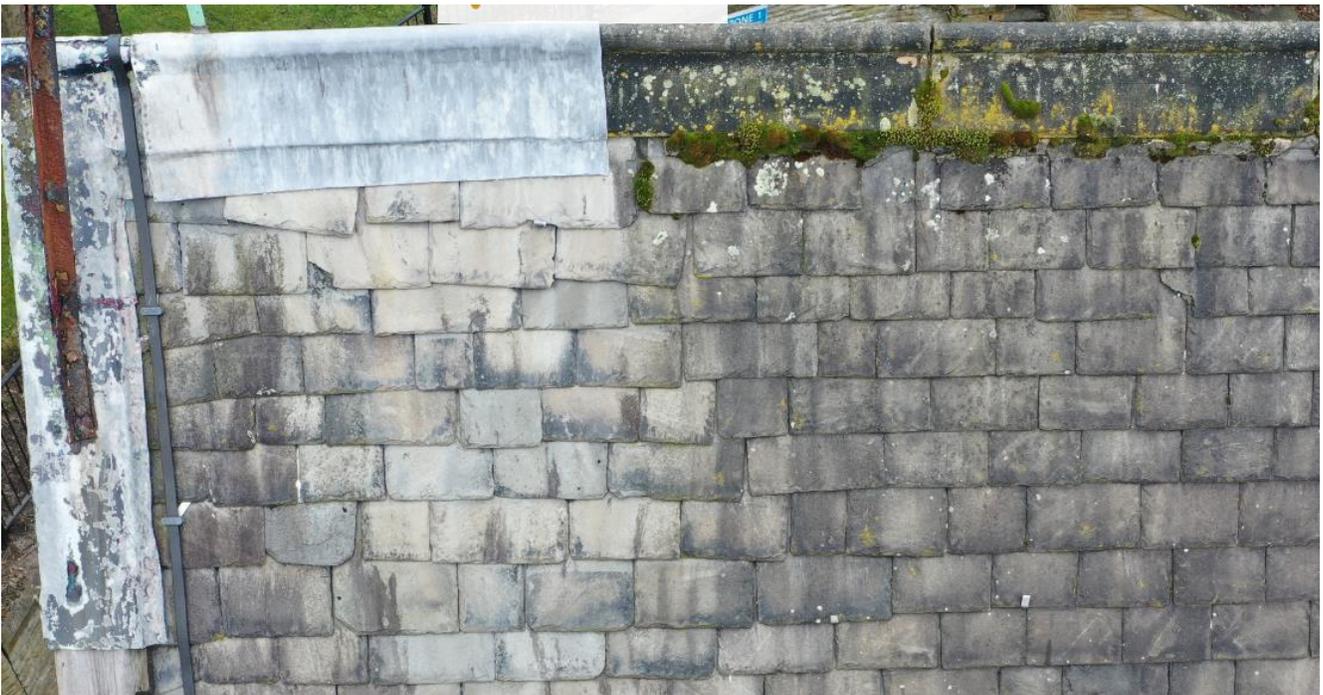
Below – Another poor lead cloak that is ill fitting to the roll top ridge. Water is getting behind it and loosening all the nails holding the slates underneath

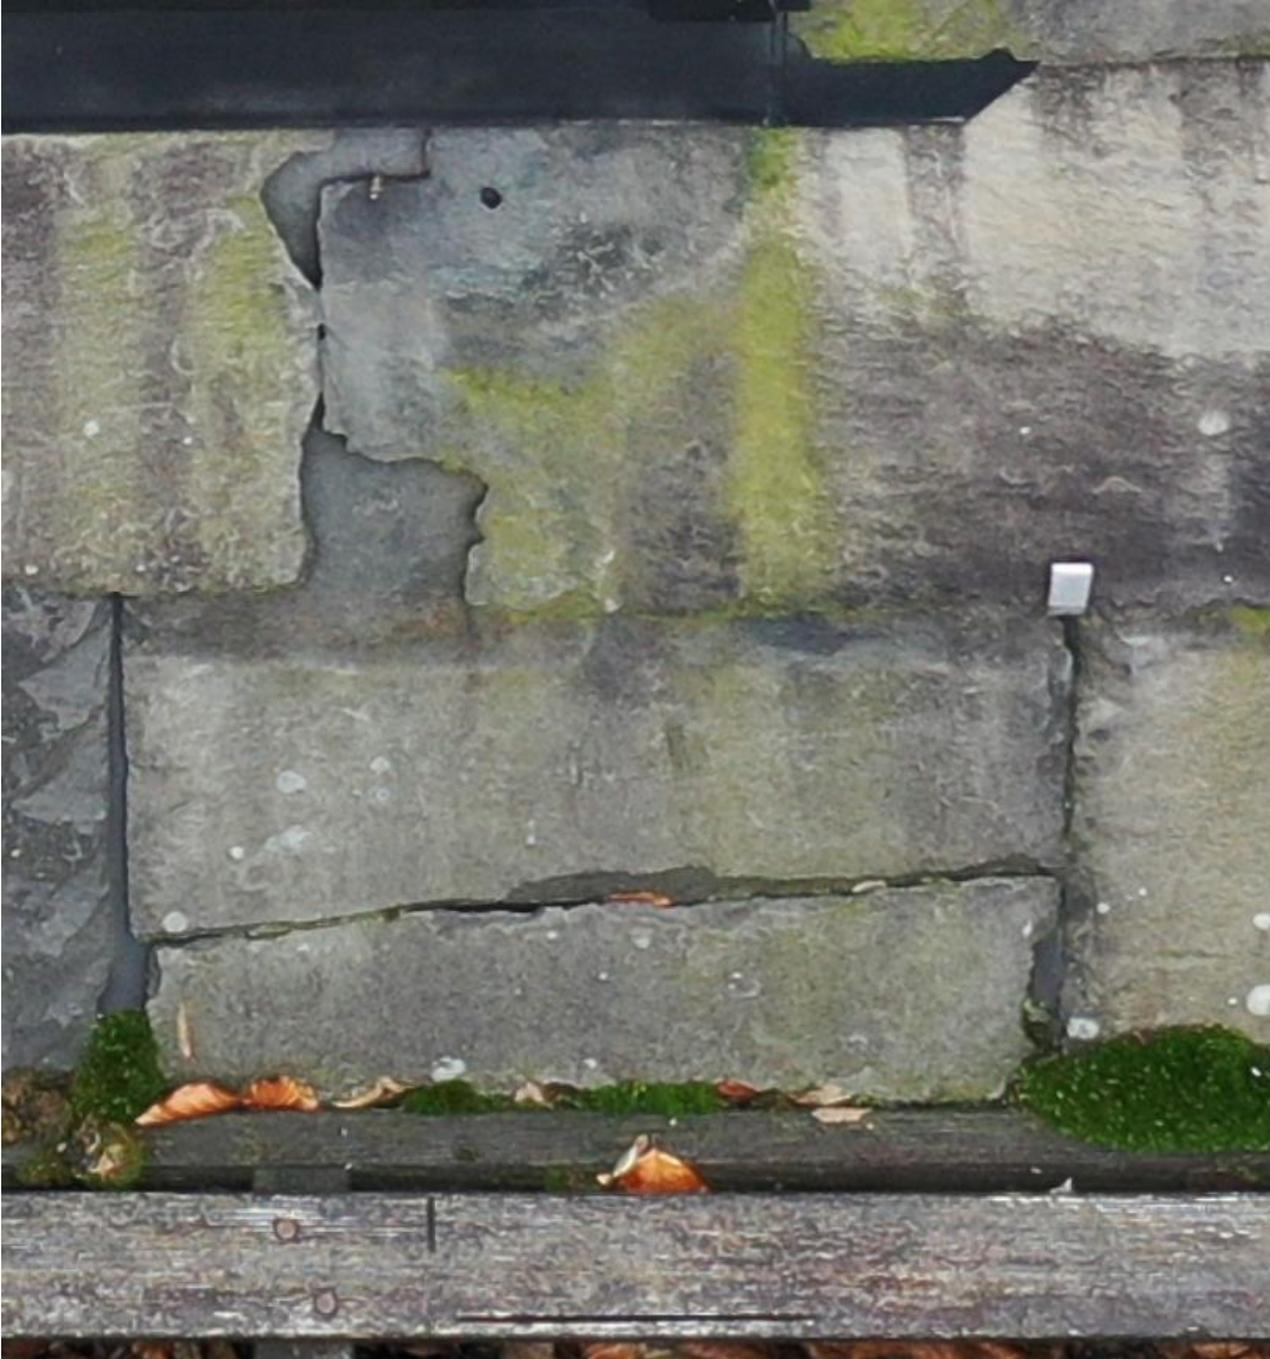
Below – further examples of slate erosion on site. Slate is thought to last 100 years, which gives an indication of the life of some of the slate on site when it is in this poor condition.

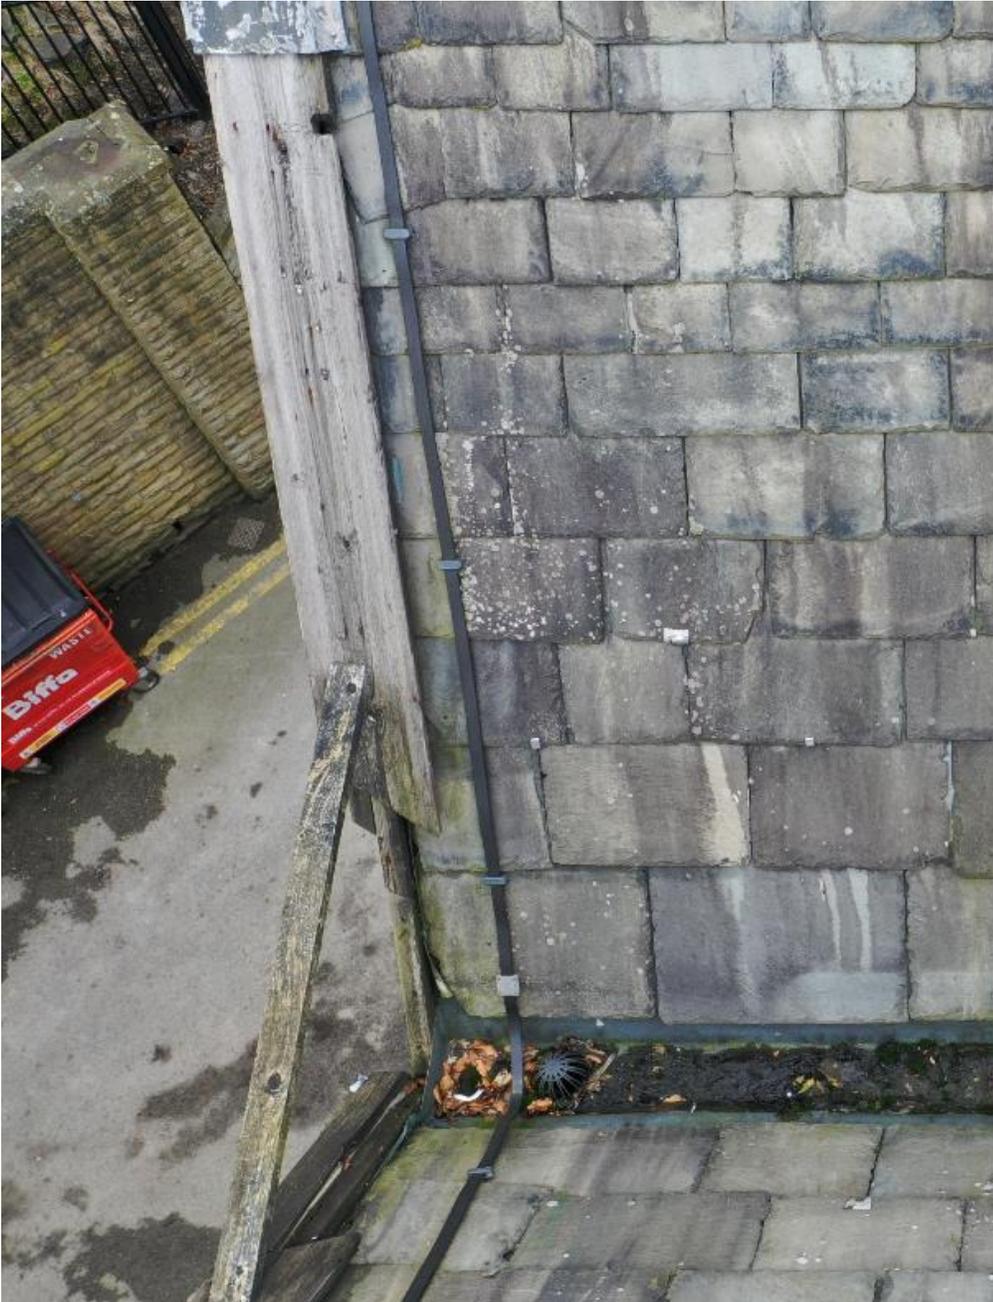
On the verge, timber verge capping has been cloaked in leadwork. This is rotten in this section and it's left a section without a verge. It is highly likely water is entering the roof in this section as there is nothing to stop it getting in or direct the water flow away from it. The timber here is completely rotten.

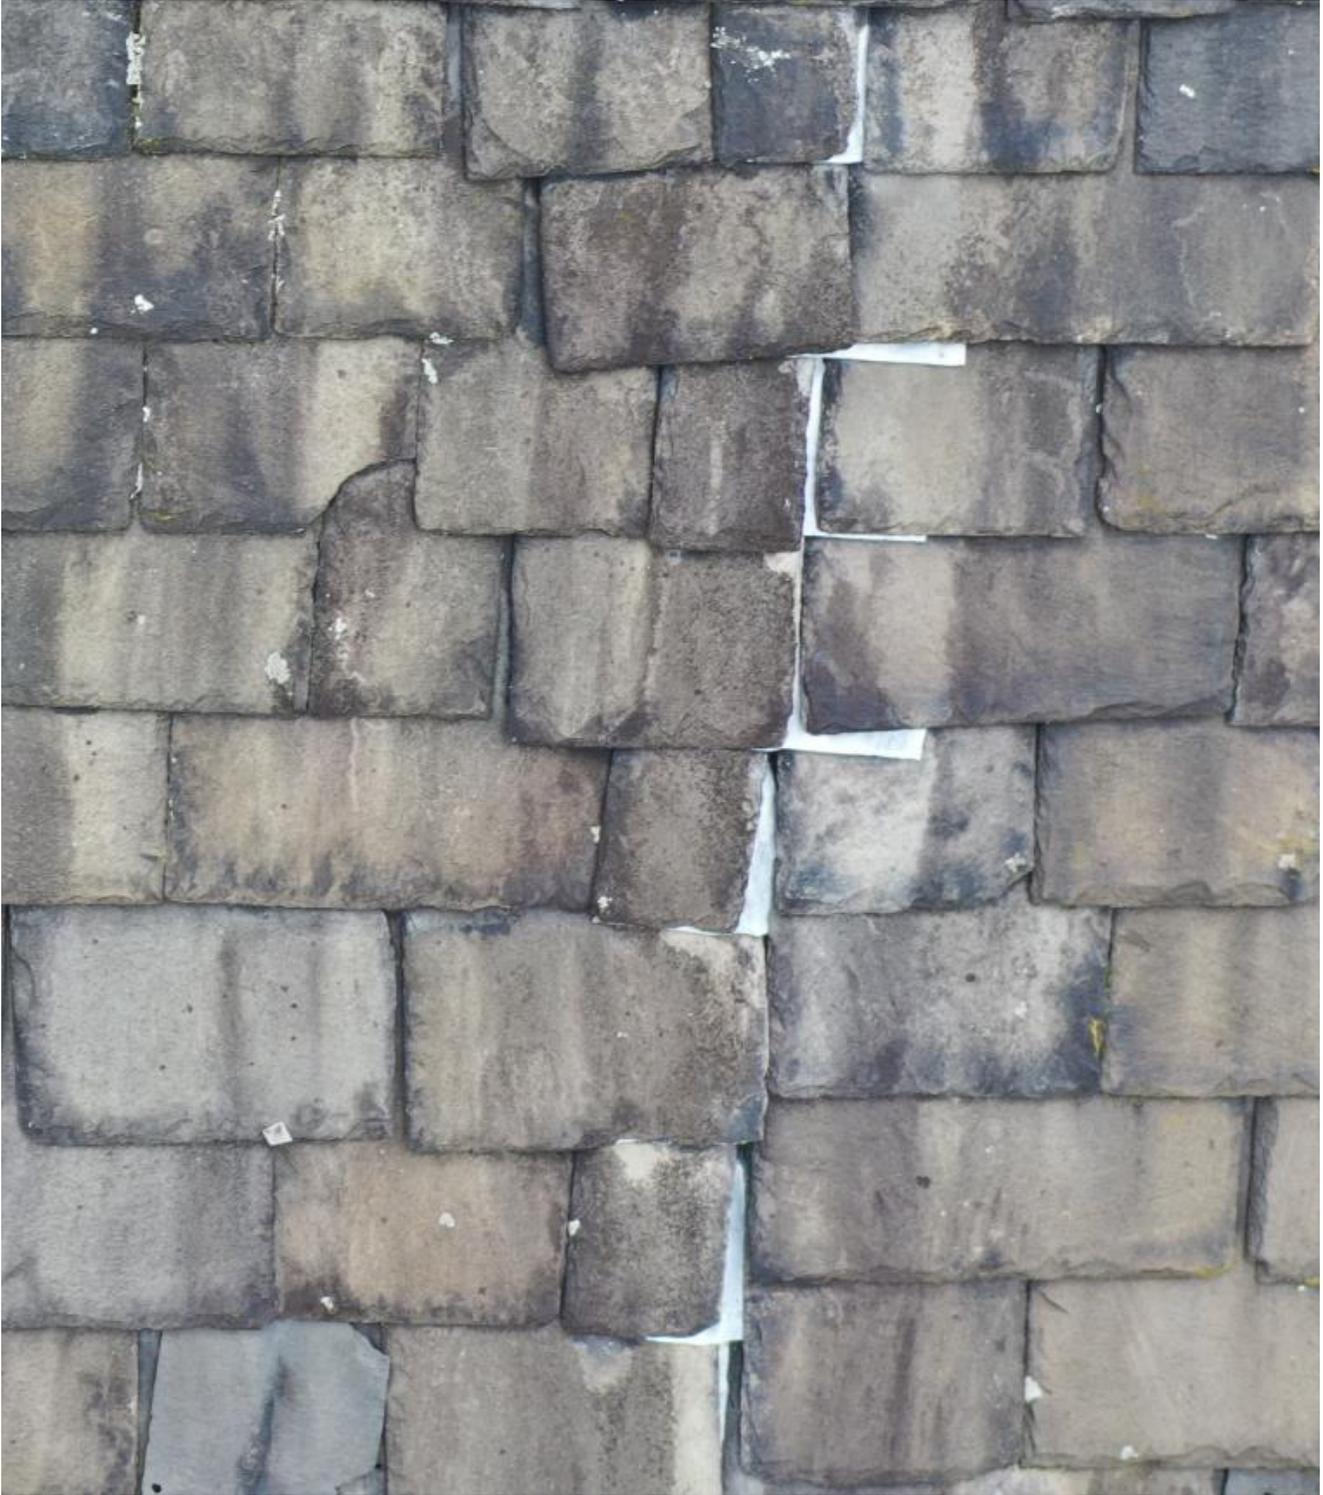
Some repair work has been undertaken by another party. The workmanship is extremely poor, and it is not known what purpose this repair has been done for.

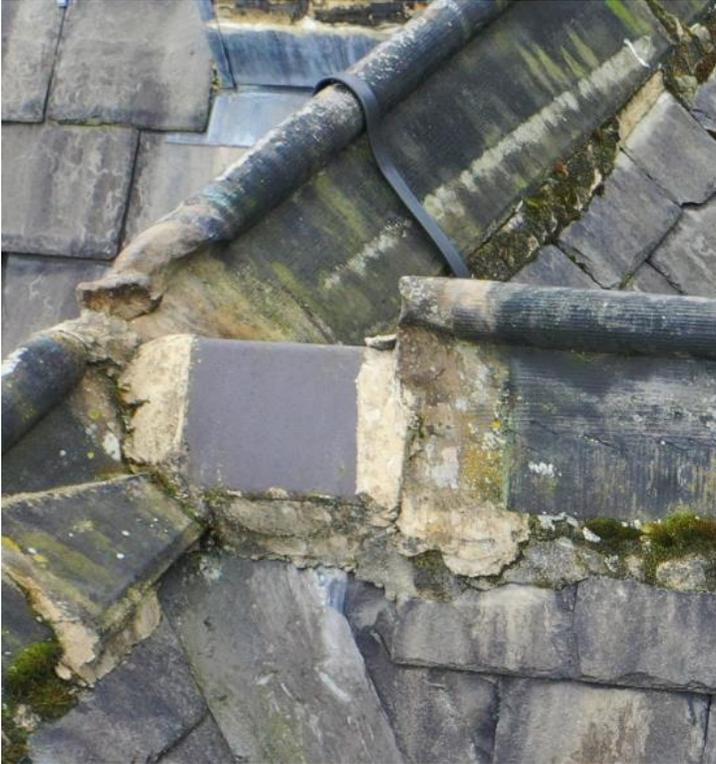
A further example of extremely poor workmanship, where someone has cut and spliced a small piece of modern ridge into the centre of the antique ridges.

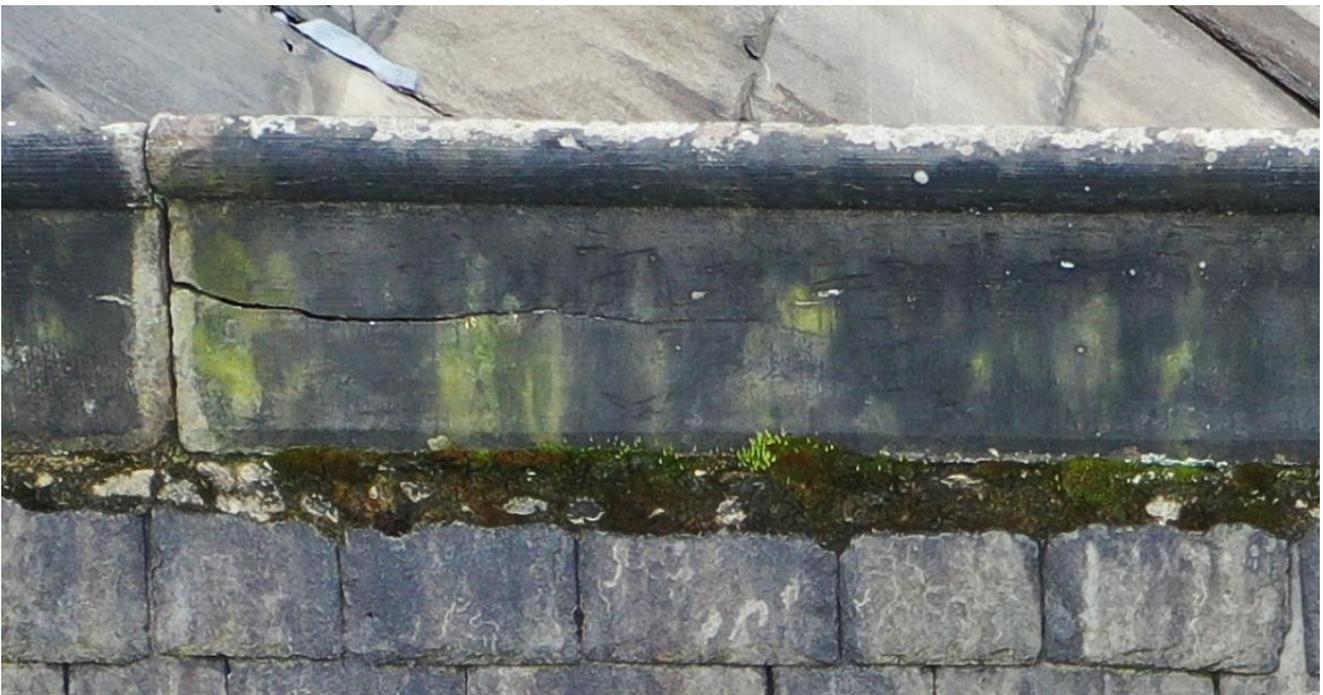
Some of the older ridges have reached their end of life and will require replacing.

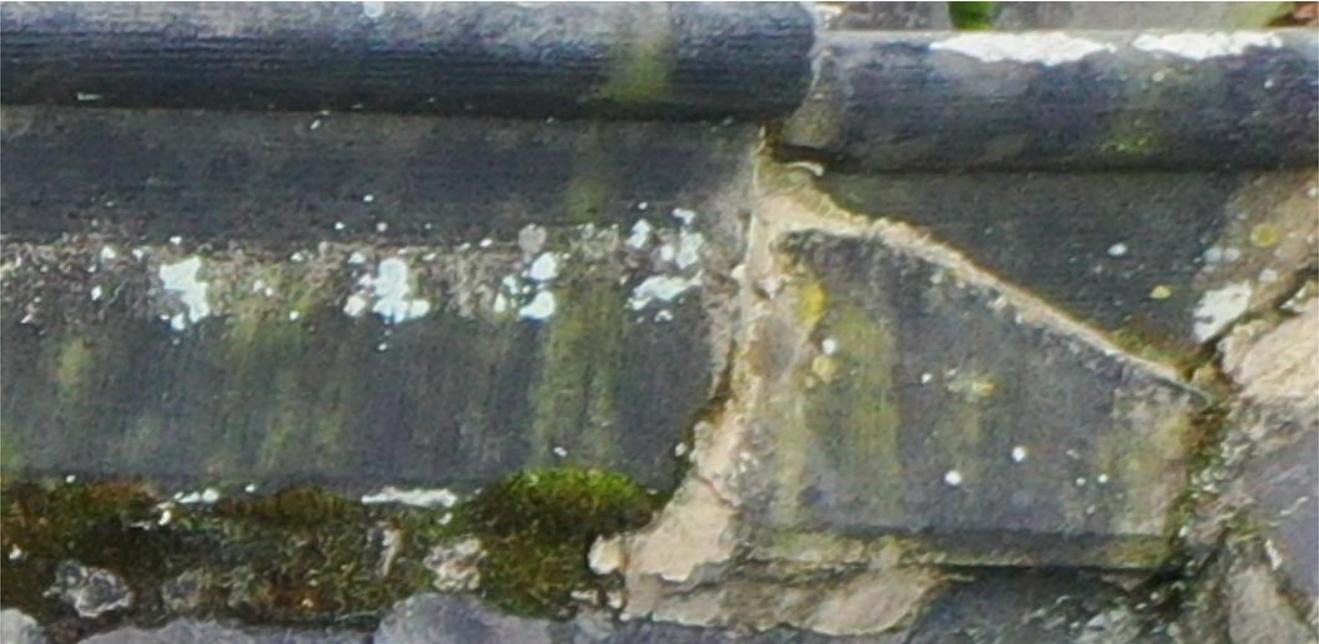
Further example of a ridge reaching its end of life. Someone has cemented this one back together poorly.

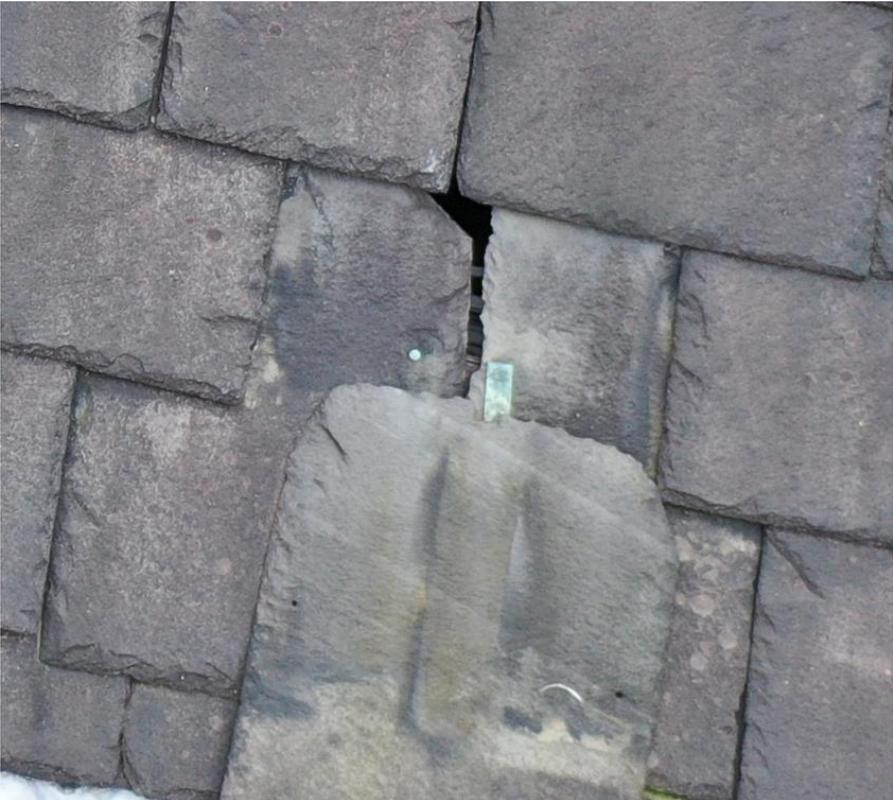
Further example of slate slippage creating a leak

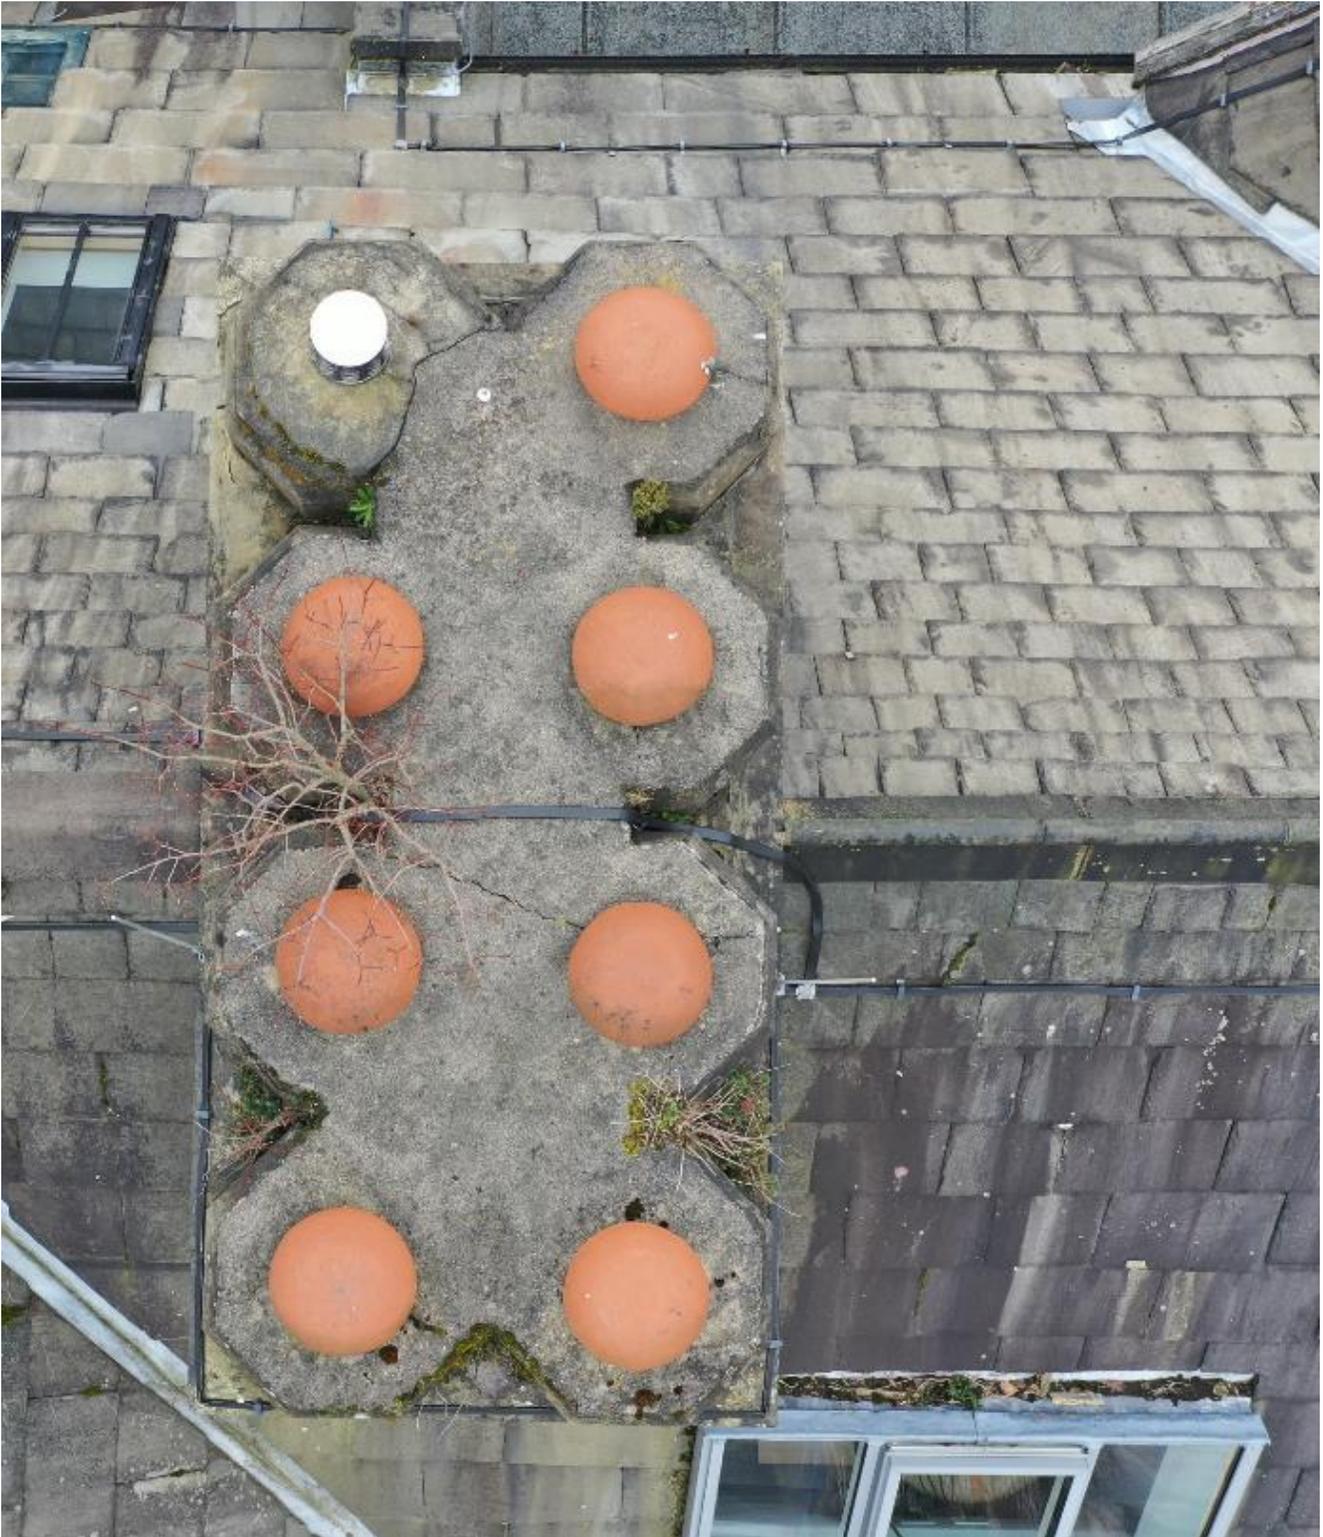
The chimney in this area also needs an overhaul. There are two trees that are disrupting the chimneys' structure and will need removing.

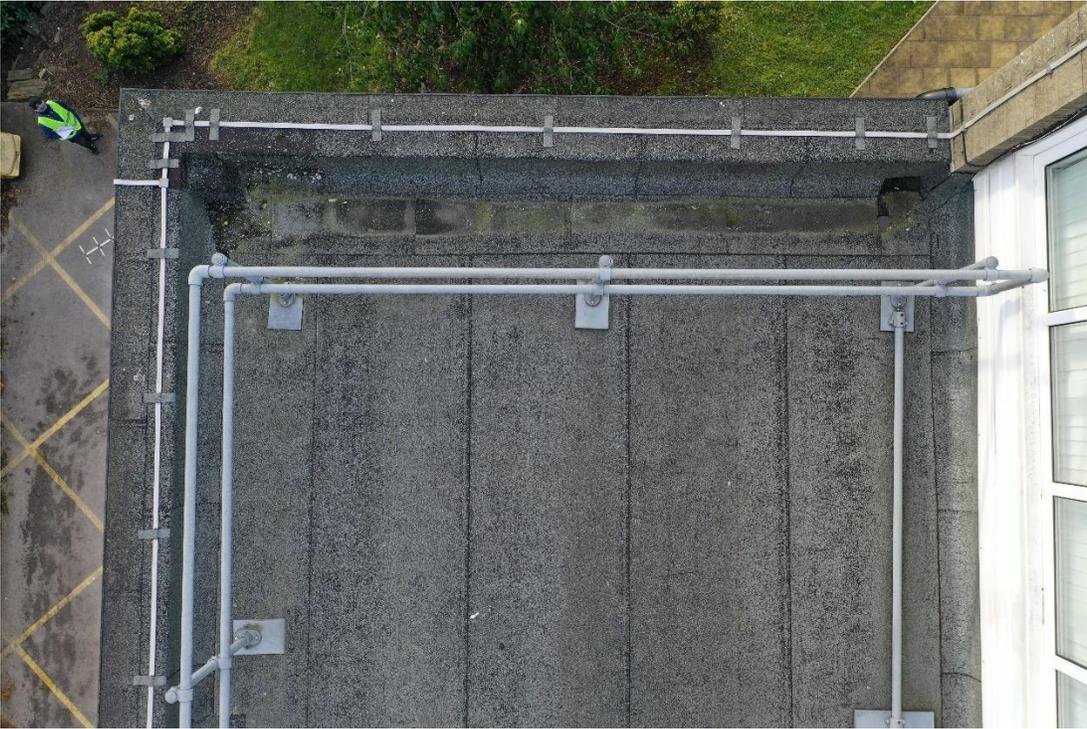
Examples of the mineral felt roof shown below

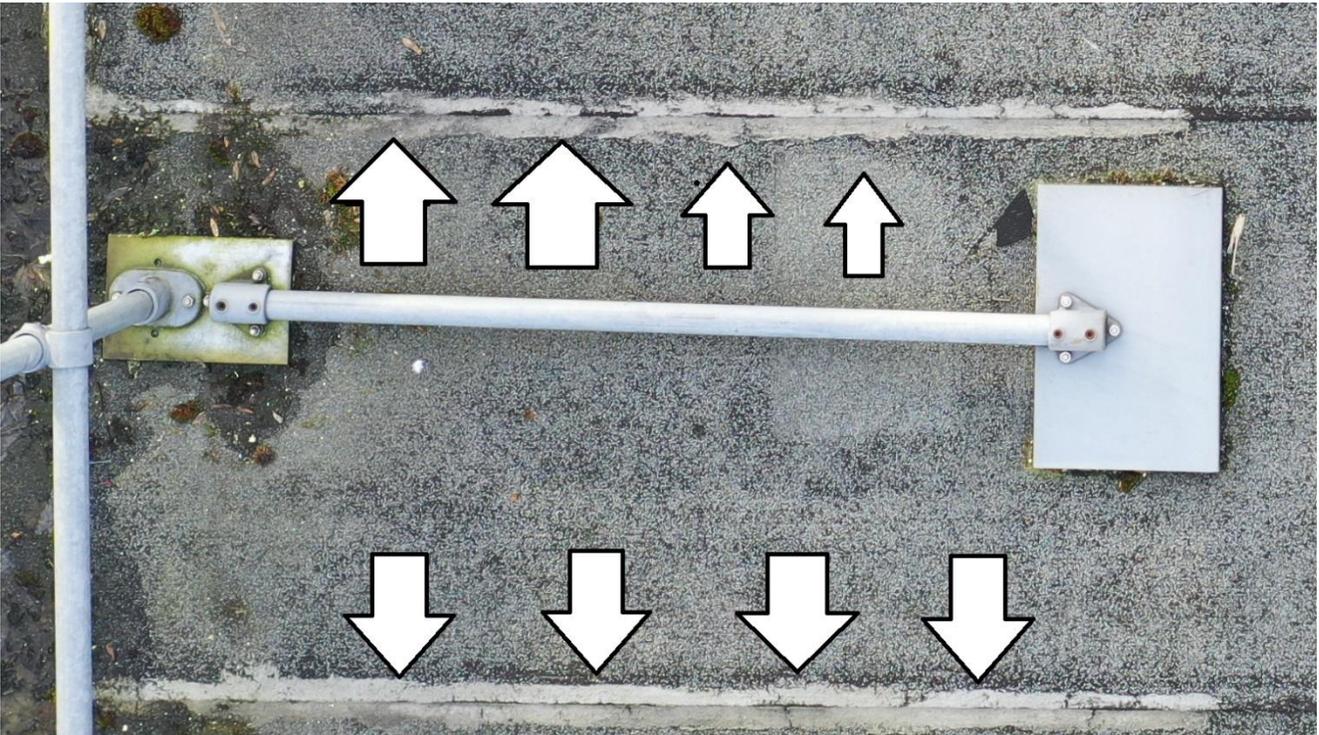
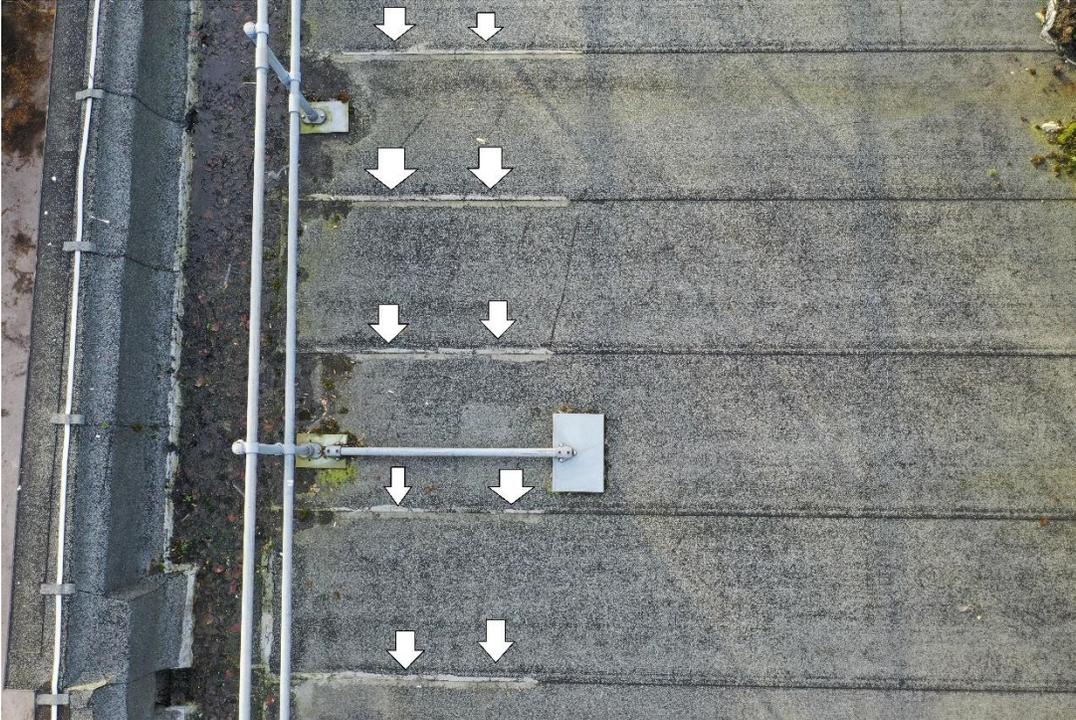
An example of where the mineral felt overlaps have deteriorated, and where a previous repair has also deteriorated. This requires immediate attention before the roof felt rots making it irreparable.

- Every seal on both roofs should be checked for splitting, and any splits identified should be rake out, and refilled in with a Flexacryl sealing compound in two coats.
- Any cracks on the second roof should be coated in flexacryl.
- This roof requires annual checking due to its nature of construction.
