External Roof Survey Report

**Daisy Bank
109 Duckworth Lane,
Bradford,
West Yorkshire,
BD9 6RL**

**JNR Contracting Limited
Authored by: Jamie Robson MAPM AIC
Aerial Drone Footage provided by: Rotorgraph**

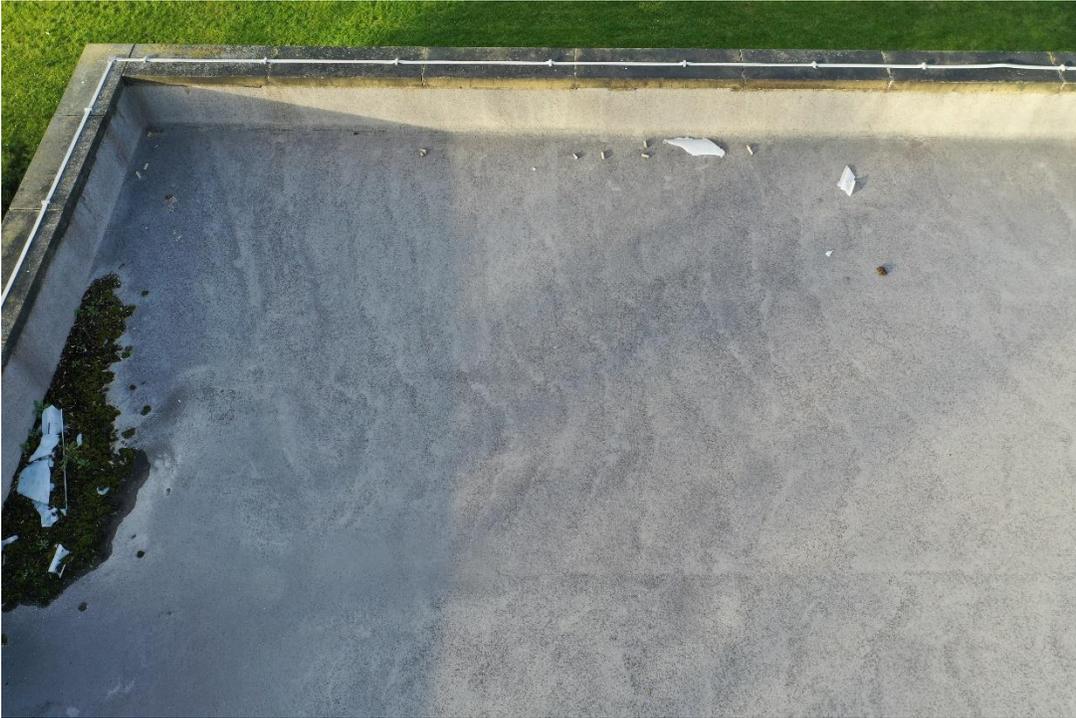
Below, an example of the other roof type.

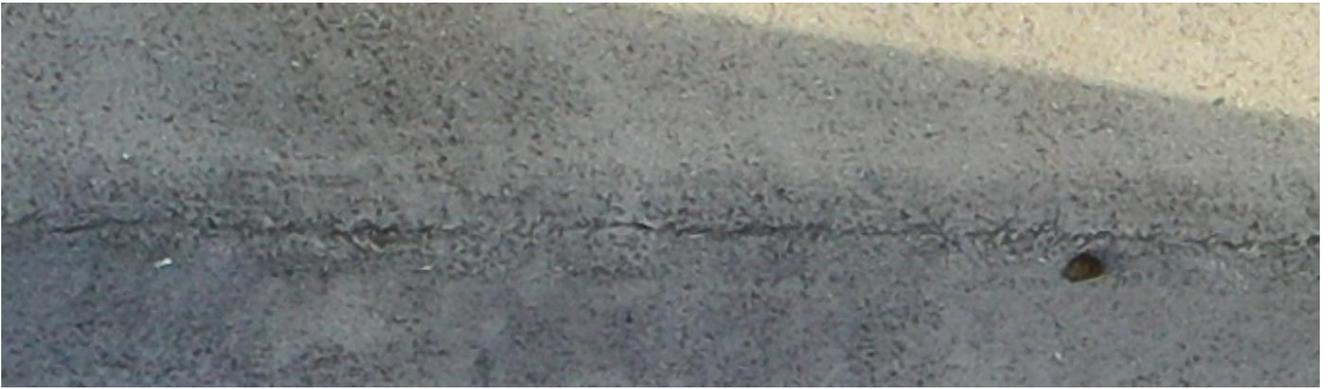
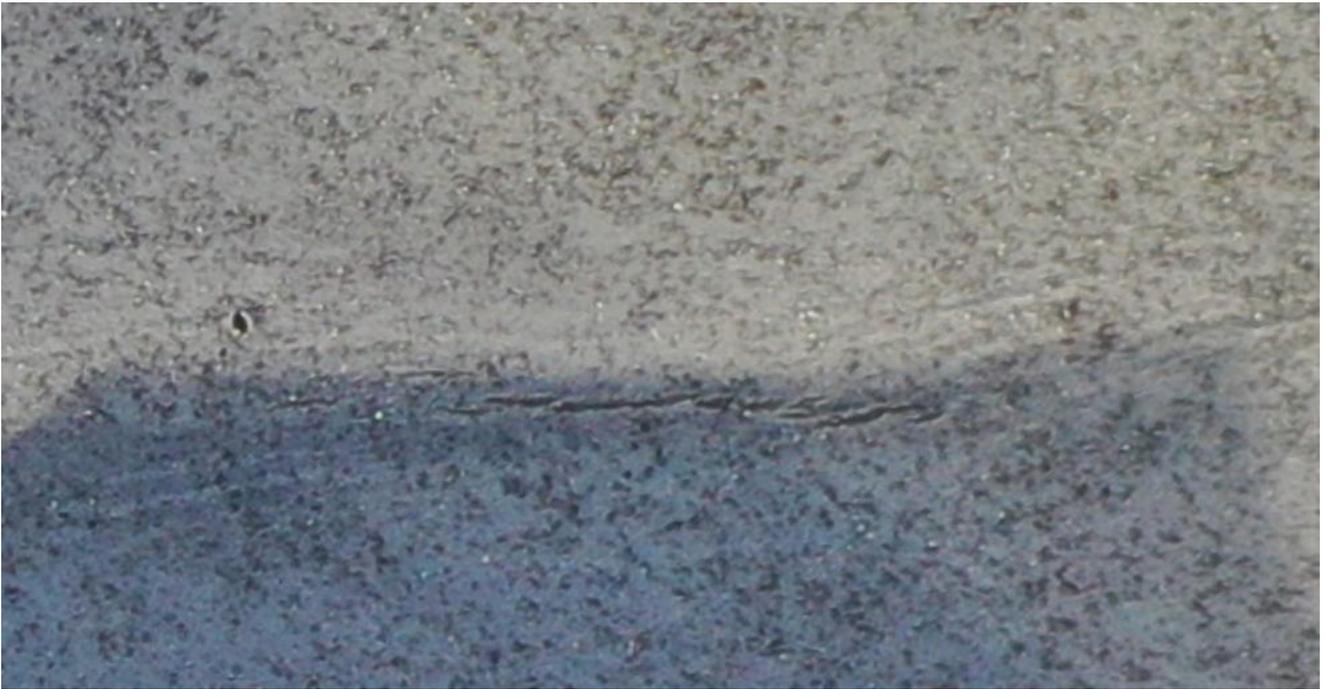
On closer inspection small tears are visible – At this stage they are repairable using a paint on compound.

- Every seal on both roofs should be checked for splitting, and any splits identified should be rake out, and refilled in with a Flexacryl sealing compound in two coats.
- Any cracks on the second roof should be coated in flexacryl.
- This roof requires annual checking due to its nature of construction.

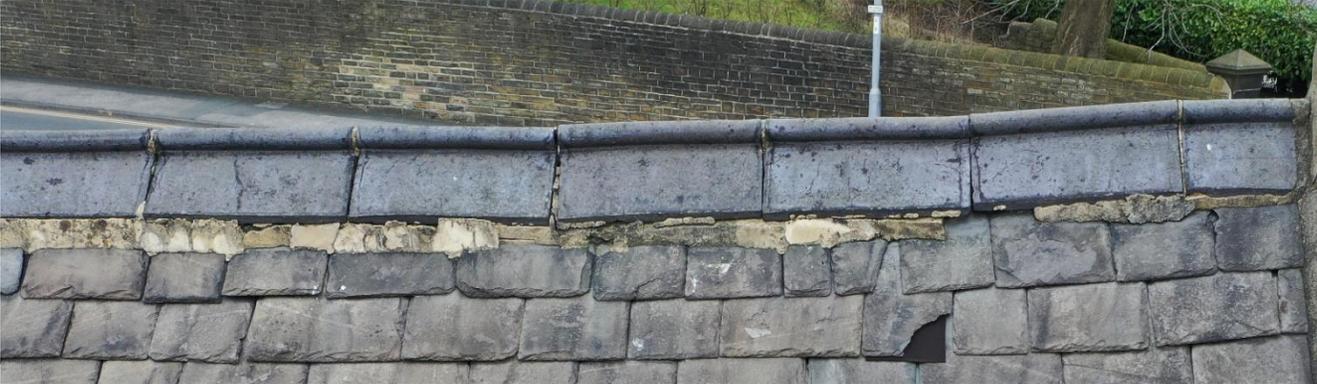
Below – The ridge pointing is badly deteriorated both between the joints of the ridges and underneath making them loose. Some broken slates are also evident under the ridges.

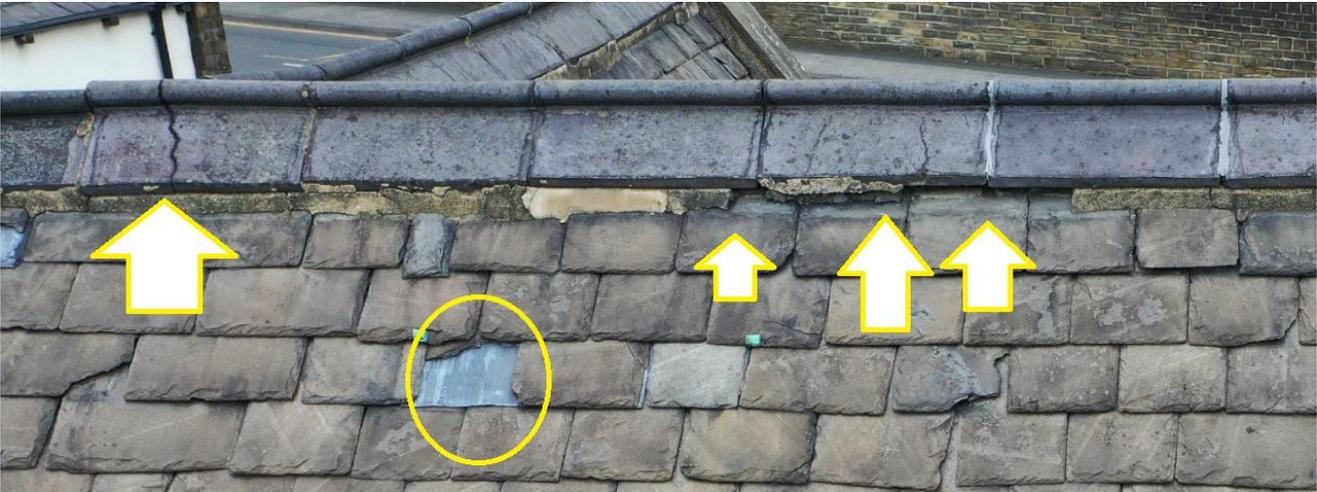
Below, Two cracked ridge tiles are evident, as well as missing pointing. Two broken slates are evident, one of which has been replaced with lead.

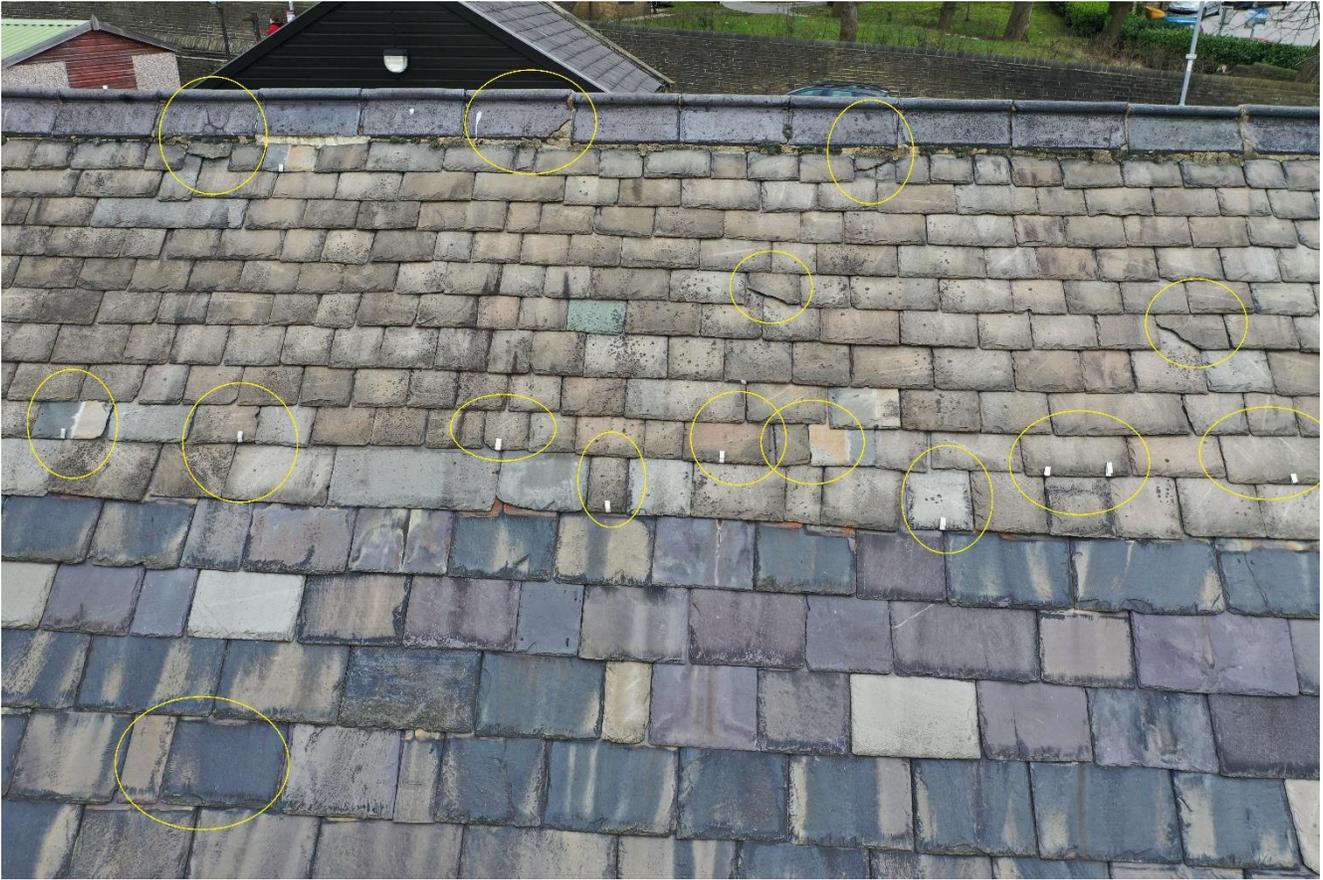
The below picture gives examples of issues on a sample of the roof. Broken slates, missing pointing, cracked ridges and poor repairs.

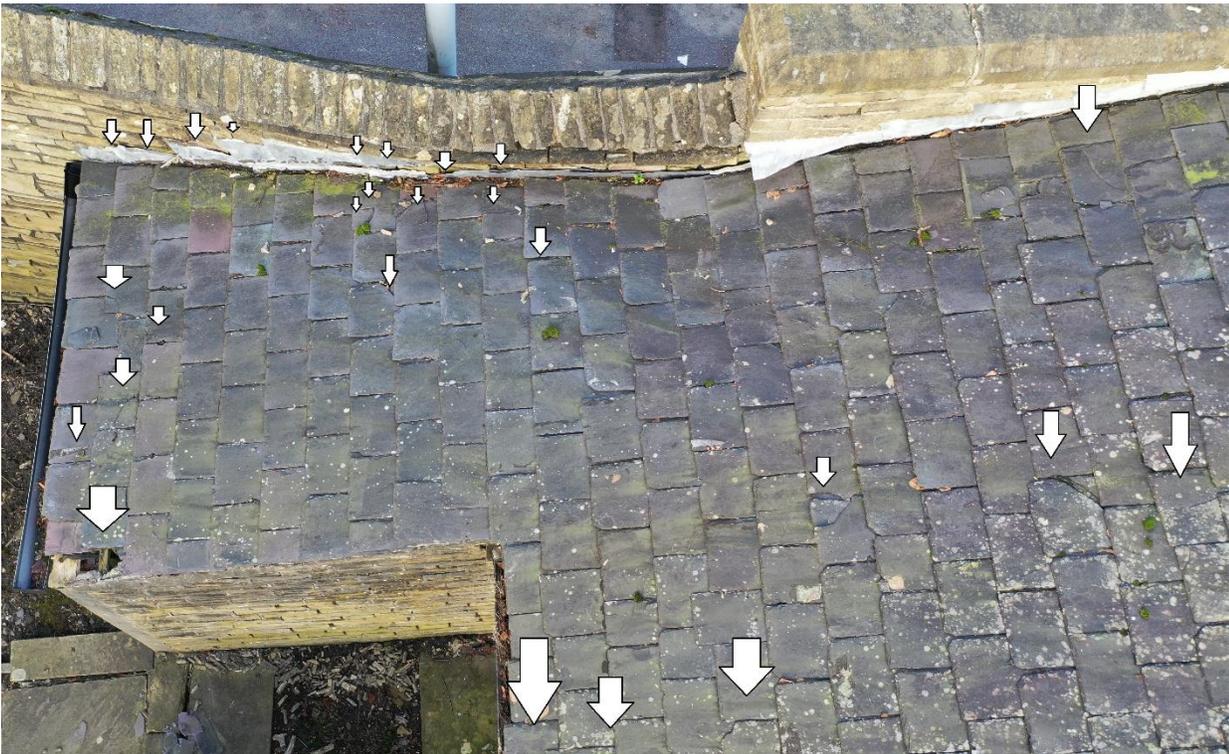
Below, one small section of roof showing over 20 repairs. It would be uneconomical to repair this part of the roof and it should be replaced. An exposed lath is shown in the bottom left corner which is rotten and all the wall pointing is eroding due to water penetration.

- The lean too structure requires completely reroofing, with new slate, new laths, felt and leadwork
- The main house requires some slate repairs, which will require a heritage roofer to dress slate and cut it to shape for replacements
- This roof requires the replacement of its timber verges which the client may want to paint in heritage colors.
- The chimney requires repointing
- The ridges require repointing
- The gutters require clearing.
- Some leadwork requires doing underneath the new timber verges, in order to make it comply with building regulations but also seal holes that have formed.

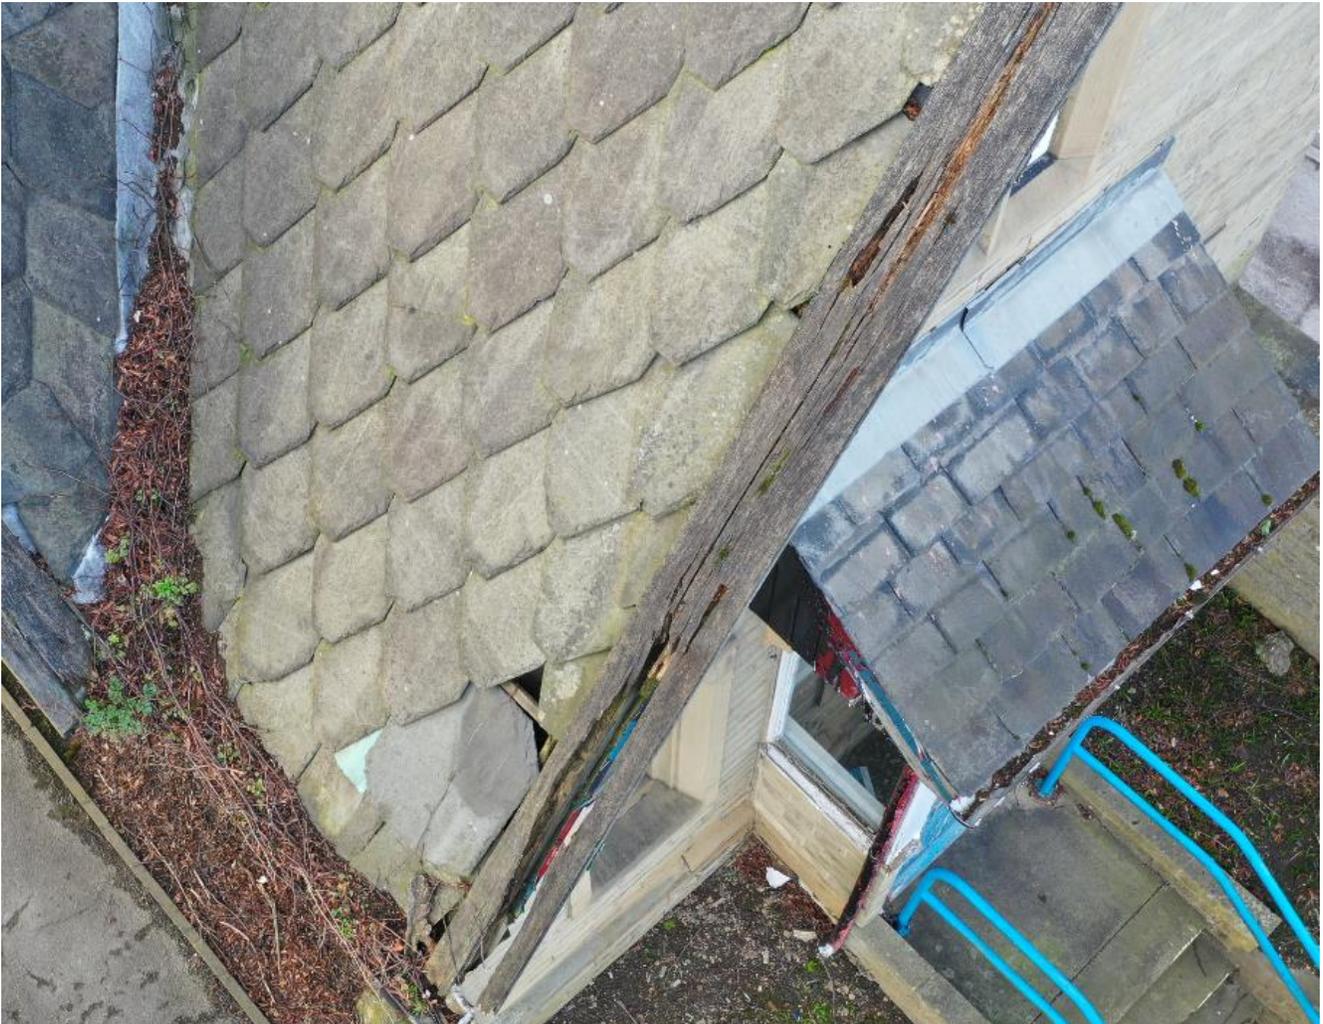
The main property is largely in great shape despite its age. The timber work is rotten and needs replacing, but apart from that there are only minor slate repairs, and repairs to lead flashing. In the picture below, the timber verge needs repairing. The gutters clearing, and the lead flashing on the porch putting back in. Although it is not visible in this picture, the chimney also needs pointing.
