Roof Inspection Report
In respect of:

25th November 2022

Drone Inspection Report - Summary of Findings

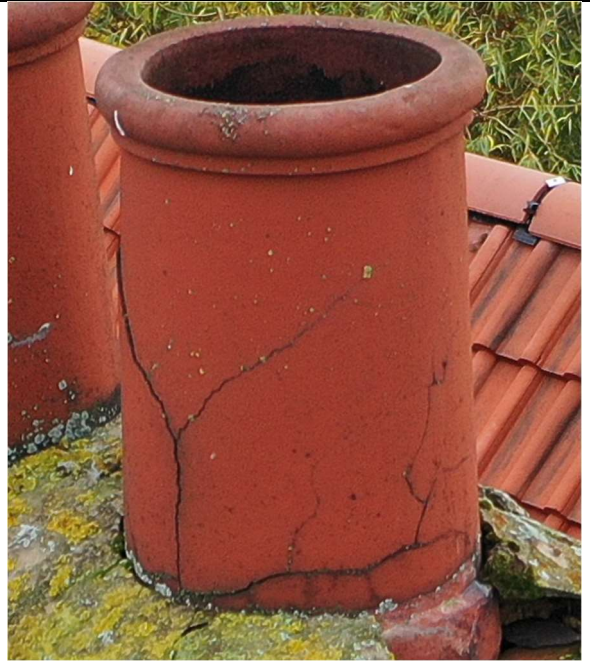
The front pot has cracks most of the way around it and should be replaced.

A close-up photo of the cracks in the front chimney pot.

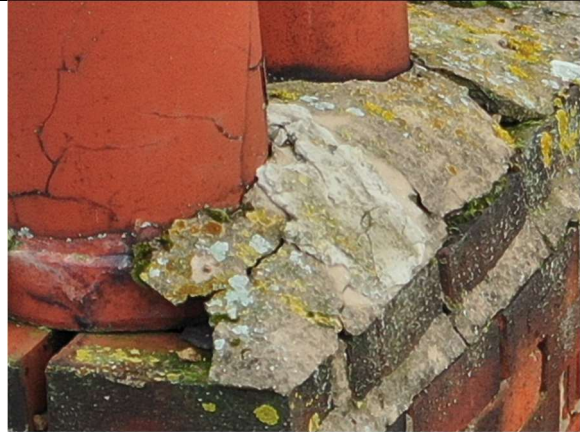
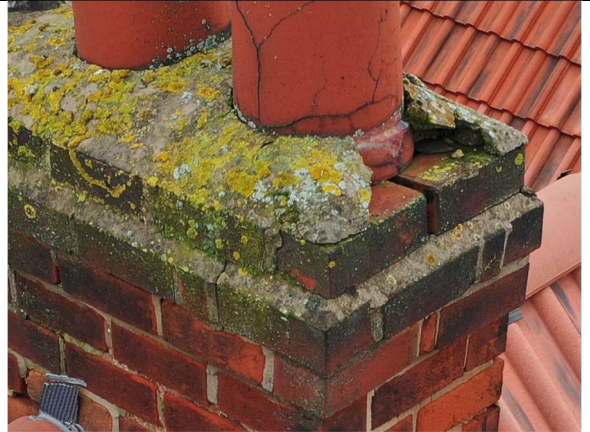
The weathered mortar fillet is cracked and should be replaced. A on the rear corner has failed and needs to be replaced.

A close-up photo of the poor condition of the corbelling.

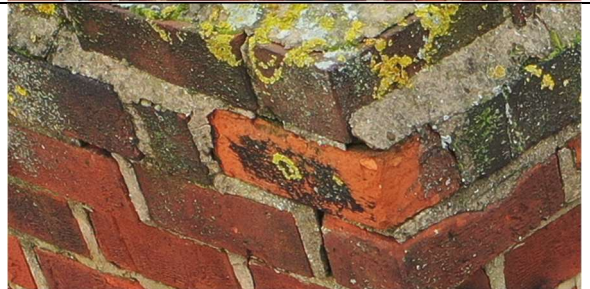
Close-up of the corbelling – the damaged brick should be replaced like-for-like.

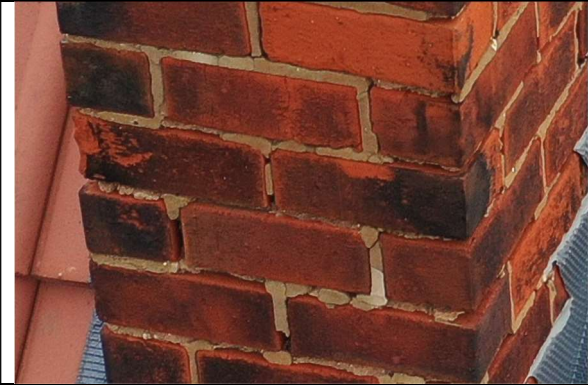
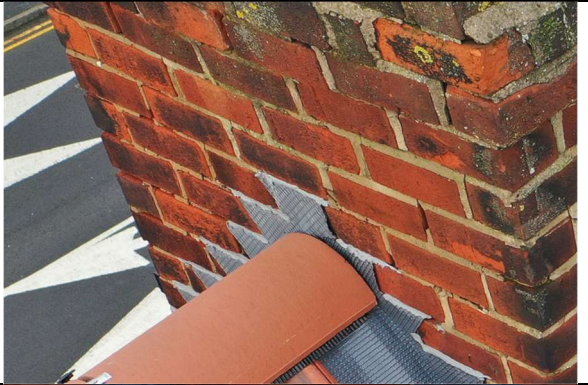
Ponting is in generally poor condition and should be raked out and re-pointed.

Photos of the pointing. This is all in poor condition and it should be repointed in a non-hydraulic lime-based mortar.

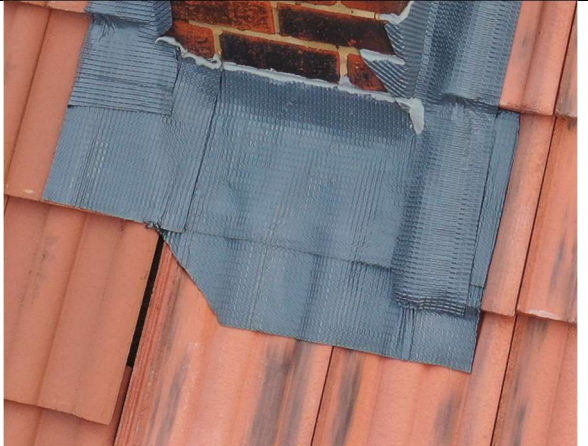
product. These products are inferior to lead and we do not recommend their use. The detail on the front pitch is poor and there is a section on the rear left-hand side that has not been replaced at all.

Flashing – messy detail on the front pitch.

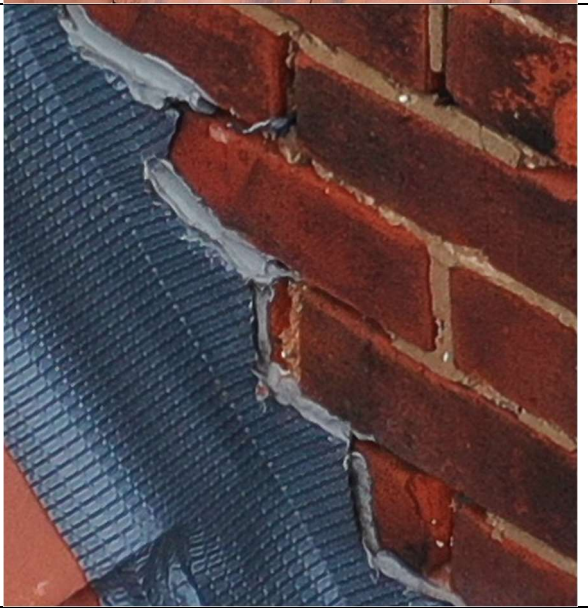
Left-hand side – detailing is poor.

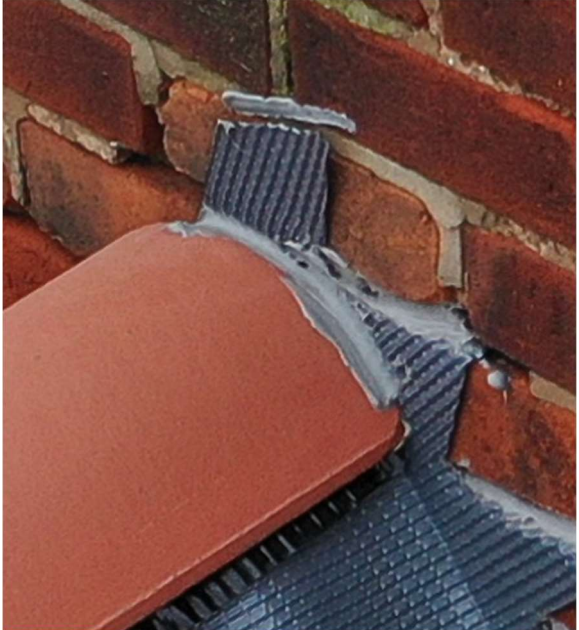
Left-hand side – the saddle piece is missing and the detailing is poor.

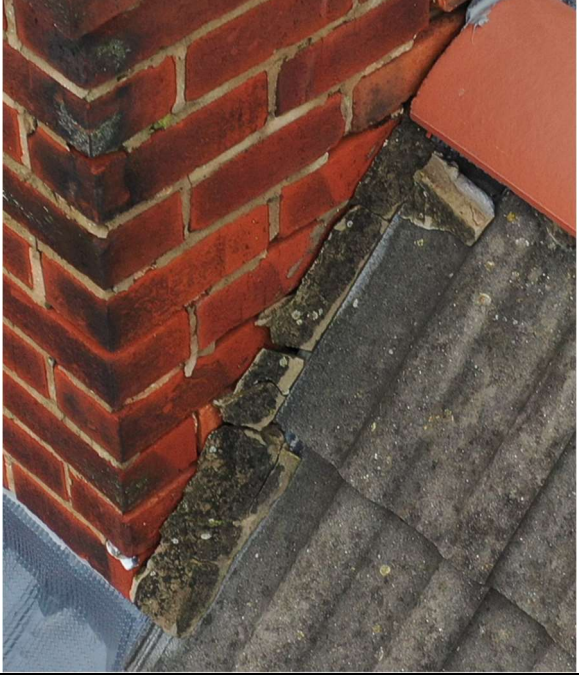
Left-hand side, rear pitch – there is no proper detail where the stack and roof abut. The old mortar fillet has come away completely and will eventually slide down the pitch and block the guttering.

This needs to be renewed as soon as possible.

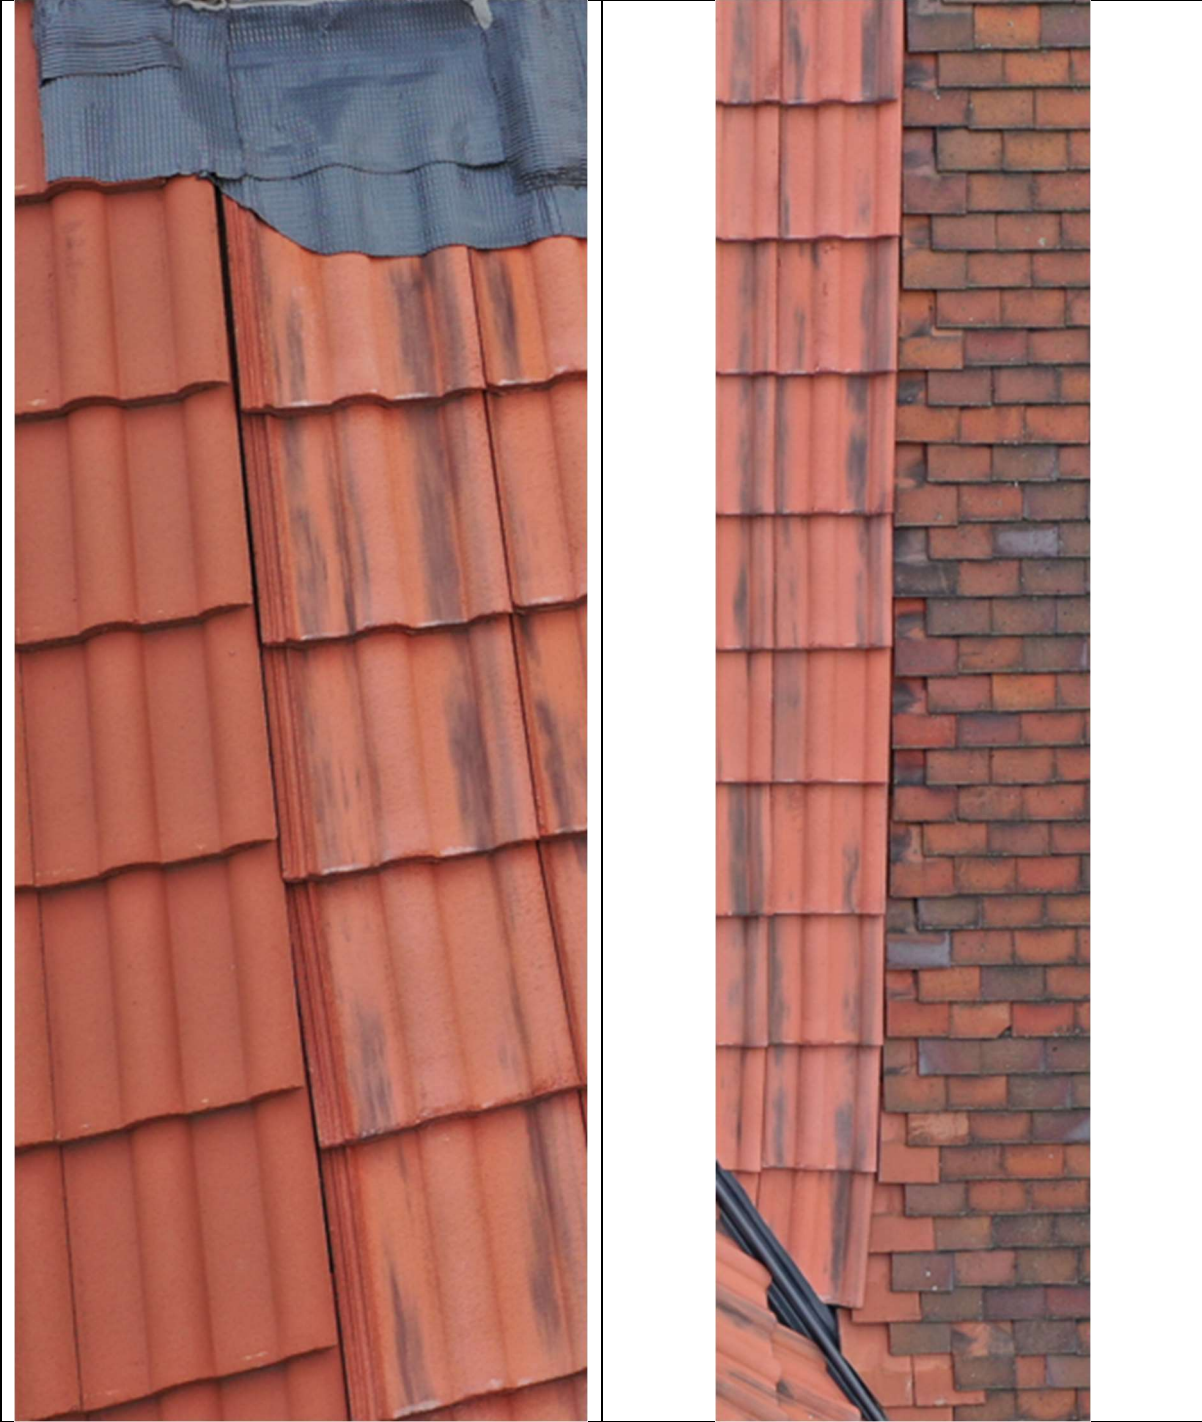
There should be a bonding gutter where the roof coverings meet on the left and right-hand abutments. We cannot see if one is present. On the right-hand abutment, all of the half-tiles are missing.

If the bonding gutter used on the front is the same as the one on the rear, the tiles should have been mortared into position.

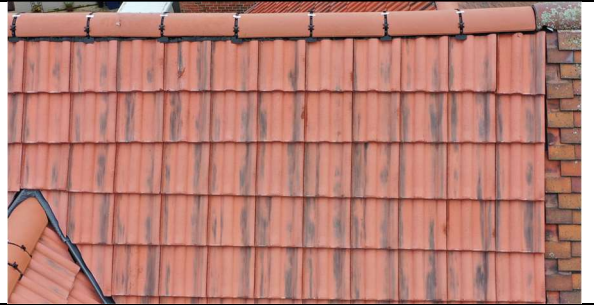
The rows of tiles across the pitch are not parallel with each other and the head lap is inconsistent.

Whilst we have not measured the tiles, the head lap does not look to be sufficient and looks to have been stretched, particularly towards the right-hand side.

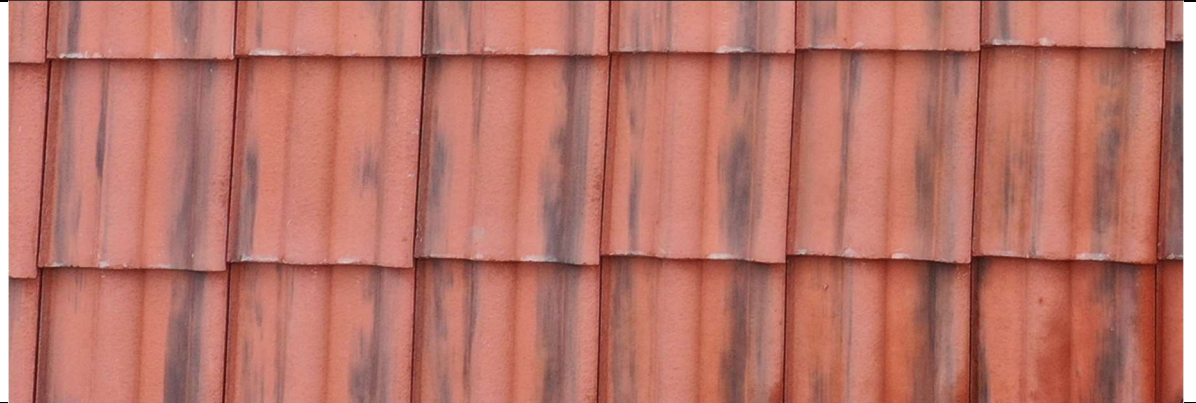
Looking at the bottom corners of the tiles, they do not sit square to each other, there is a step between most of the tiles.

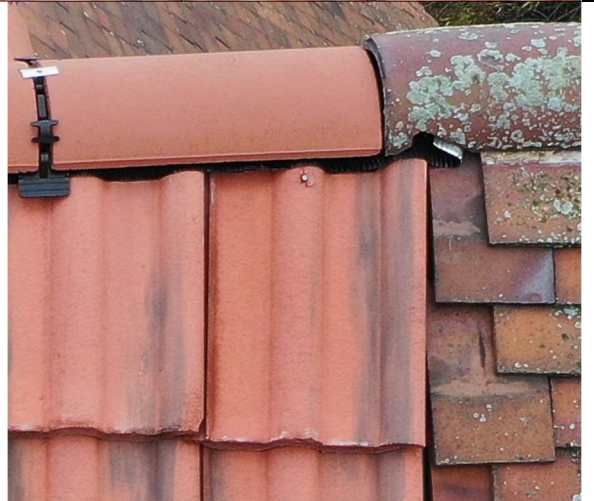
Ridge, right-hand side – the end union fixing on the ridge tile is missing.

The top course, right-hand side tile looks like it is not set square, is slipping and has a fixing in which does not match the rest of the tiles. Has this been amended?

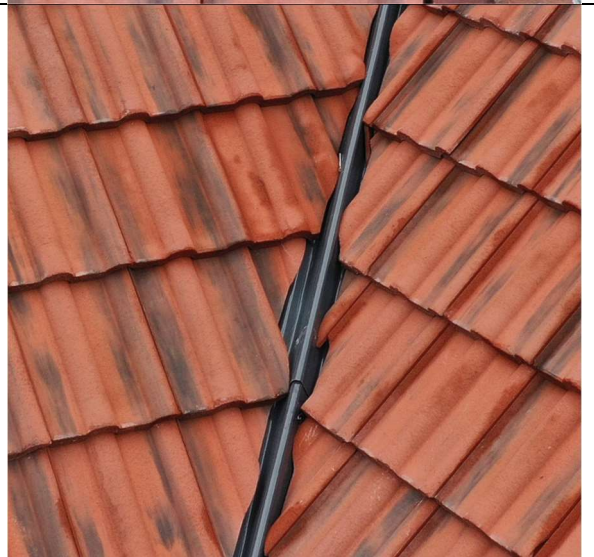
Left-hand valley – the tiles are not set in the valley in a uniform fashion. Some of these require re-cutting/replacing.

Some of the smaller tiles will need tile support brackets added underneath them.

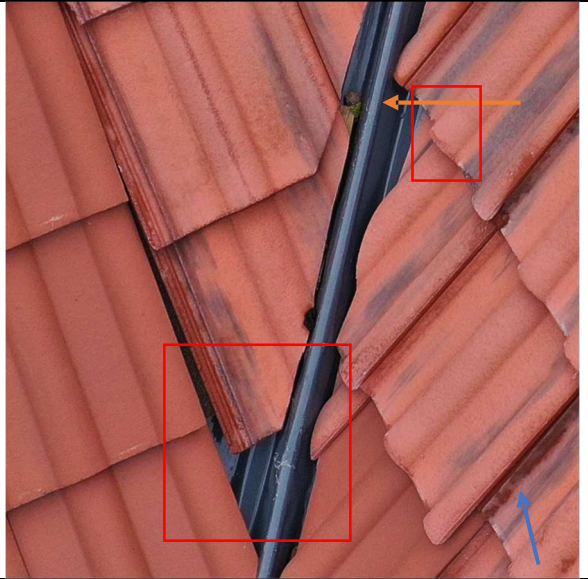
Left-hand valley – there are tiles missing at the bottom of the valley (red boxes) and debris is trapped between the valley liner and the tiles (orange arrow).

Blue arrow – tile slipping down.

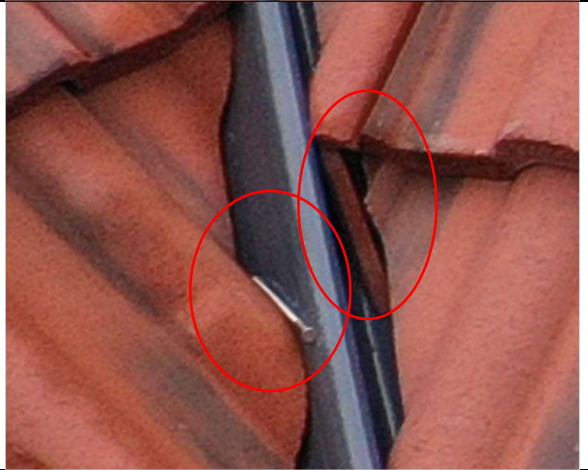
Debris in the valley.

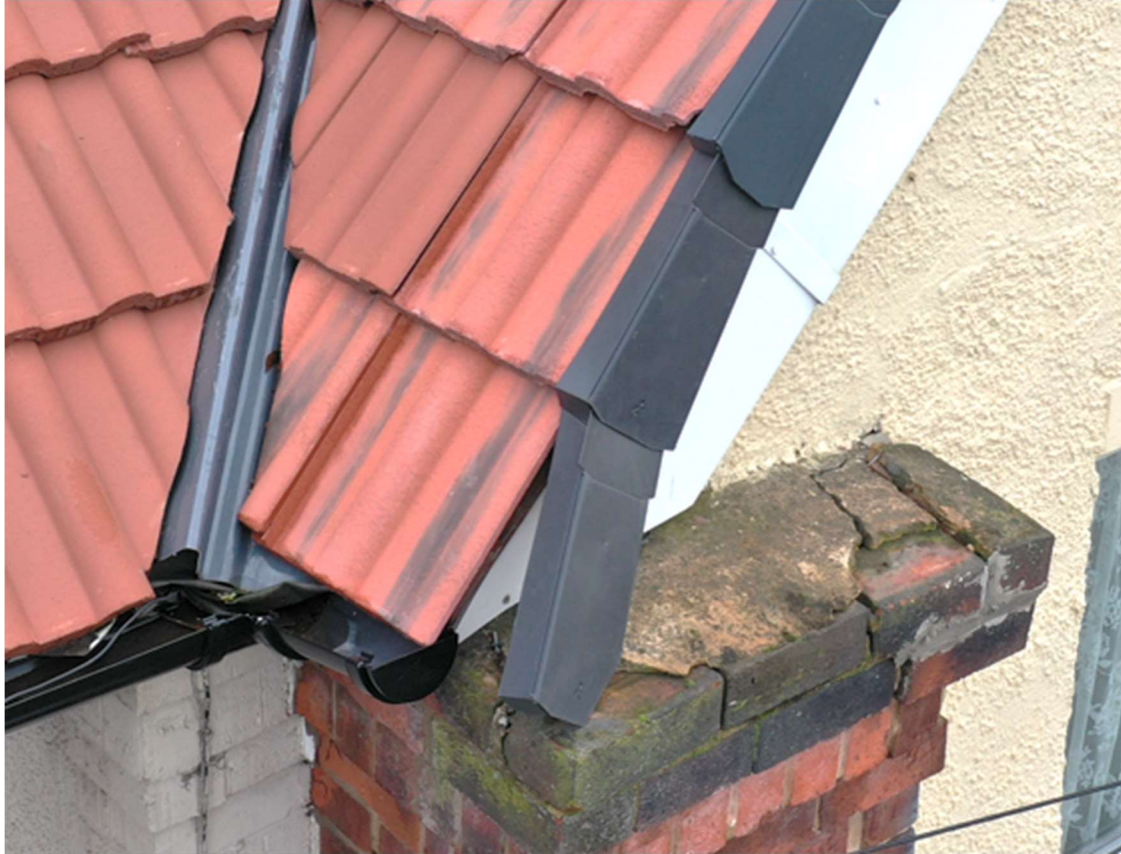
Left-hand side, lower area of the pitch. All this needs to be tidied up.
Tiles do not sit correctly in the valley.
The dry verge system needs to be mechanically affixed to the battens.
The capping bricks need to be re-launched.
There is ponding in the guttering, to the point that the 90-degree elbow is full of water and any further rain is likely to see water cascading over the top of the guttering and down the front elevation.

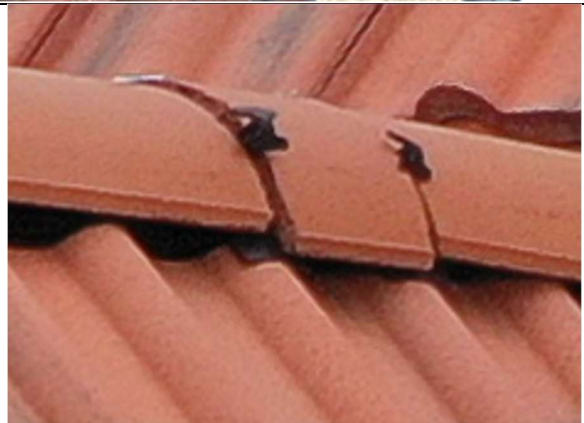
Ridge – cut tile is not sat square on the ridge and the union fixing clips are coming away. This should be repositioned and re-affixed.

The ventilation band is not stuck down to the tiles properly.

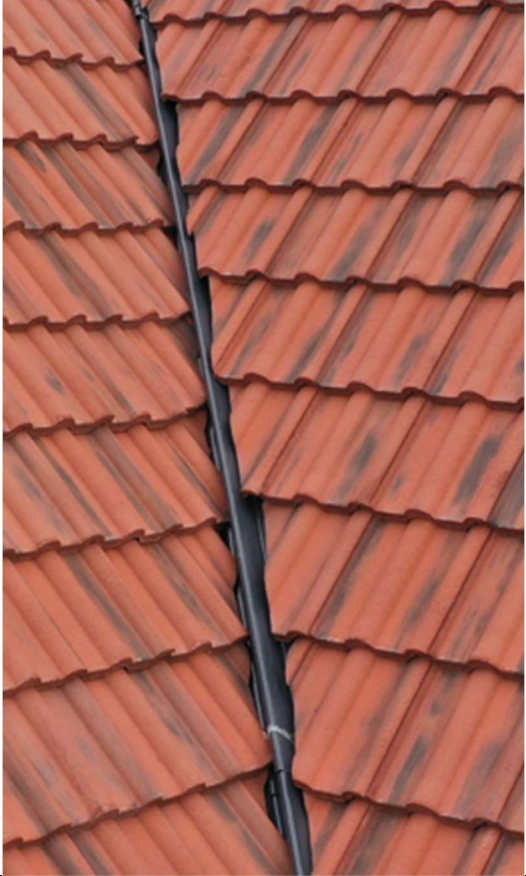
Right-hand valley – the upstand on the GRP valley does not look like it is sitting upright, it looks like it is leaning into the dormer.

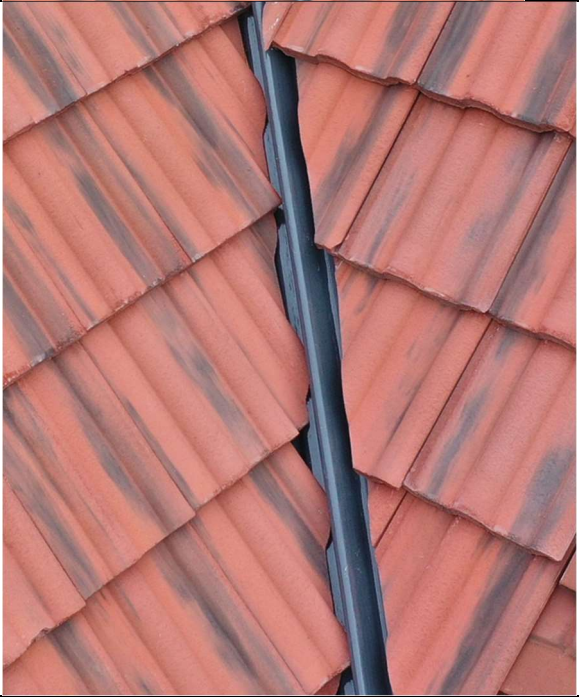
Example of tiles not being uniformly cut to the valley line.

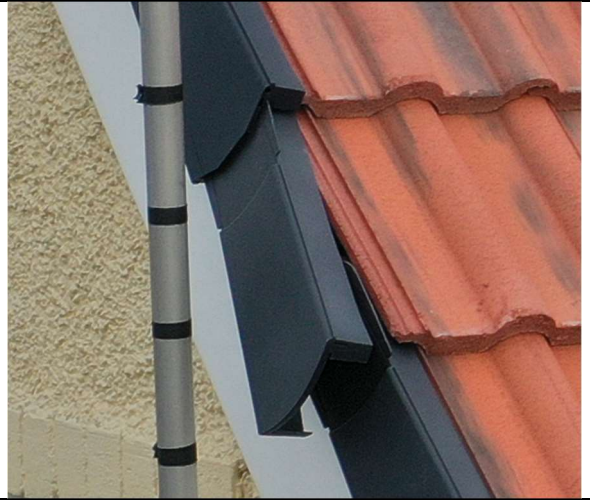
Right-hand dormer – the dry ridge system needs mechanical fixing to the batten.

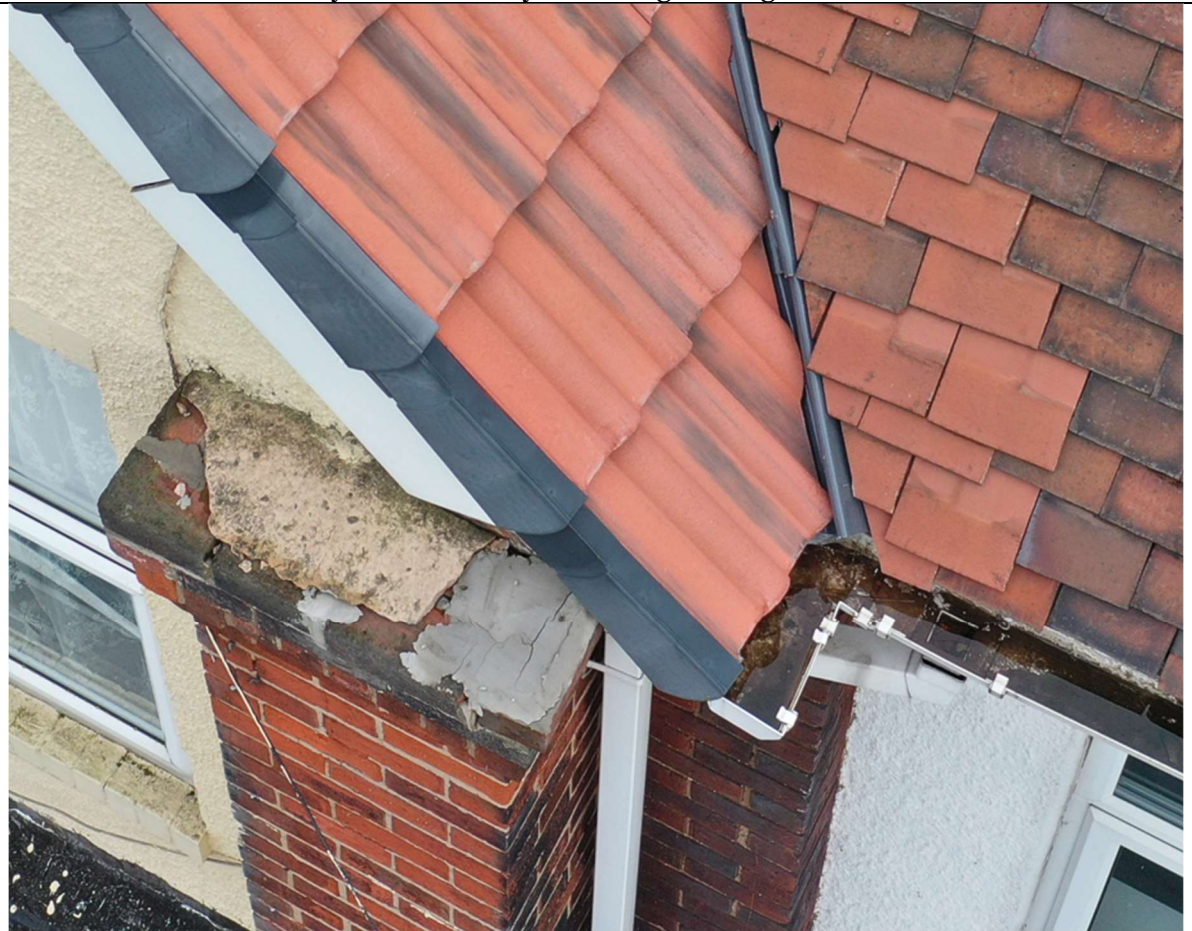
Right-hand side, lower area of the pitch. All this needs to be tidied up. Tiles do not sit correctly in the valley. Some of the older clay tiles are sat on top of the upstand, some look like they need better support. The dry verge system needs to be mechanically affixed to the battens. The capping bricks need to be re-flashed. There is ponding in the guttering, the outlet does not look like it is properly connected to the fall pipe and it looks blocked. Tiles should be set so they come half way over the guttering.

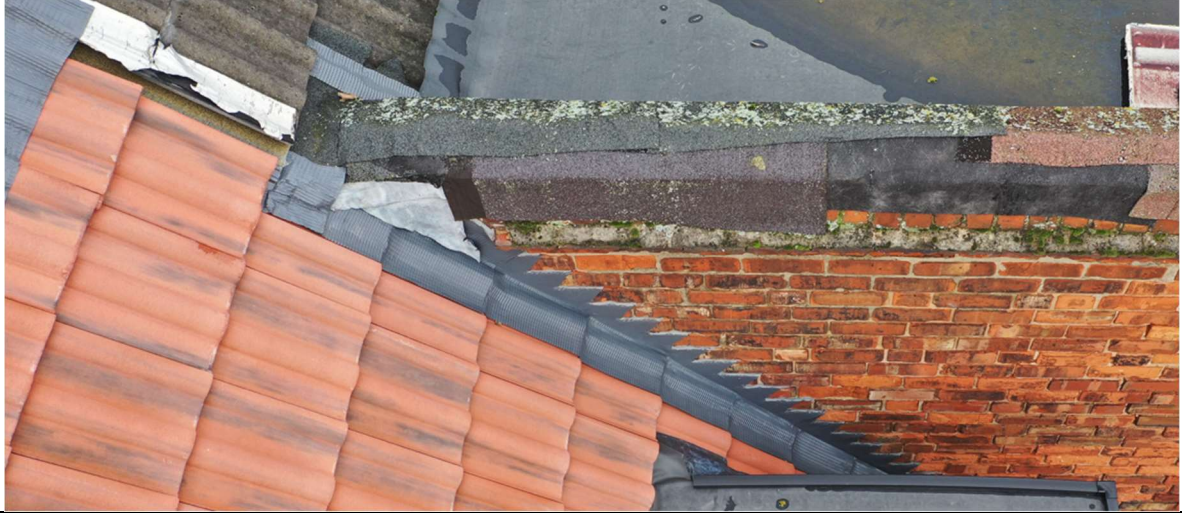
Abutment – lead flashing and soaker detail has been replaced with a single-piece cover flashing in lead replacement material. We do not recommend that lead be replaced with these inferior products. We cannot see if an abutment soaker has been used.

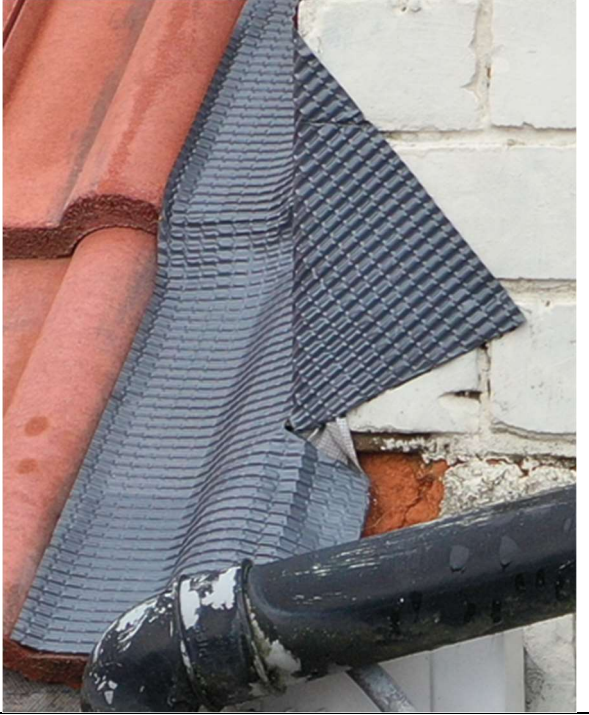
At the bottom of this run, the flashing is not detailed into the brickwork.

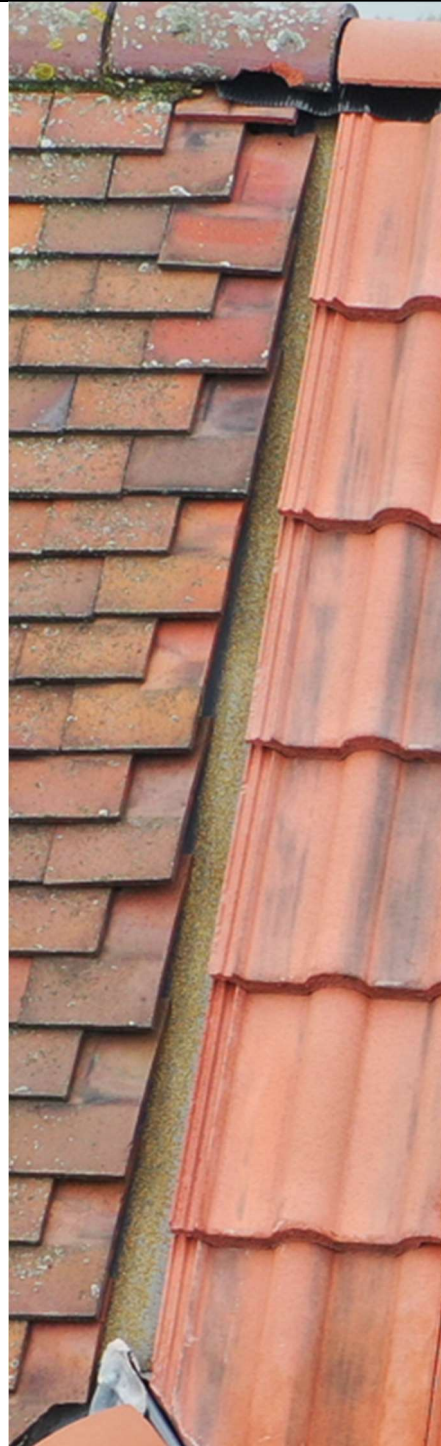
This bonding gutter is a 'wet' style one and the tiles should be mortared up to. They are not. The tiles at the lower end do not sit far enough into the gutter.

On the neighbouring covering, every other half-tile is missing.

It would have been better to set the roof out using the high point of the tile as opposed to the interlocks.

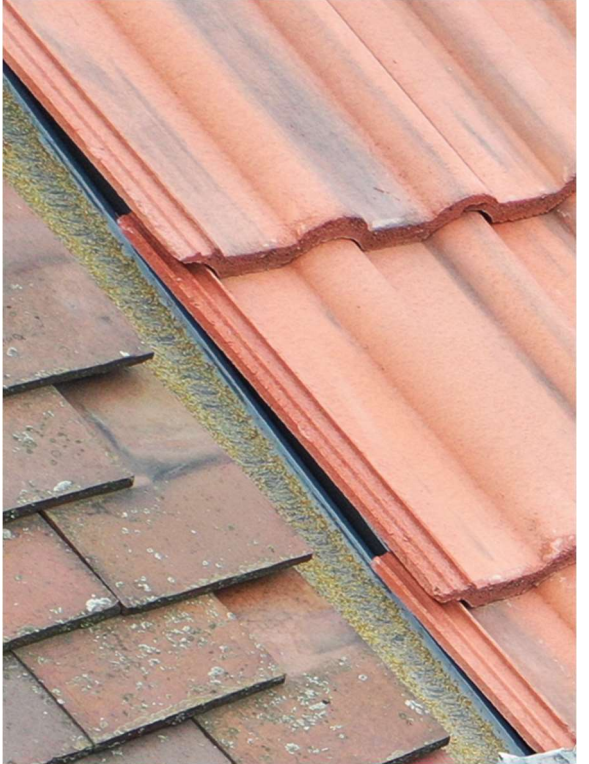
Right-hand abutment – this style of bonding gutter requires tiles to be mortared in. There is no mortar here.

The head hap also looks to be insufficient.

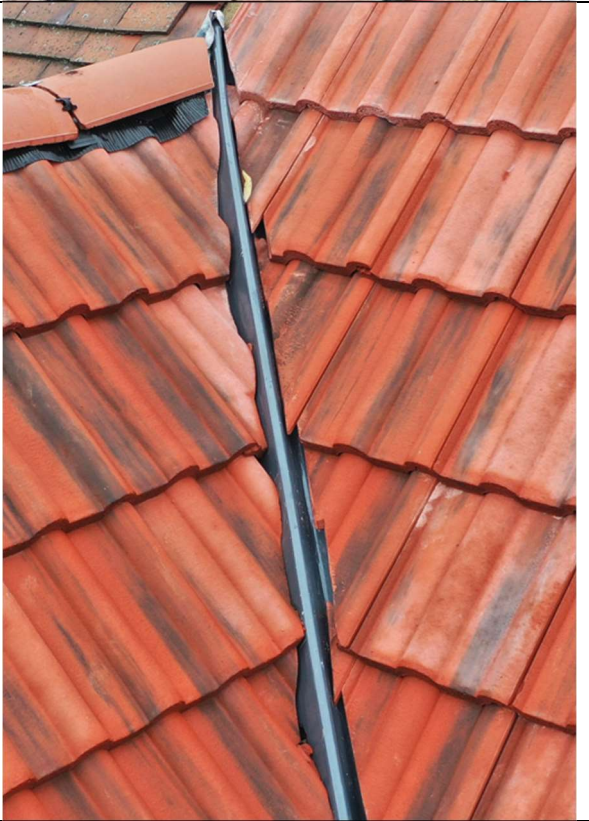
Tiles are not cut uniformly to the upstand.

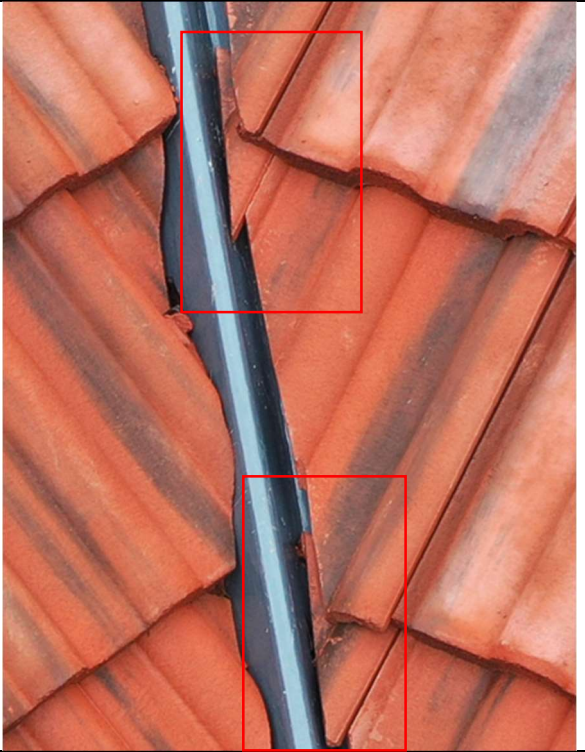
Smaller pieces of tile need tile support brackets fitting to their undersides.

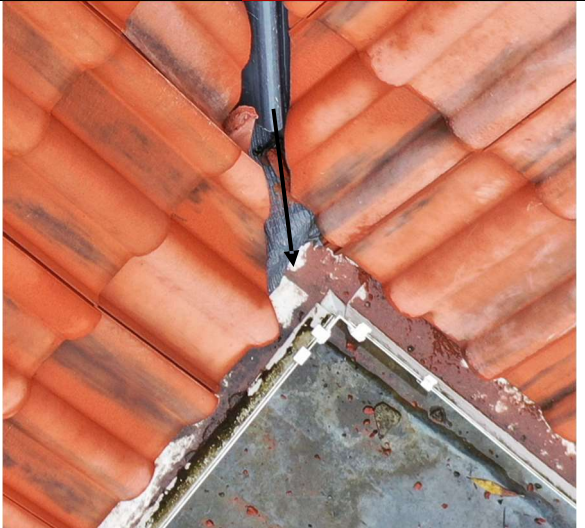
Valley – the upstand does not look to come far enough down the valley.

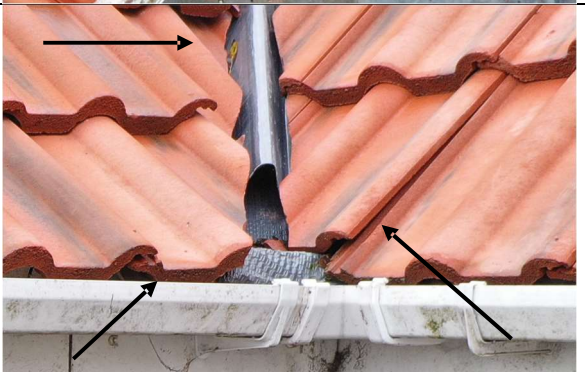
Close-up from underneath.

Note that the bottom tiles do not sit flat on the pitch as they should– see black arrows.

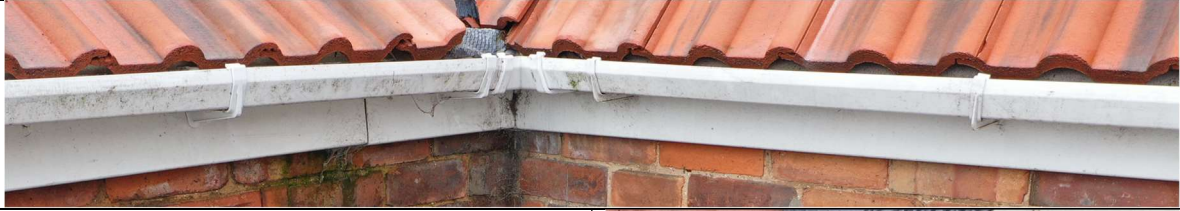
From what we can see, it does not look like an eaves board has been used.

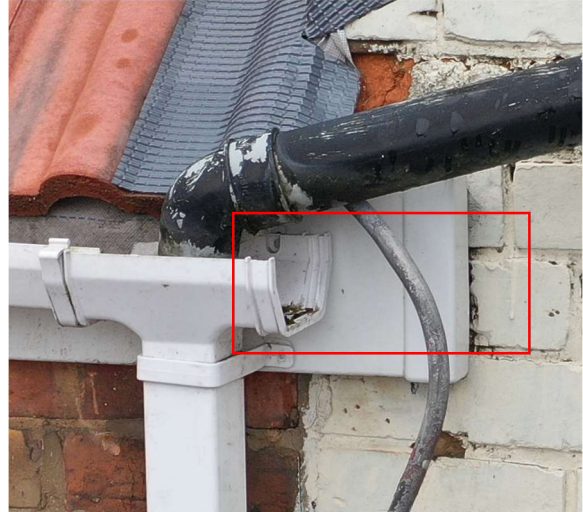
The end section of the guttering is missing and should be replaced straight away. Having the neighbouring properties fall pipe discharging into the guttering is not ideal.

If they must use the subject properties' rainwater goods to discharge their rainwater, a branch into the fall pipe would be far better.

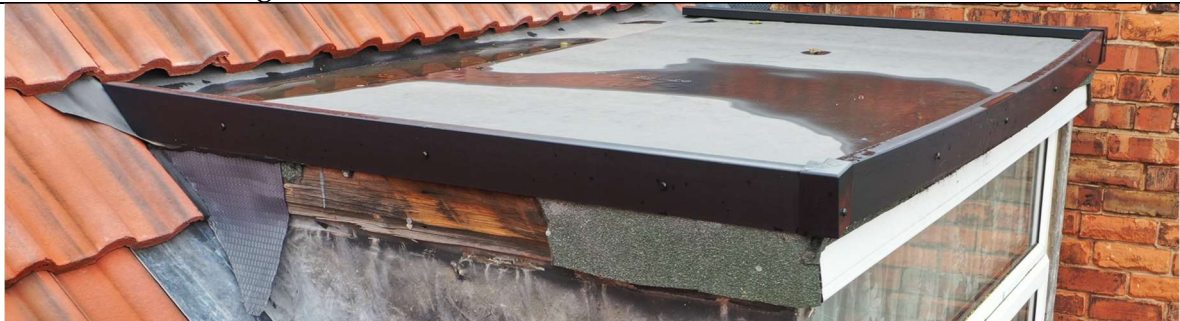
Dormer window – ponding suggests that the roof has not been cut to the correct fall. Capping corners need additional fixings. The front fascia trim looks to be bowing out and down. Facia trims missing completely from the right-hand side. The upper section of the trim looks to be cut too close to the pitch for rainwater to escape. All needs addressing in the short term.

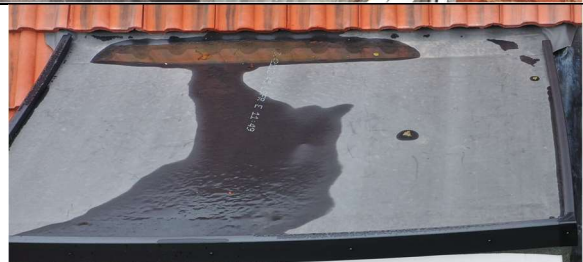
A better view of the ponding.

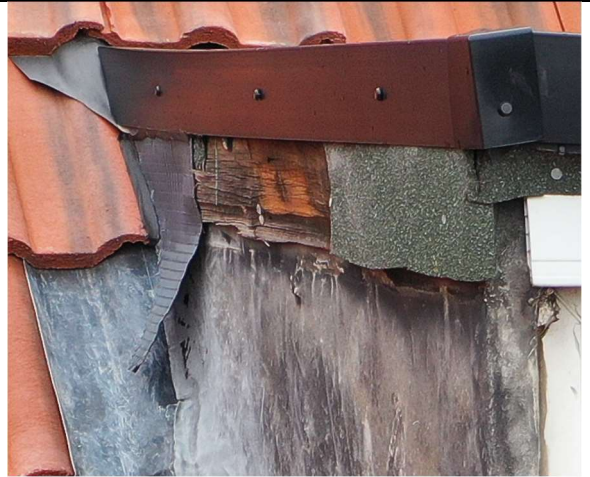
Close-up side-on.

The dormer is a mess and needs repairing properly.

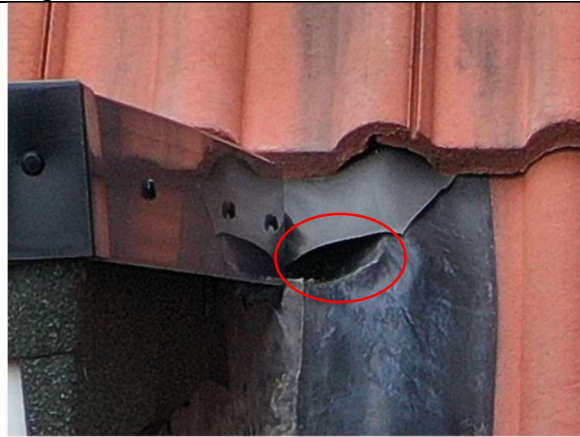
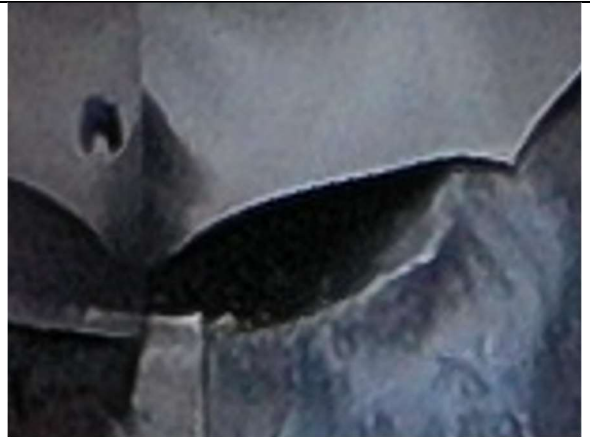
Left-hand side – close-up – we can't quite see what is going on here, but it looks like there is a hole between the two/three different flashing materials. This needs tidying up as soon as possible.

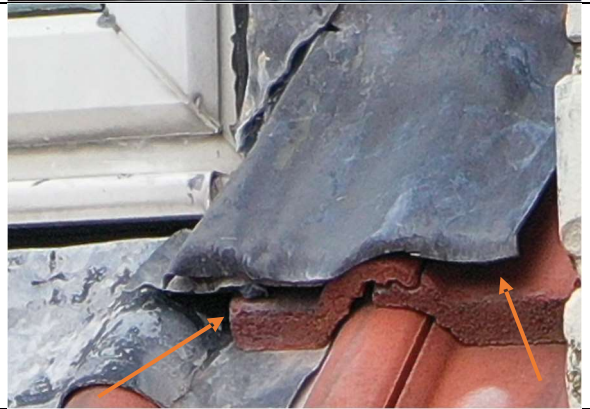
Dormer window – the flashing is not tamped into place.

It will be subject to wind lift and rainwater penetration.

From the staining on the tiles below, it looks like patination oil has not been used on the lead detail.

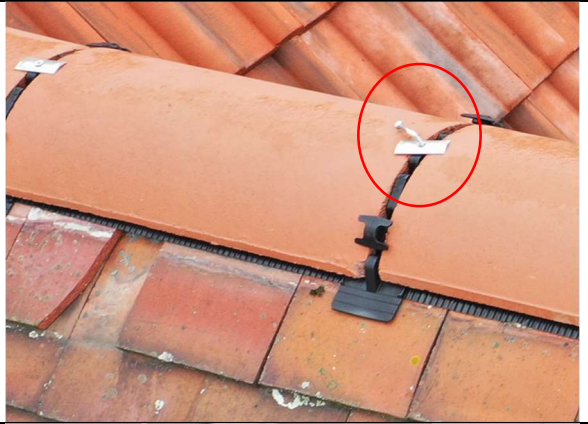
Another fixing with just a bent screw/nail in it.

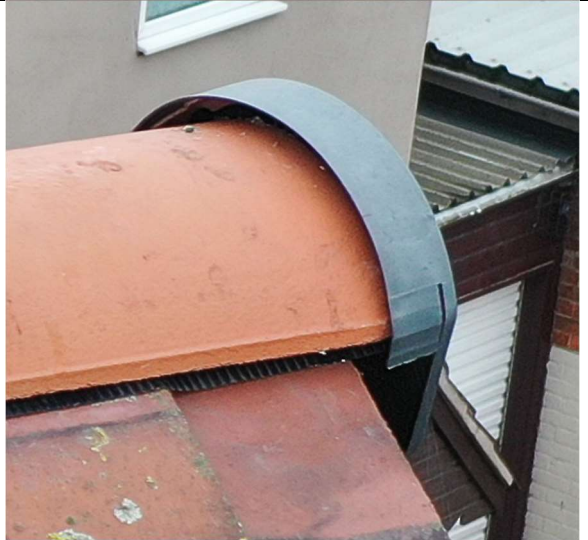
Ridge – the end cap does not look like it fits correctly/is properly affixed.

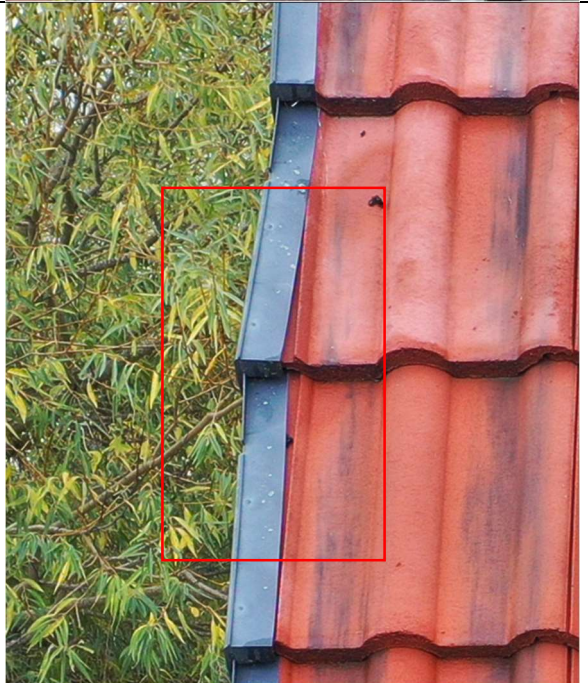
Dry-verge system not properly affixed.

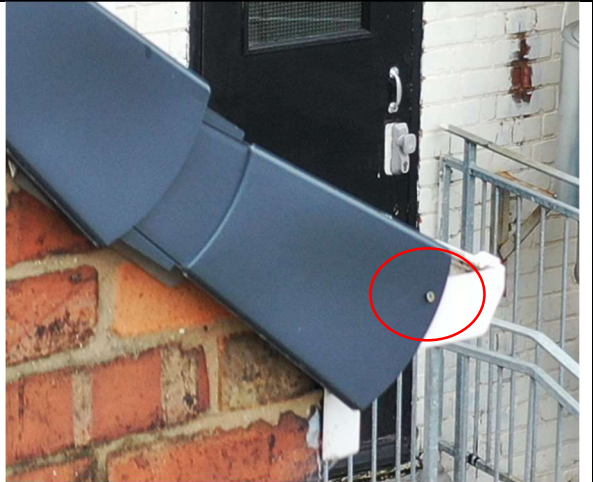
Dry-verge system looks like it has been mechanically affixed to the guttering. This is not acceptable.

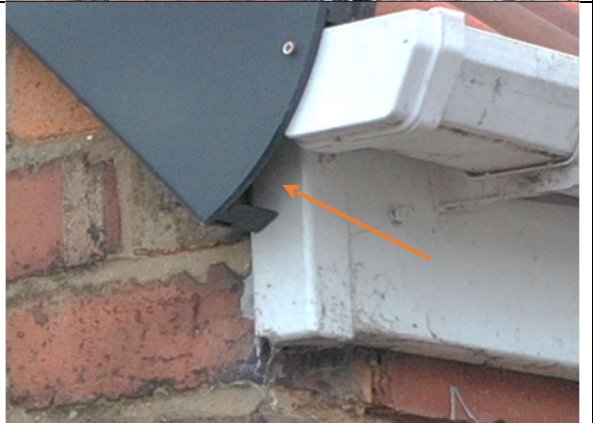
This hole needs plugging to stop birds and vermin etc getting access to the roofspace.

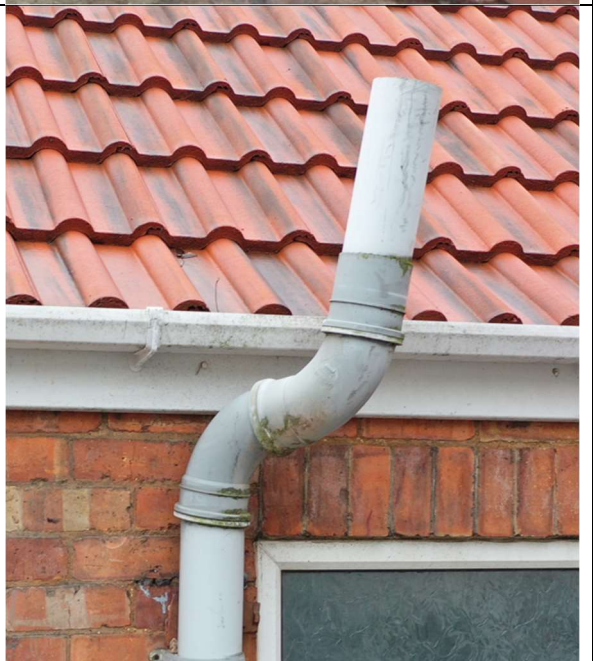
The top of the soil vent pipe should have a bird guard on.

It also looks loose and should be better supported.

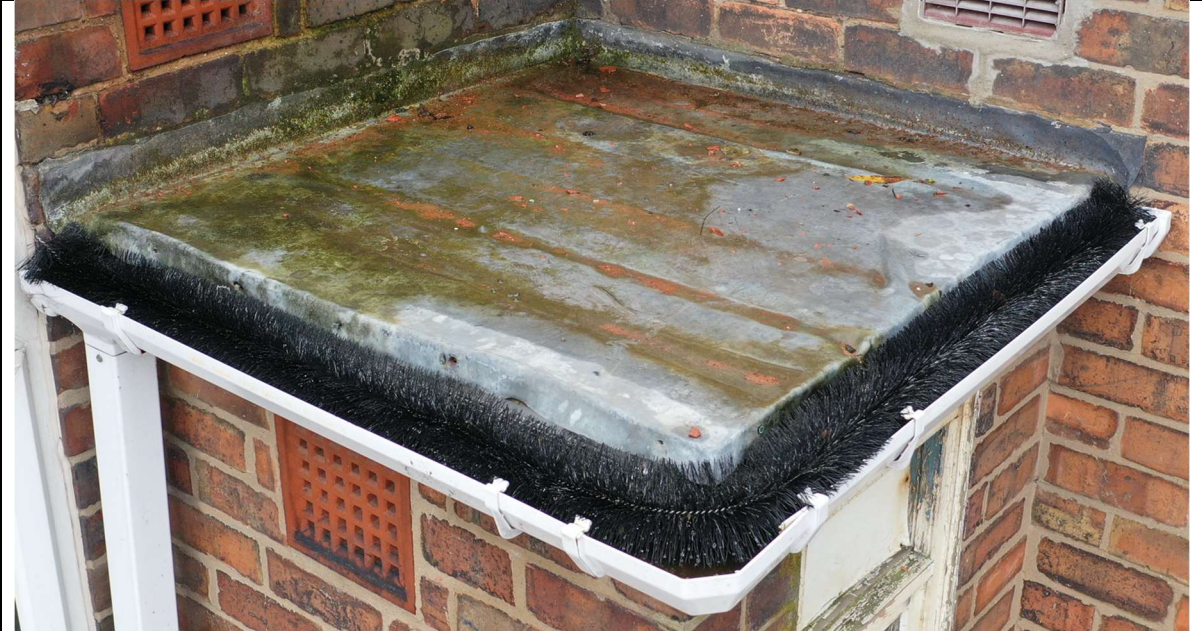
Single story off-shot – the roof covering is in poor condition. The area is too large to be covered by a single sheet of lead. It is ruckling and does not look to be set to the correct fall.

We do not recommend 'hedgehog' systems in guttering as they make it very hard to clean out.

Consideration should be given to replacing this in the near future.

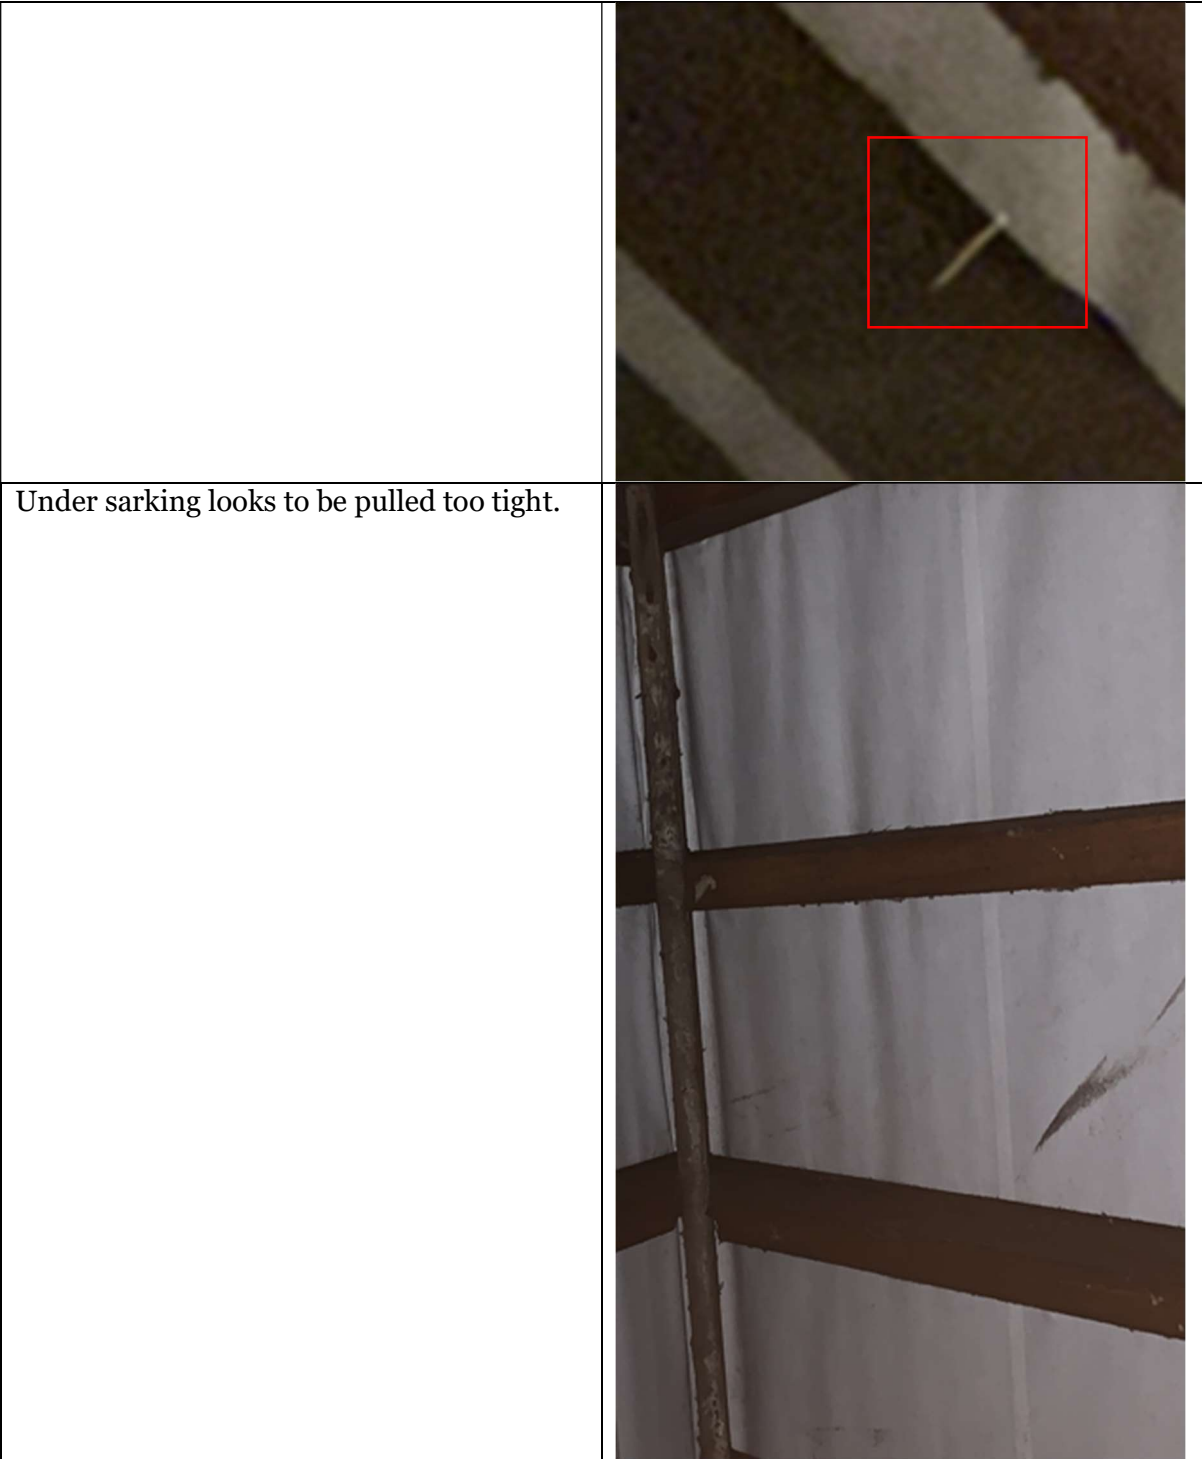
Note that when more than 50% of the roof covering is replaced, the roof needs to be insulated to the regulations at the time of the re-roof. Here, it does not look like this has happened.

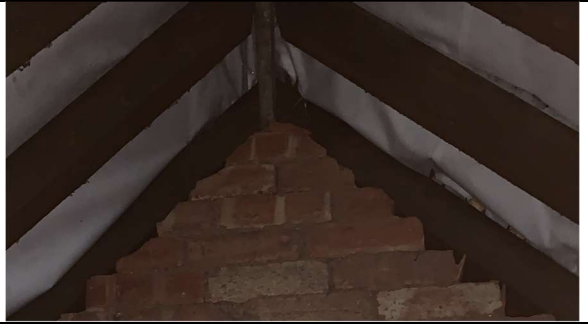
Under sarking is ruckled in places. It should be laid flat with a slight sag in between the rafters.

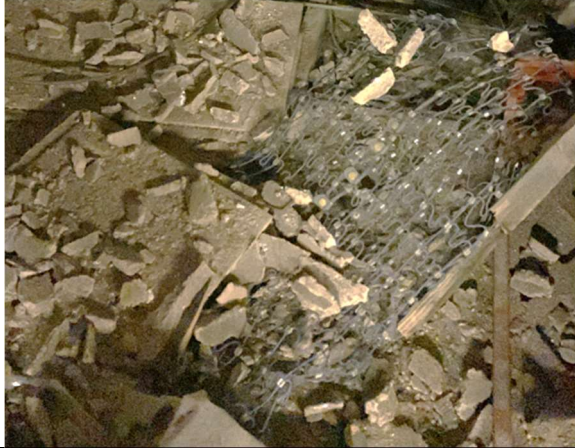
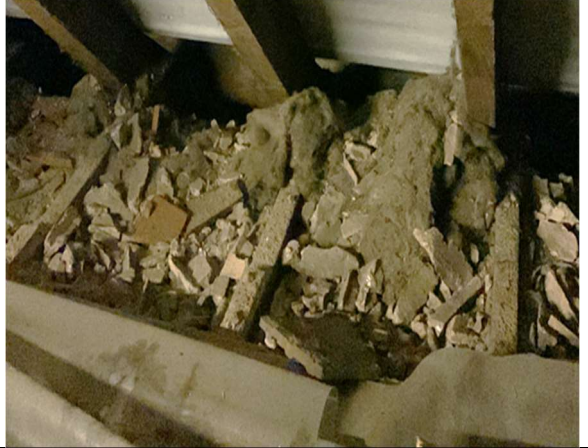
All debris needs clearing from the roofspace.
