Roof Inspection Report
In respect of:

25th November 2022

Drone Inspection Report - Summary of Findings

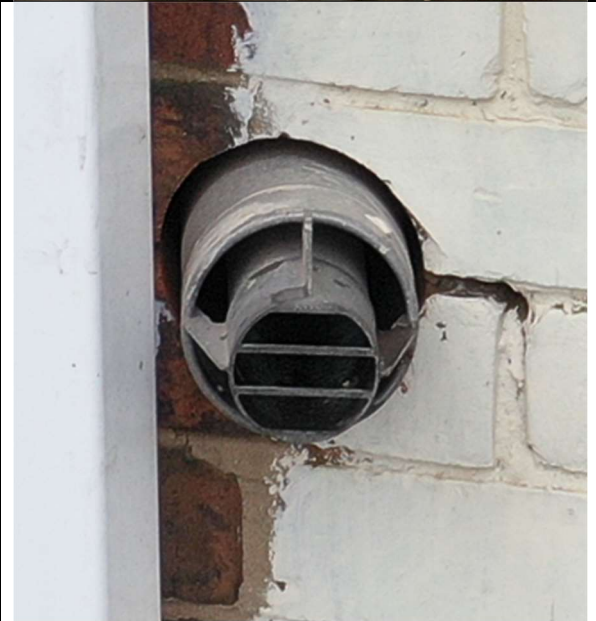
We are not gas experts, however, recommend the boiler installation is checked by an appropriate gas safety engineer as soon as possible. The flue has been put through the wall at an angle, the flue is not sealed and the rubber flange is missing.
