ROOF INSPECTION REPORT

1 Cold Spring House
Haworth Road
Cullingworth
BD13 5EL

10 October 2024

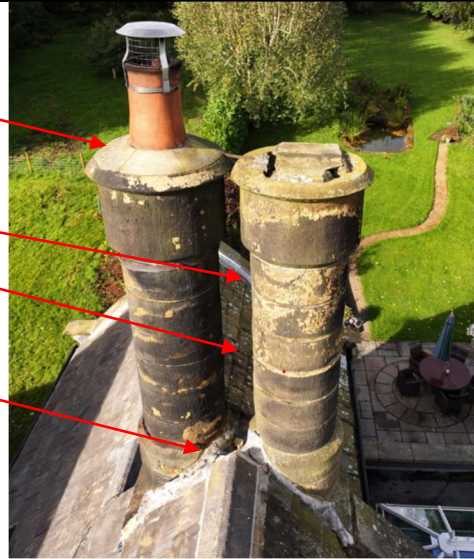
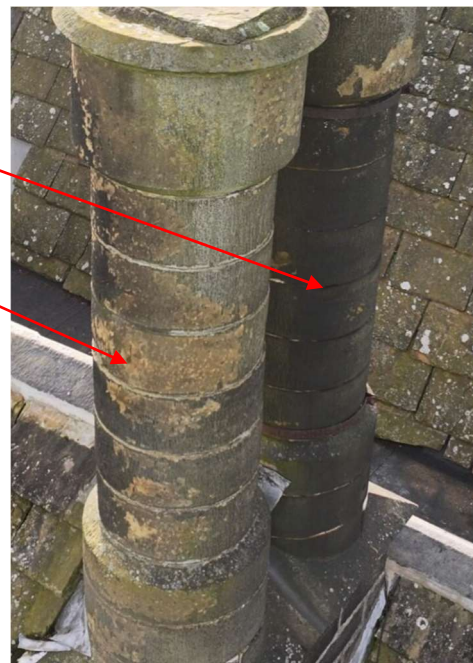
Chimney stack, example of defects

The flaunching is cracked and these should be repaired when practical, these will worsen through general weathering and 'freeze-thaw' which will eventually allow water ingress (Photo 0414)

Some of the blocks have cracked to the flue that has been capped off, this will allow water ingress and should be repaired or replaced. (Photo 0414)

To the flues, in areas the pointing is weathered and missing. Some isolated areas of pointing are missing to the main stack stonework, (Photo 0426) these should be repointed as soon as practical.

Cracked flaunching

Cracks to stonework

Missing pointing

Weathered stone

1. Review and consider if additional ventilation is required to capped off flue.
2. Repair cracks to flaunching.
3. Repair or replaced the cracked stones.
4. Replace lead flashing.

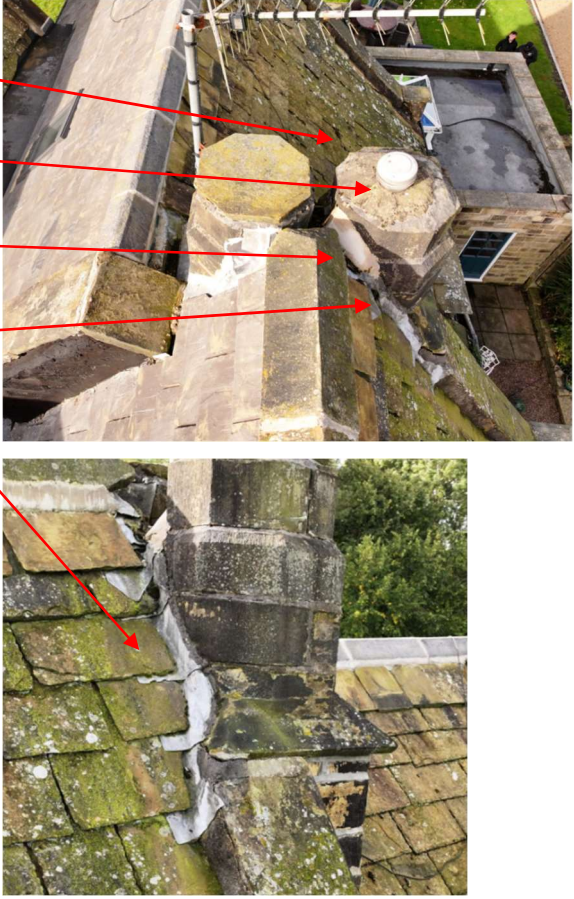
Chimney stack, example of defects	
Cracked flaunching

The flaunching is in poor condition, it is weathered and cracked and these should be renewed when practical, the pointing is also missing and loose to the capping stone, this will eventually allow water ingress and the internal areas should be checked for dampness. (Photo 0461)

The lead flashings and soakers to this stack are also weathered and in average condition, due to the awkward detail at the junction with the roof ridges, areas of mortar have been applied, most likely to assist with weathering the detail. We anticipate that this may be a vulnerable area and at risk of water ingress. It should be maintained in good condition. (Photo 0458). The lead flashing at the junction with the outer slope has been poorly installed and is weathered, it should be replaced when practical.

Redundant service flue	
Additional mortar	
Poor/weathered lead flashing & soakers

1. Review and consider if additional ventilation is required to capped off flues.
2. Renew flaunching and repoint capping stone.
3. Isolated repointing to stonework.
4. Replace lead flashing.

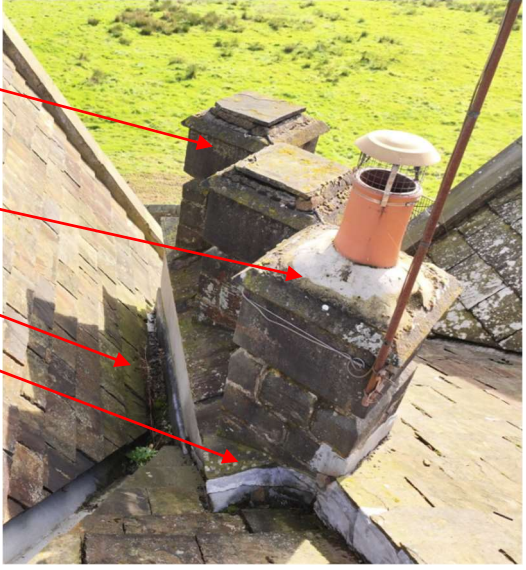
The flaunching is in poor condition, it is weathered and cracked with sections missing, there is also an accumulation of moss which will retain water, the pointing is also cracked and weathered to the capping stones of the capped off flues. These should be renewed when practical. (Photo 0367)

The lead flashings and soakers to the south side of the stack are also weathered and in poor condition, this may be the neighbour's side of the stack, and possibly their responsibility (Photo 0365). The flashing to the north side, appear reasonably new (Photo 0368), except those at the rear abutment

Chimney stack, example of defects	
<p>Loose and weathered mortar/moss growth</p> <p>Cracked flaunching</p> <p>Congested apron flashing/valley</p> <p>Poor/weathered lead flashing & soakers</p>

1. Review and consider if additional ventilation is required to capped off flues.
2. Renew flaunching and repoint capping stones.
3. Isolated repointing to stonework, crown stones and so on.
4. Replace lead flashing to rear saddle, (assuming south elevation flashing is the neighbour's responsibility).
5. Clear out vegetation from apron flashing/valley to north side of stack (discussed elsewhere).

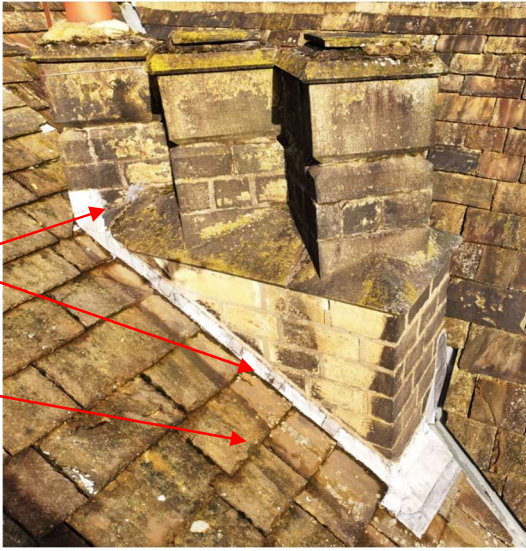
<p>ASSUMED NEIGHBOURS SIDE OF STACK (NORTH)</p> <p>Weathered stone and isolated missing pointing</p> <p>Poor/weathered lead flashing & soakers</p>

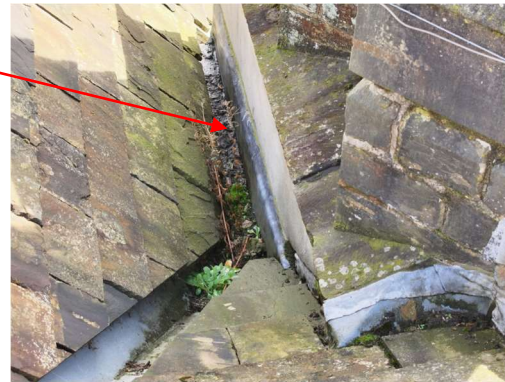
Congested apron to shared stack

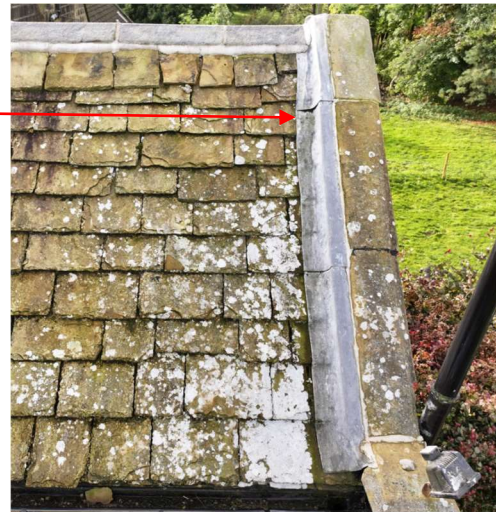
To the rear west facing gable, lead flashing has been dressed over the coping stones, this usually is dressed underneath, therefore it may be a secondary layer, upon occupation, the presence of a flashing below the coping stones should be confirmed, in the absence of one, a new flashing should be installed (Photo 0425). The lead is a little weathered but in satisfactory condition despite its non-traditional location. The installation could indicate a previous issue with rainwater penetration.

Flashing over copings to rear gable coping stones

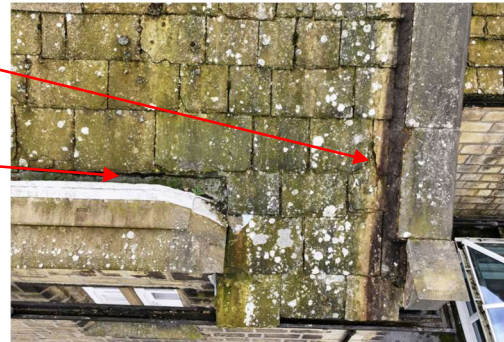
A mortar fillet closes the gap between the coping stones and gable ends to the front and middle north facing roof slopes, and the front gables facing east. These are cracked and weathered, the fillet is almost completely missing in many areas. These should be renewed as soon as possible (Photo 0441 & 0443).

extremely weathered and cracked mortar fillet

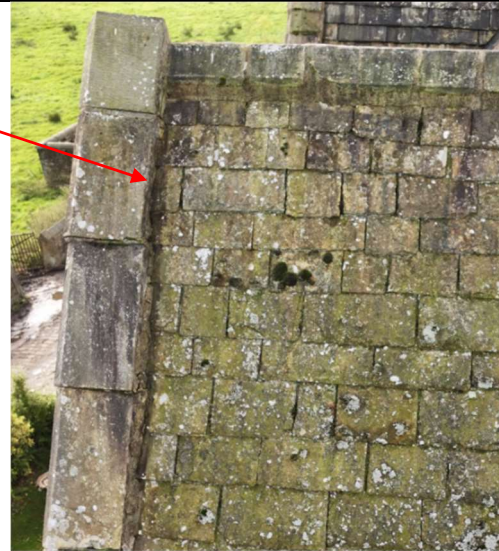
Missing mortar fillet

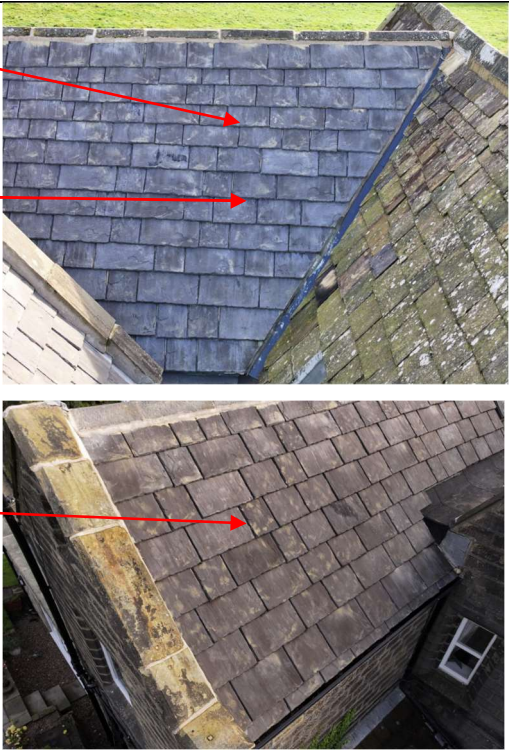
Some of the newer tiles have slipped slightly and ridden up on one another, this could allow minor water ingress (Photo 0394). The spacing and joints between the newer tiles are a little irregular, some tiles are slightly higher, this may allow water ingress over time. (Photo 0406) Minor undulation in the slope may be causing this. This suggests the roof structure may have deflected, and we recommend that the roof spaces are inspected to confirm the condition of the roof structure and check for any deflection and distortion. We recommend that the minor deflection noted to the roof slopes is investigated further by a structural engineer.

Example of defects – Roof Coverings	
<p>Irregular spacing,</p> <p>Slipped</p> <p>minor deflection</p> <p>Weathered coping stone</p>

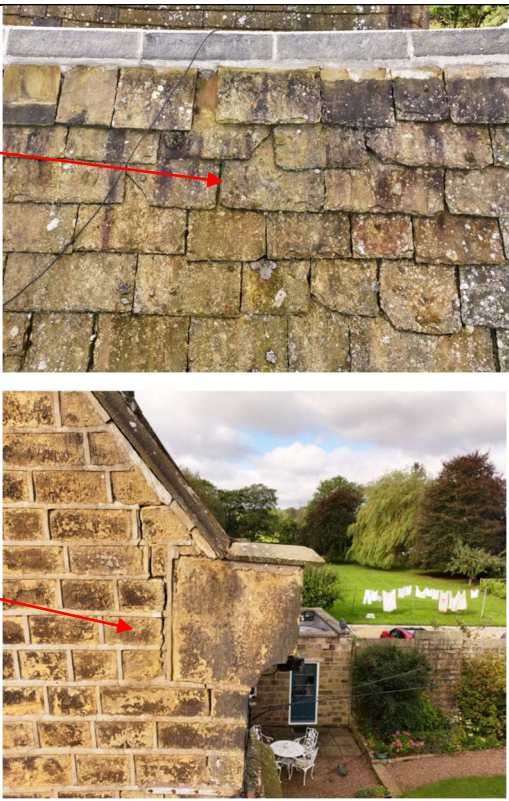
On the north facing slopes, the tiles are weathered and many have deteriorated, a number of chipped, broken and slipped tiles are noted (Photo 0433).

<p>Slipped, chipped and broken (North facing slope)</p> <p>Loose/cracked pointing. Possible movement in corbel.</p>

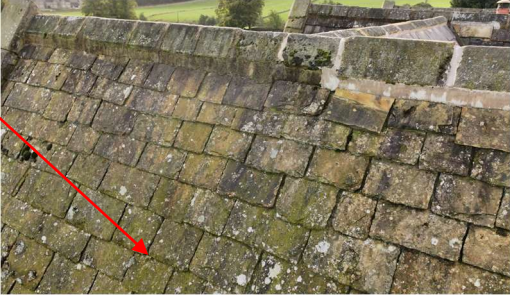
We anticipate that the coverings on the north slopes are approaching the end of their useful life and we recommend that you budget for recovering them. The slates to the central north facing roof slope appear to be in the poorest condition out of the three roof slopes, this slope could be prioritised if you are considering phasing recovering. (Photo 0433).

<p>Weathered slates to north facing slope</p>

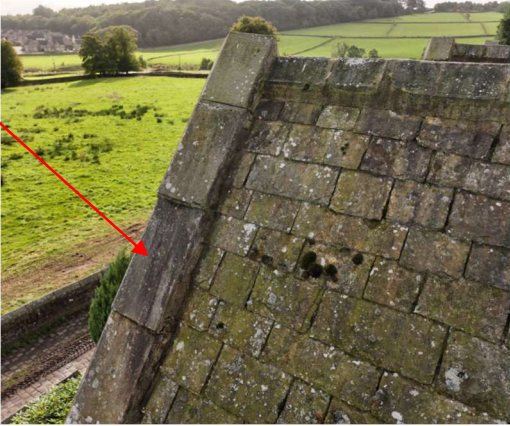
<p>Check copings are secure, alignment is out.</p>

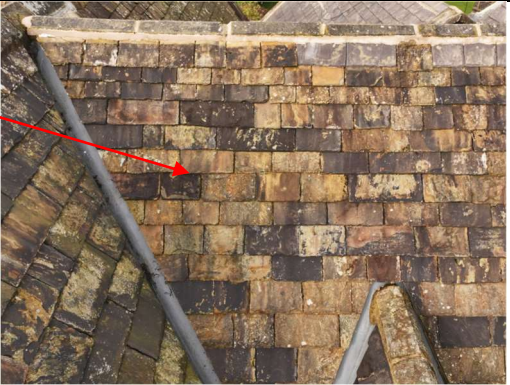
<p>Spalling, weathered</p>

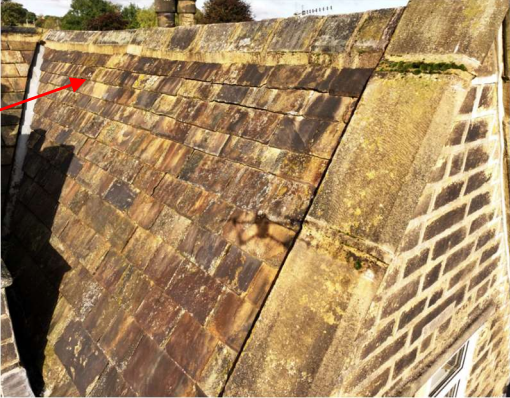
The tiles on the east facing slopes (front) are aged and weathered, some of the surfaces have spalled and chipped. These are generally in better condition than the north and should be serviceable for short-medium term future, routine maintenance is still due and you should also budget for isolated replacements in the meantime. Recovering is likely to be required during your occupancy of the property.

<p>Better condition compared to north, number of spalled slates.</p> <p>Cracking to ridge tile bedding.</p>

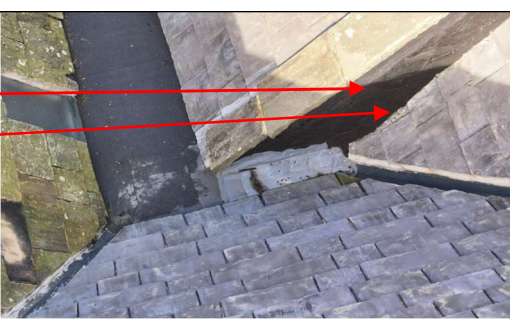
<p>Black waterproof paint, possible indication of water ingress issue.</p> <p>No obvious lead flashing</p>

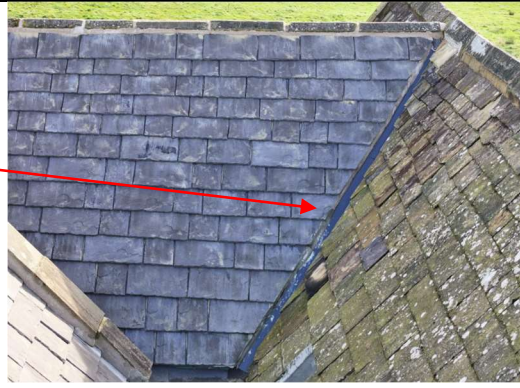
Cracked pointing to verge, painted valley gutters.

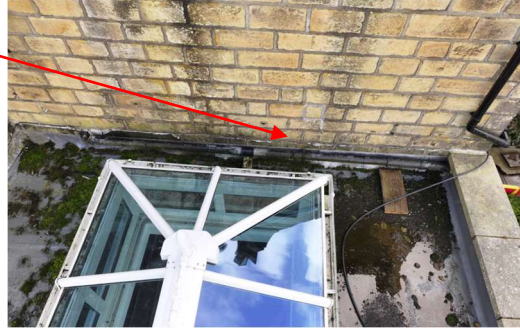
Moss, pipe secured on timber wedges.

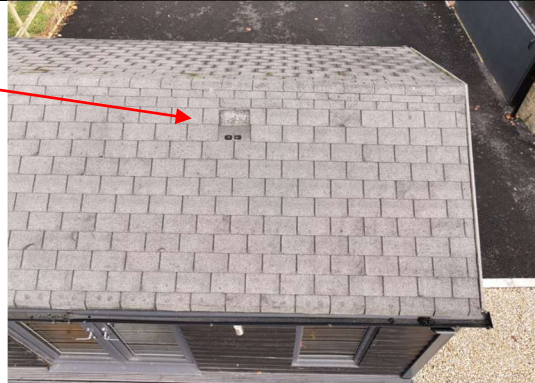
Missing felt tile.

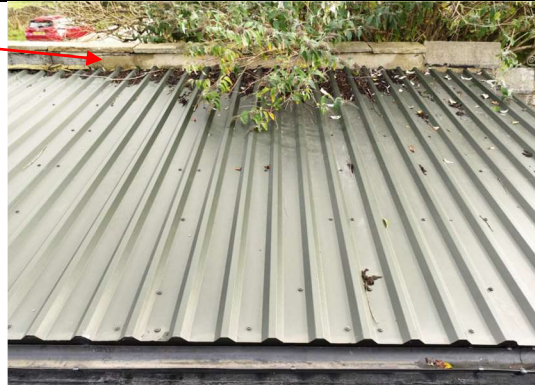
Store roof, blown render.

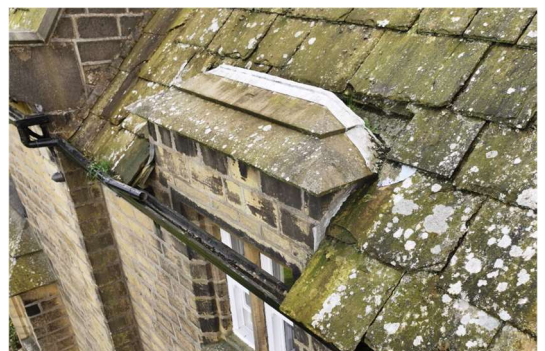
There is a downpipe unconventionally dressed into the gutter on the north elevation (Photo 0438) the circular pipe from the next roof slope is laid in the gutter, we anticipate that during prolonged and heavy rainfall this will over-flow. There is also vegetation build up. We recommend that you budget for altering this arrangement.

Overall, the rainwater goods appear to be in reasonable condition, however routine maintenance is due. You should budget in the first instance for adapting the circular down pipe arrangement in photo 0438 and clearing through those that are congested. The internal areas below the valley gutters should be monitored for water ingress, the GRP coatings will need replacement at some point.
