## Roof Inspection Report

Barkisland Mill

21<sup>st</sup> September 2023

## Drone Inspection Report - Summary of Findings

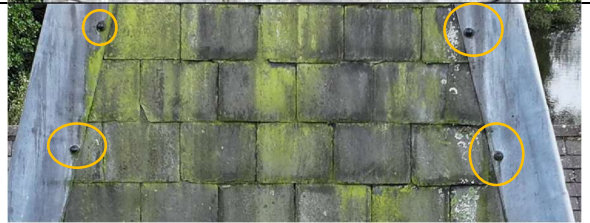
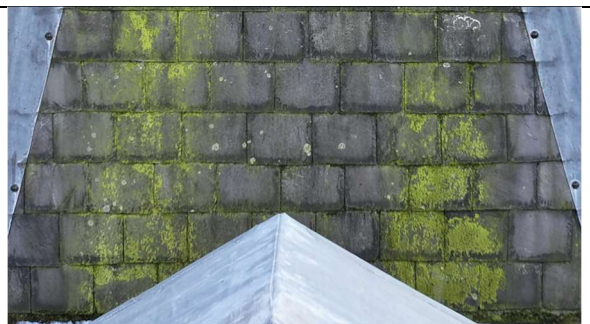
General comment, all towers – the build-up of algae should be killed and removed.

The slates are generally heavily pollution-stained.

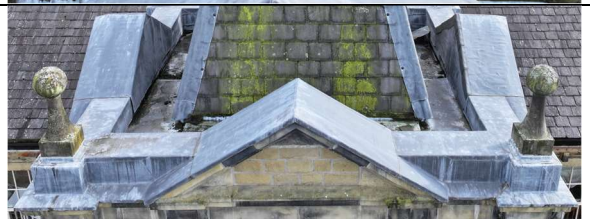
General comment, all towers – there is little room for expansion and contraction of the leadwork around the wall heads/parapets.

These should be monitored for tearing.

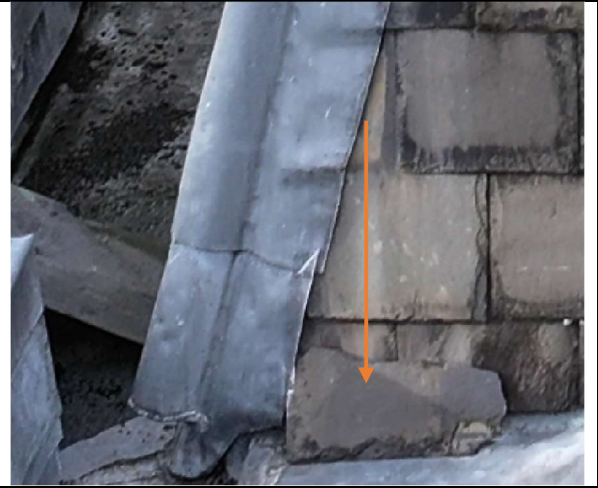
Rear pitch – the slipped slate should be re-affixed in the short-term.

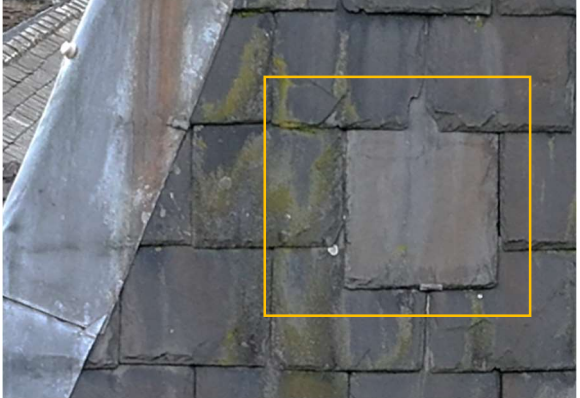
| <p>Left-hand pitch – the slipping slate should be re-affixed in the short-term.</p> | |

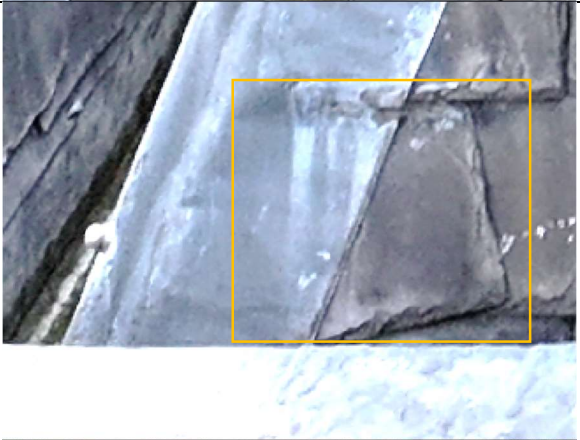
| <p>Left-hand pitch – the slipping slate should be re-affixed in the short-term.</p> | |

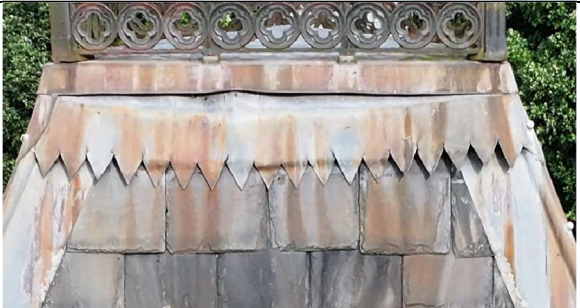
| <p>Right-hand pitch – the cover flashing is coming away and should be re-affixed in the short-term.</p> | |

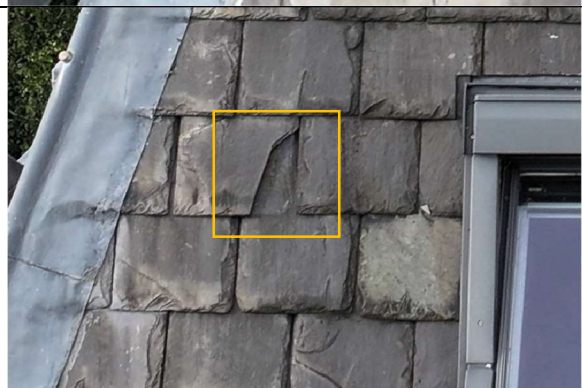
Rear pitch – the chipped slate should be replaced in the short-term.

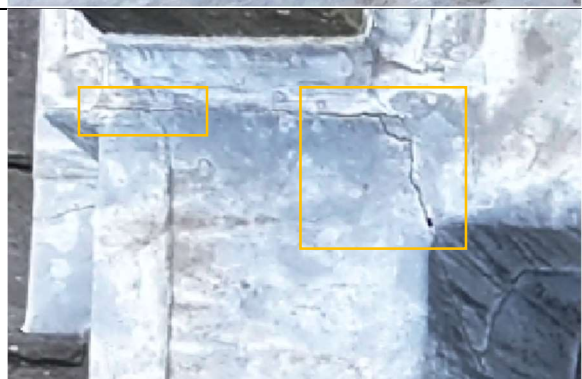
Parapet wall, rear right-hand corner – there appear to be two areas of tearing in the lead – these should be repaired as soon as possible.

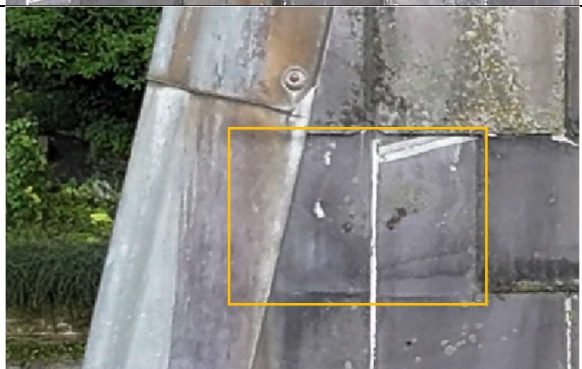
Right-hand pitch – the missing slate should be replaced in the short term.

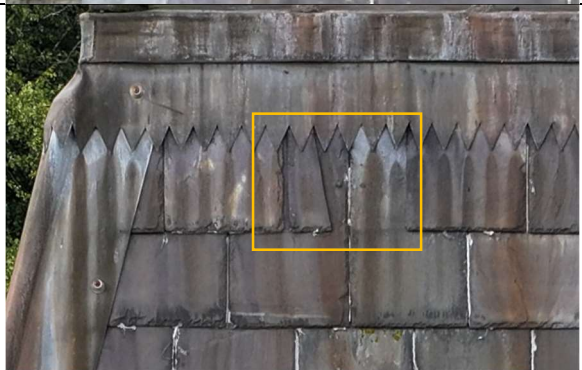
Rear pitch – the missing slate should be replaced in the short term.

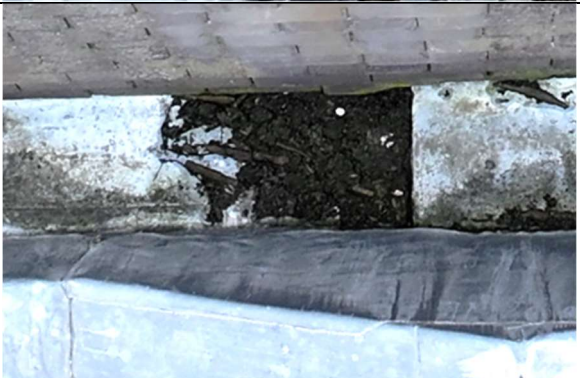
| <p>Box guttering – this should be cleared of debris.</p> | |

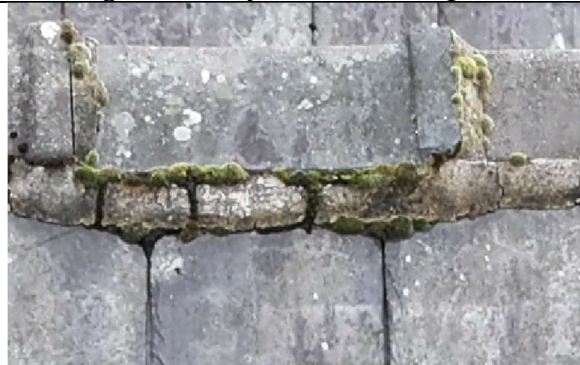
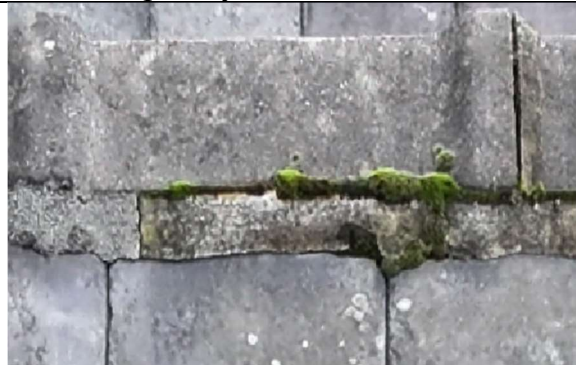
Ridge – there are areas of cracking to the ridge pointing and moss is beginning to build up. The ridge will likely need to be re-pointed in the next couple of years.

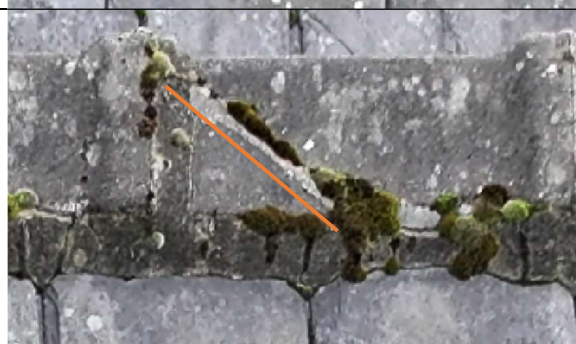
Ridge, left-hand section – the broken tile should be replaced in the short-term.

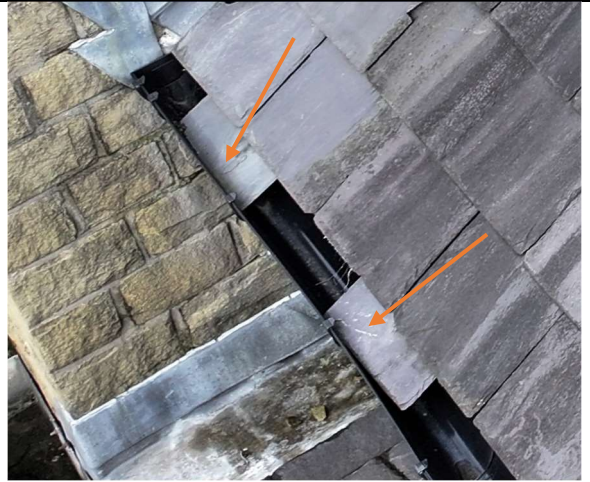
Centre left section, tower section – the slipped slated at the eaves course should be re-affixed as soon as possible.

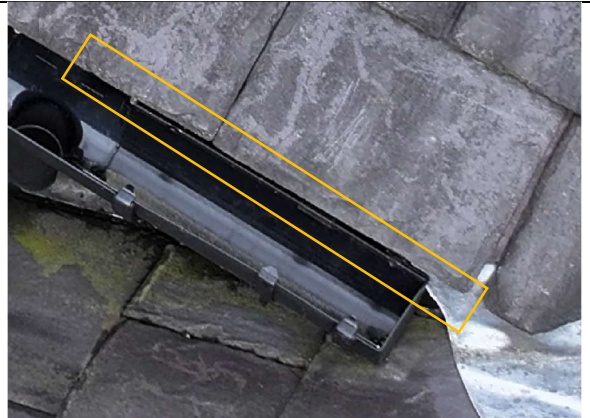
Centre left section, tower section – the slates toward the valley do not sit over the guttering, likely as the guttering channel is too deep to fit under the eaves course.

This needs to be corrected, a worked lead slip is likely the most economical solution to this.

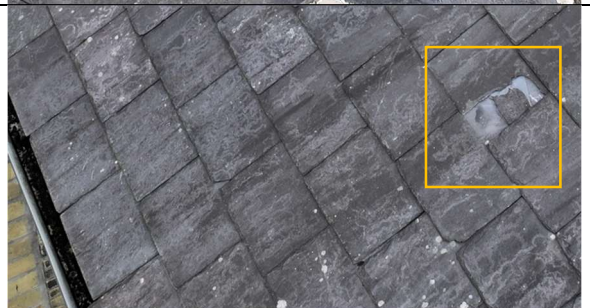
Centre left section – the damaged slate should be replaced as soon as possible.

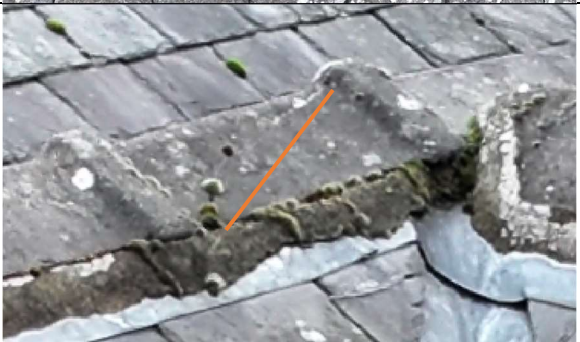
| <p>Centre left section – the cracked ridge tile should be replaced in the short-term.</p> | |

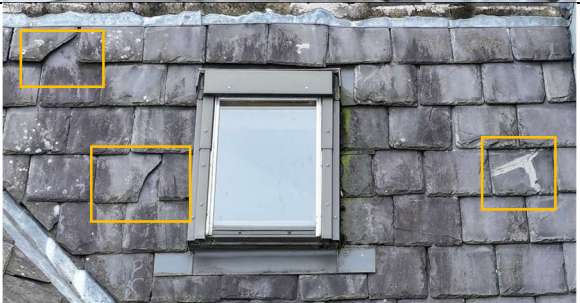
| <p>Centre left, tower section – the damaged slates should be replaced in the short-term.</p> | |

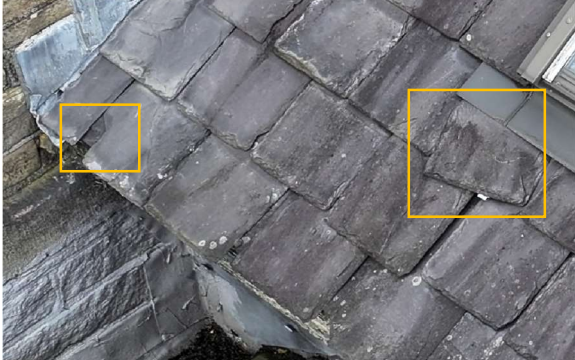
| <p>Centre-right, tower section – the slipping and damaged slates should be replaced in the short-term.</p> | |

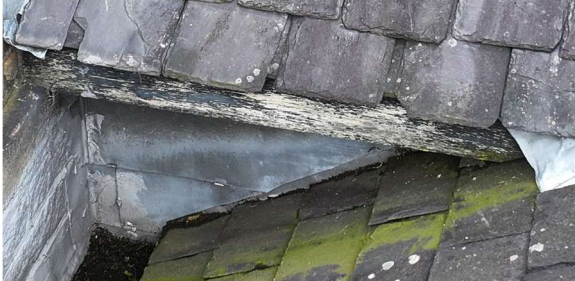
| <p>Centre-right, tower section – there is no guttering on the tower section and the fascia looks to be in very poor condition and will likely need replacing in the next year.</p> | |

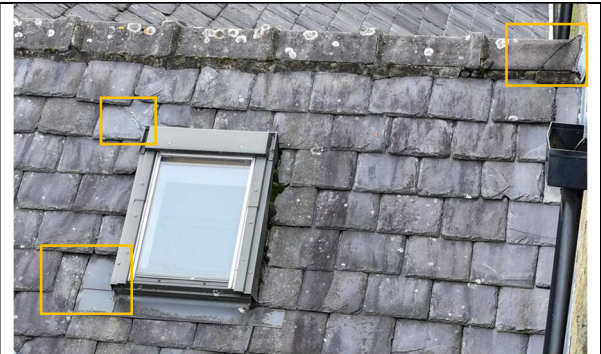
| <p>Centre-right, tower section – the damaged and missing slates and tile should be replaced in the short-term.</p> | A photograph of a roof section featuring a central skylight. Three yellow rectangular boxes are overlaid on the image to highlight areas of roof damage: one box is on a missing slate directly above the skylight, another is on a damaged slate to the left of the skylight, and a third is on a damaged slate at the top right edge of the frame. |

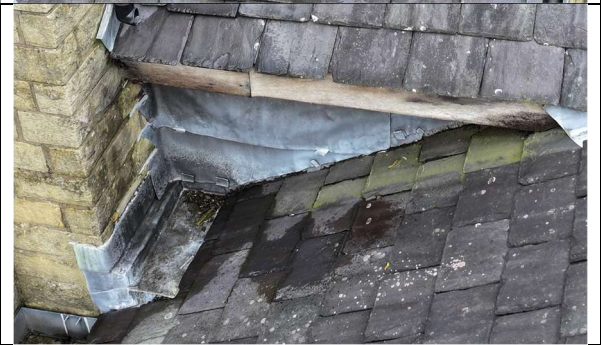
| <p>Right-hand side, tower section – there is no guttering on either side of the tower section.</p> | A photograph showing the right-hand side of the roof where it meets a brick wall. The roof surface is severely damaged, with several slates missing, exposing the underlying wooden batten and waterproofing. There is no guttering visible on either side of this section. |

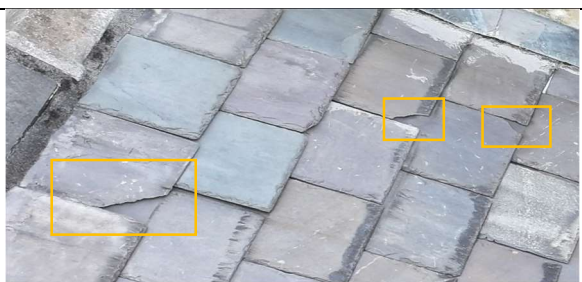
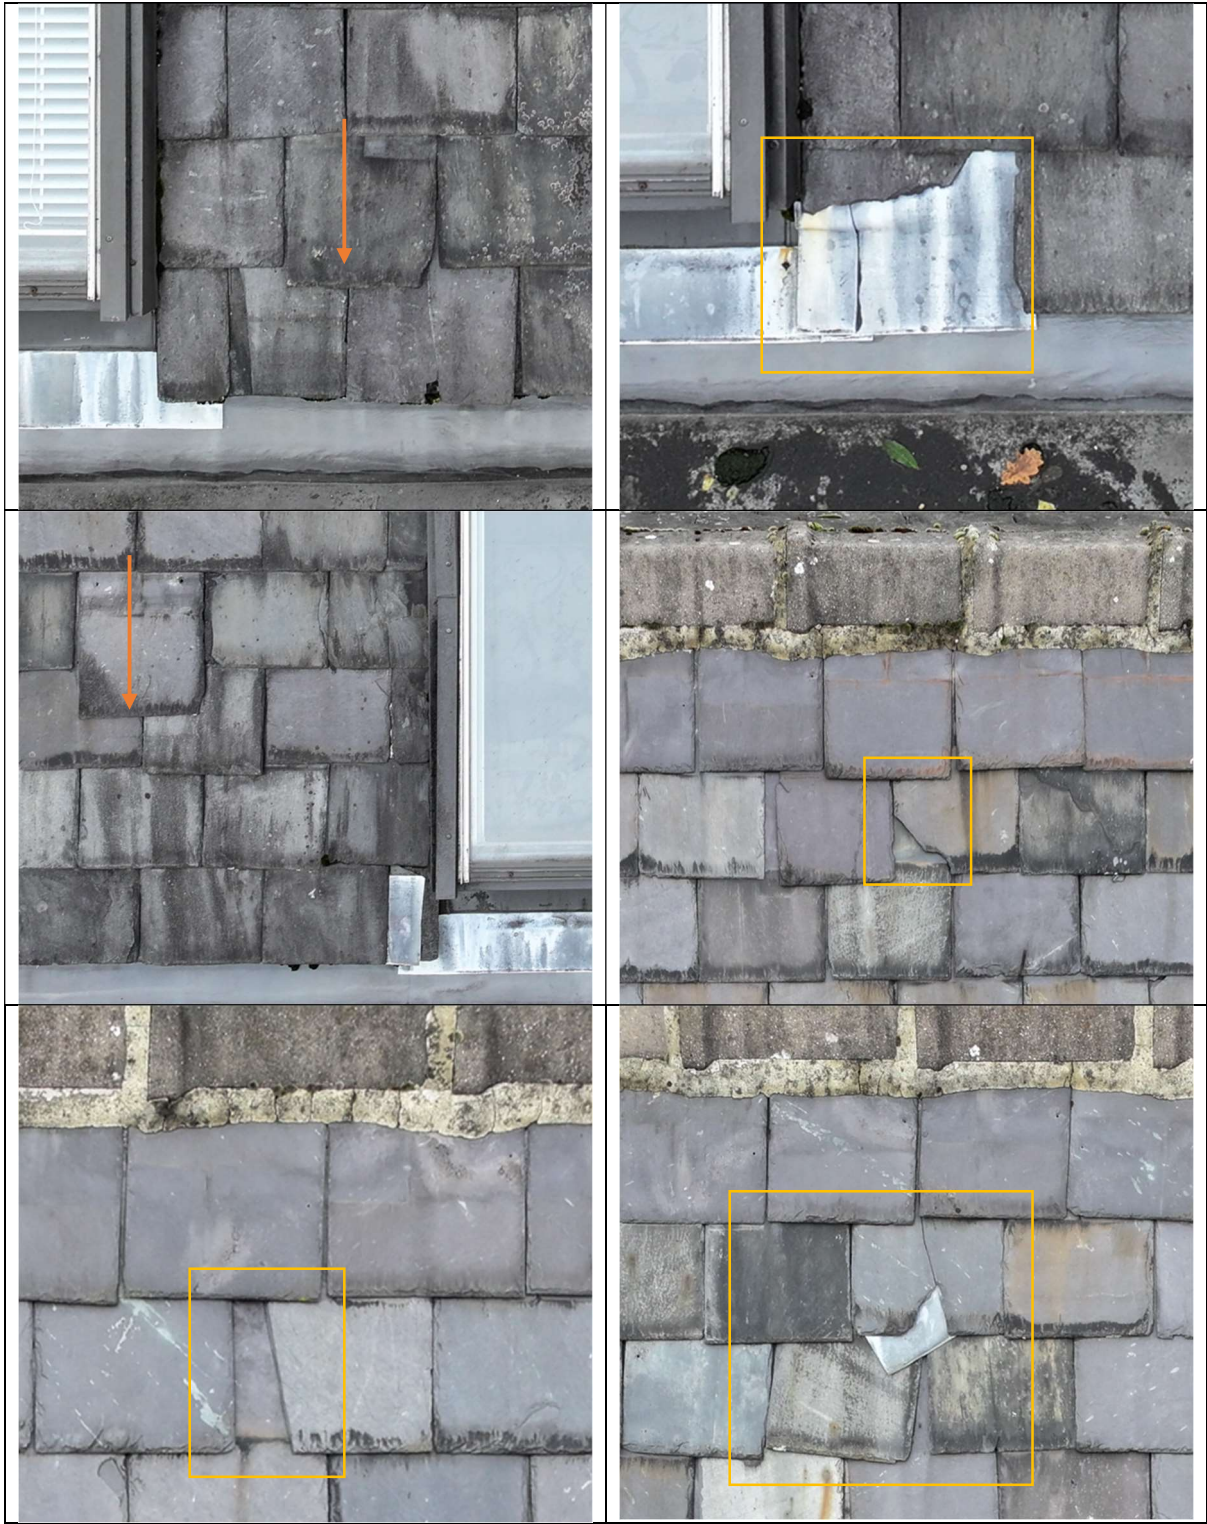
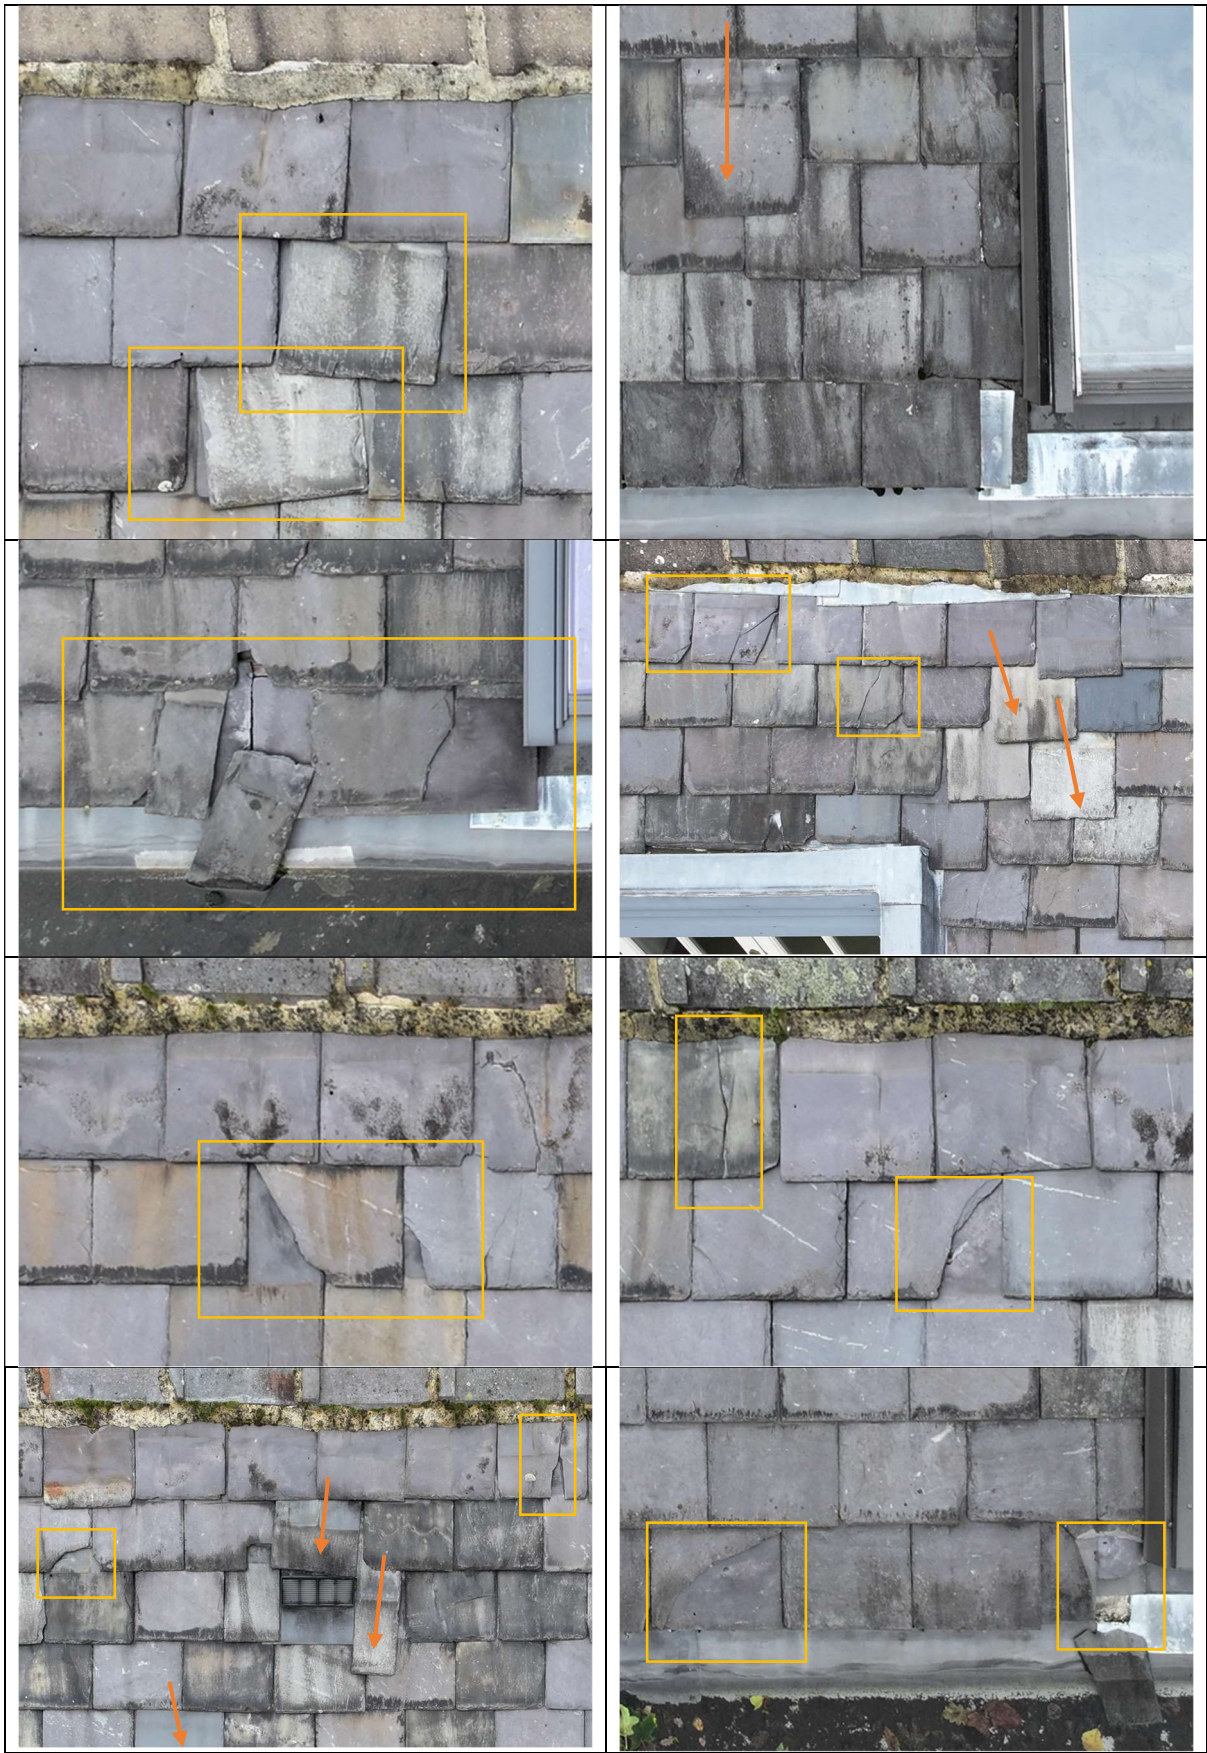
The damaged and slipping slates should be replaced in the short term. We have included photos of the areas of concern below. The photos run left to right and we have marked damaged slates in yellow boxes and slipped slates with an orange arrow.

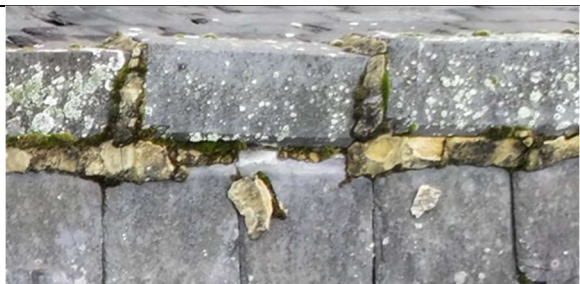
The ridge pointing is in poor condition and will likely need to be raked out and repointed in the next year.

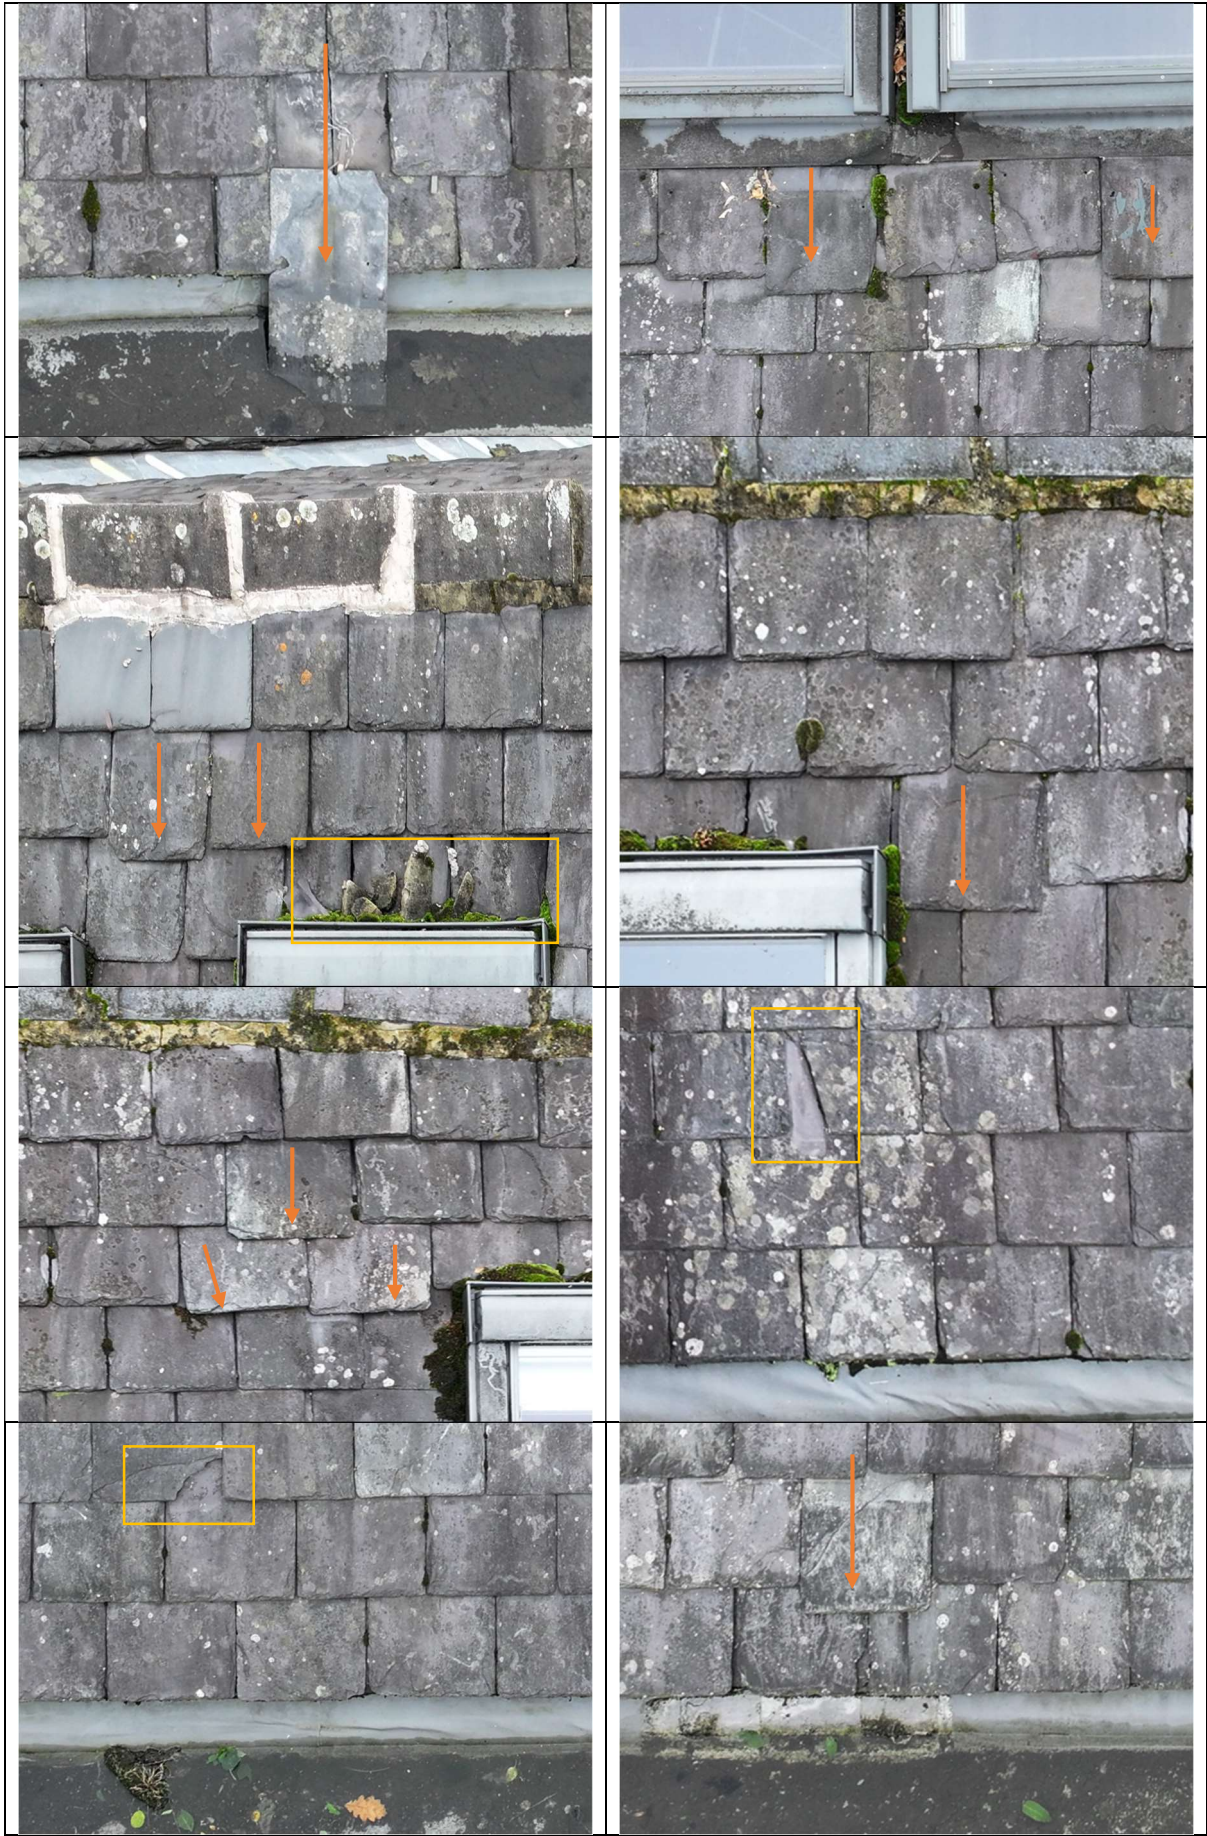
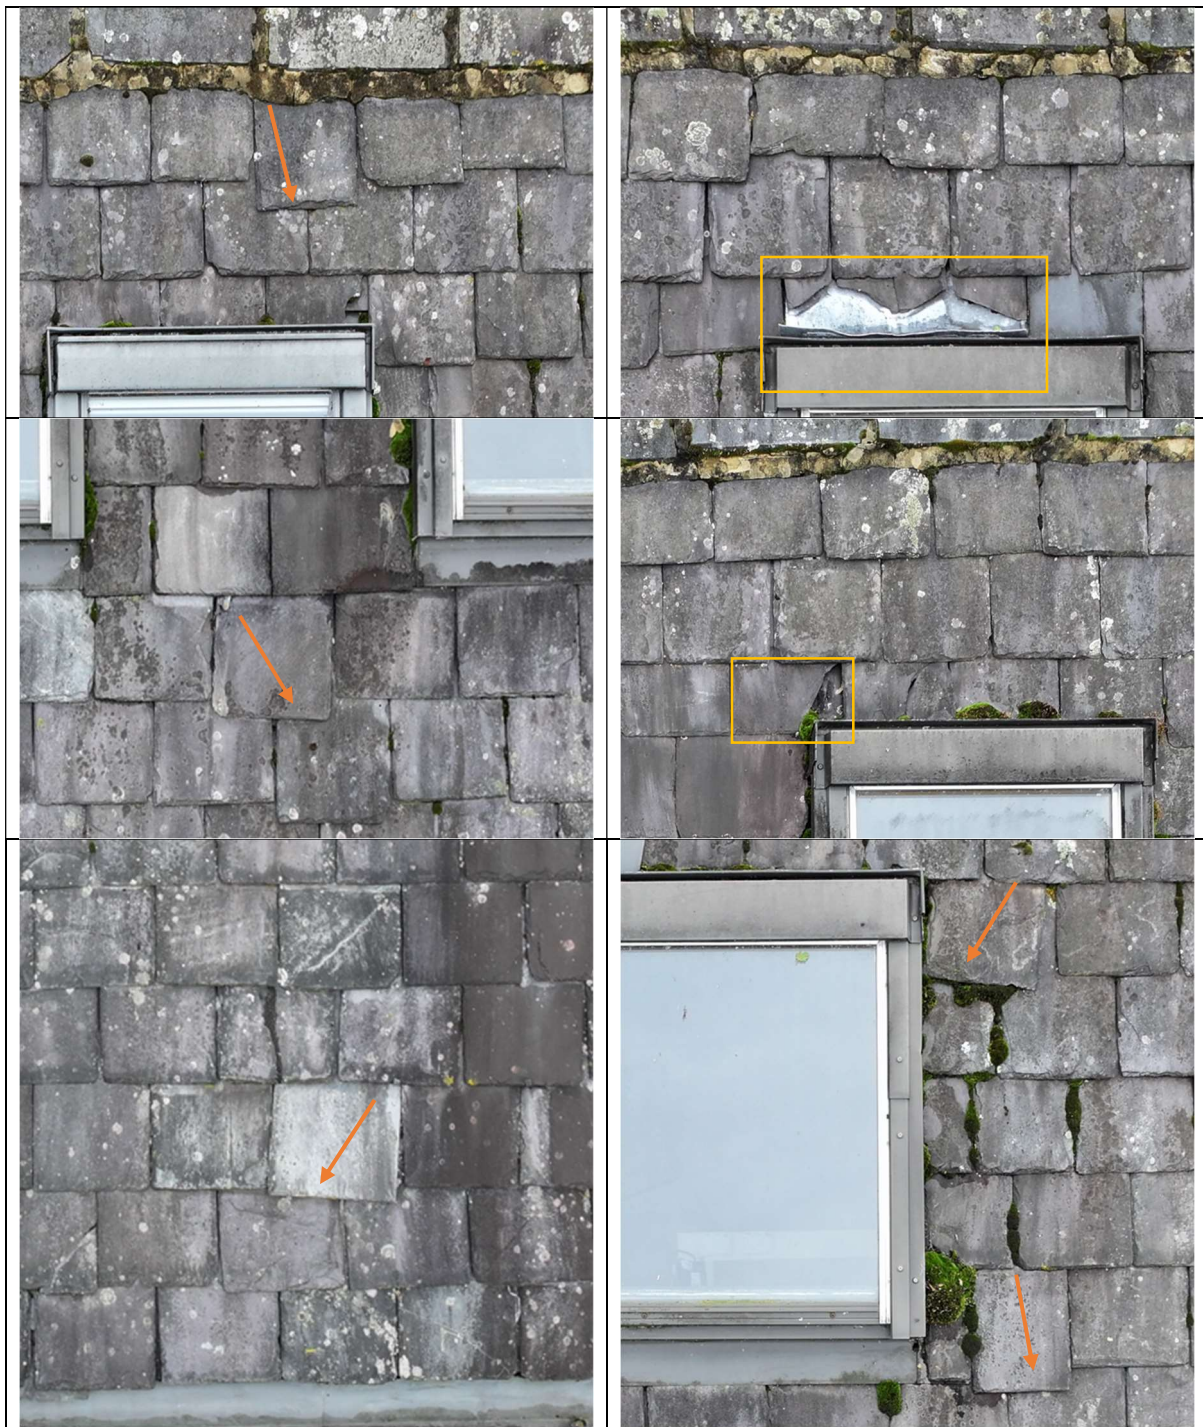
All of the damaged, chipped, slipped and missing slates should be replaced in the short term. Matching slates should be used.

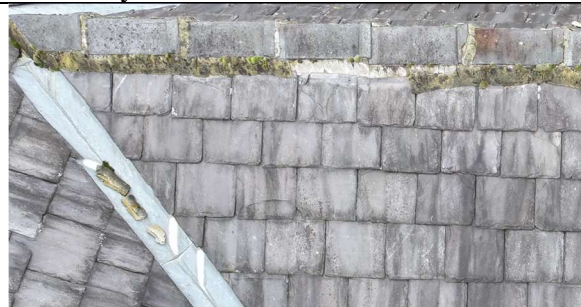
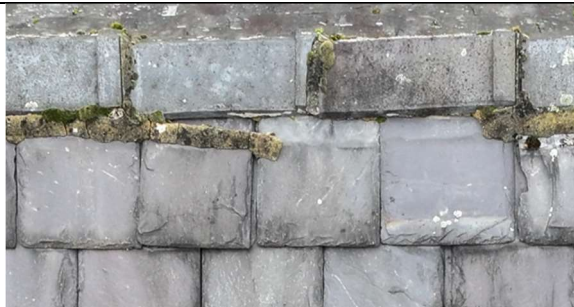
The ridge pointing is in poor condition and will likely need raking out and repointing in the next year.

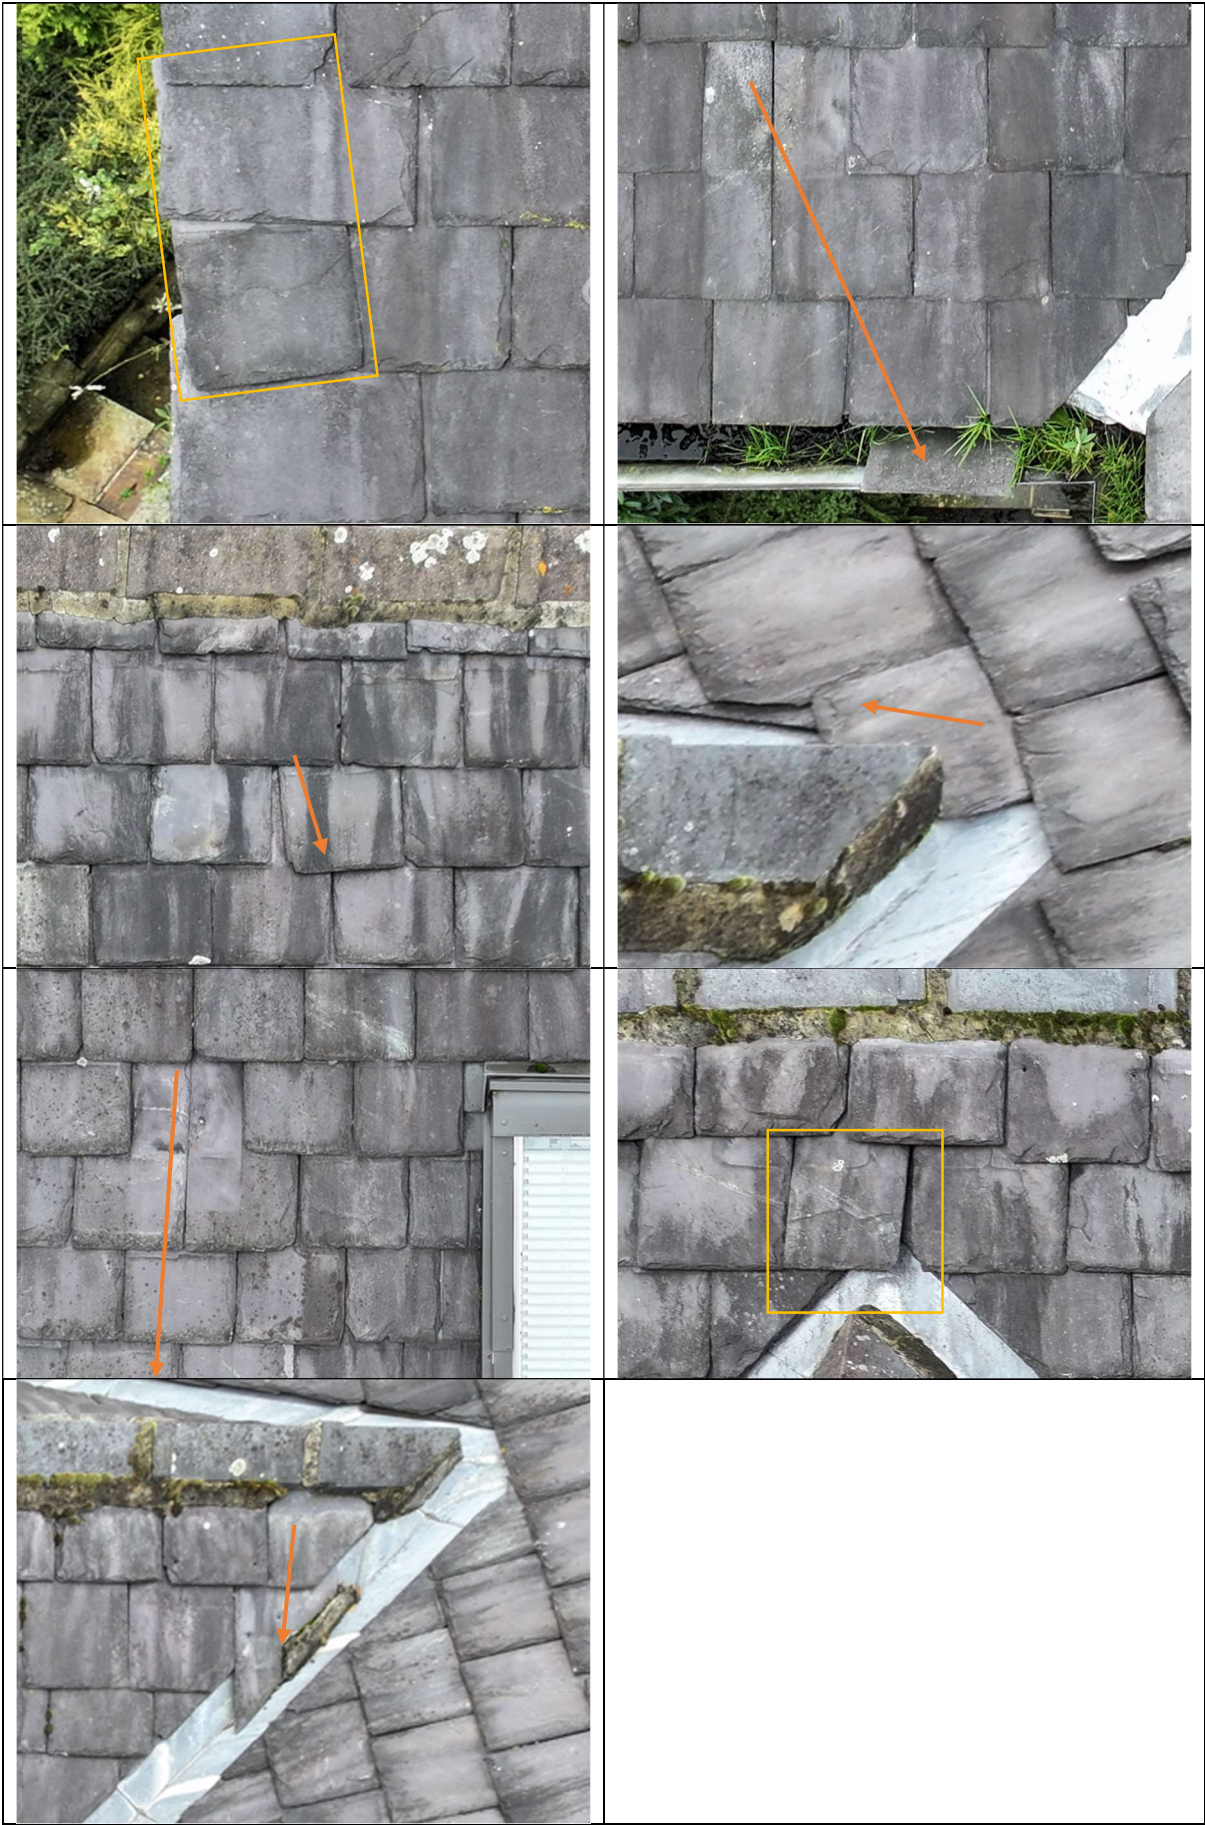
All of the damaged, chipped, slipped and missing slates should be replaced in the short term. Matching slates should be used.

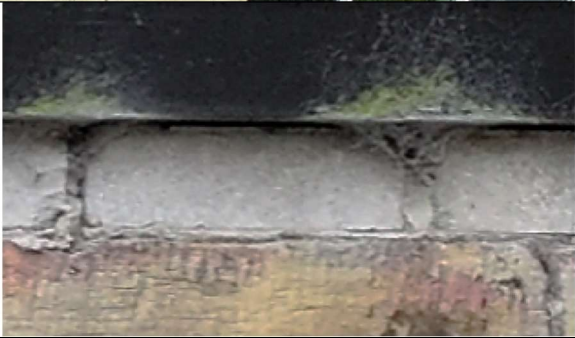
| General comment applicable to all guttering sections – there are areas of damaged paint along the lower arris – these areas should be prepared and redecorated in an appropriate paint. | |

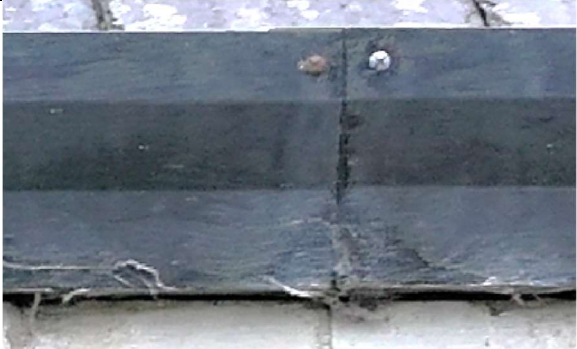
| <p>First union from the left – the left-hand fixing is corroding and there is a small area of moisture staining and failed paint.</p> <p>This union should also be checked for leaks and repaired as required. The corroded fixing should be replaced at the same time.</p> | |

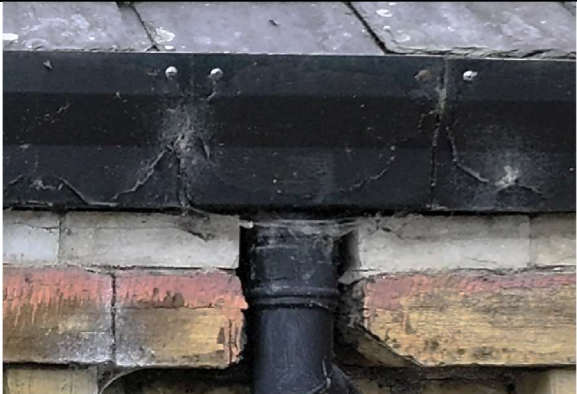
| <p>Left-hand outlet – one of the fixings is corroding and there are areas of damaged paint on the two sections of guttering and the outlet piece.</p> <p>The outlet should be checked for leaks and the corroded fixing replaced.</p> | |

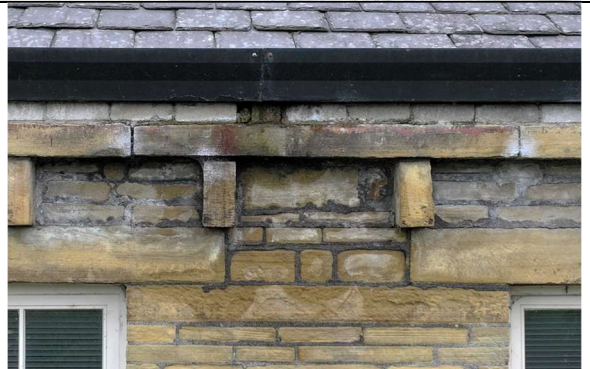
Centre left-hand run, union to the right-hand side of the outlet – the wallhead is saturated, likely as a result of a leak in the guttering.

This needs to be repaired as soon as possible to prevent further deterioration of the stone and problems with moisture ingress.

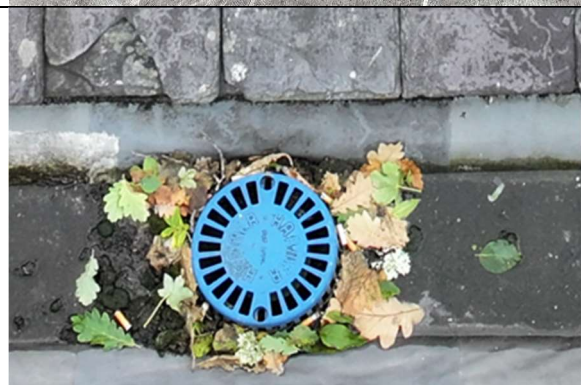
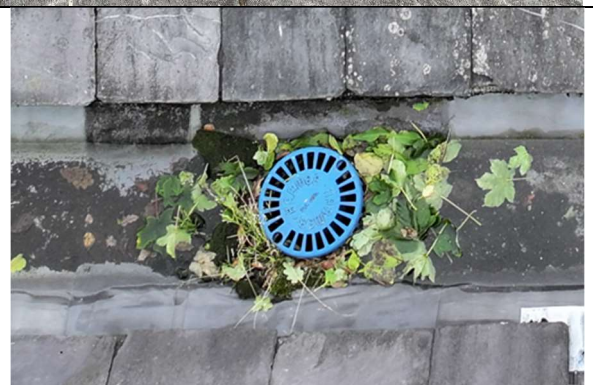
There is ponding along most of the length of the valley gutter – this needs to be cleared out straight away and the fall checked.

We recommend that this is cleared out at least each Spring.

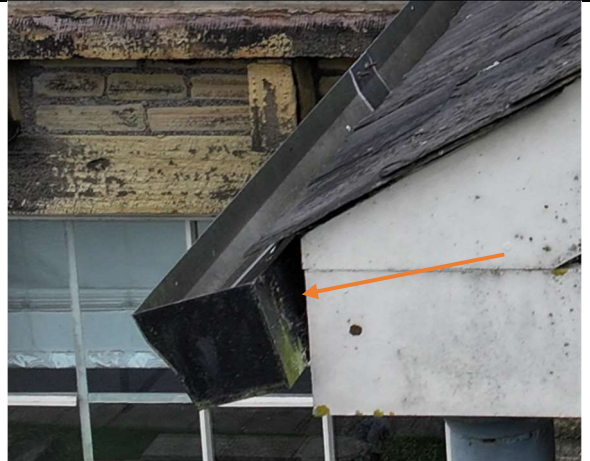
Dormer 9 – the guttering does not appear to be adequately fixed to the fascia.

This area should be inspected and re-affixed as appropriate.

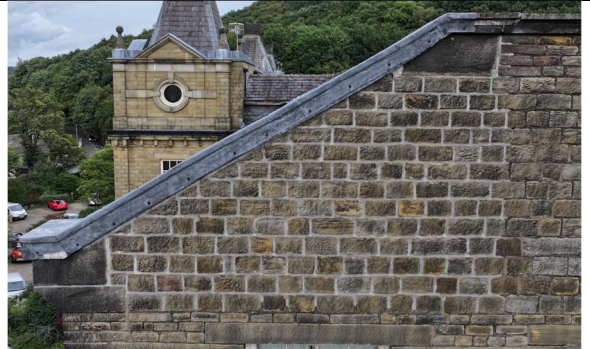
Coping stones – the wall heads are saturated in places, likely as a result of incorrect detailing (see Section 1.5 below) and missing/inadequate throating (drip grooves) on the underside of the stones.

These should be checked next time high-level works are undertaken and cut/amended as necessary.

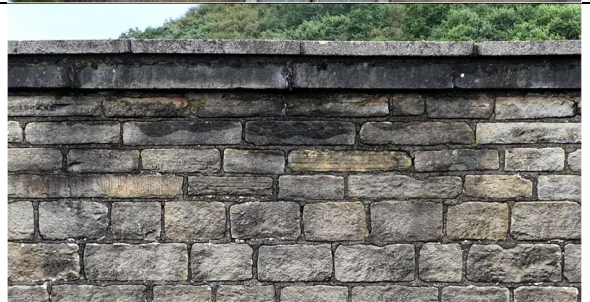
Rear spandrel – the areas of repointing on this section of the wall have been undertaken to a poor standard.

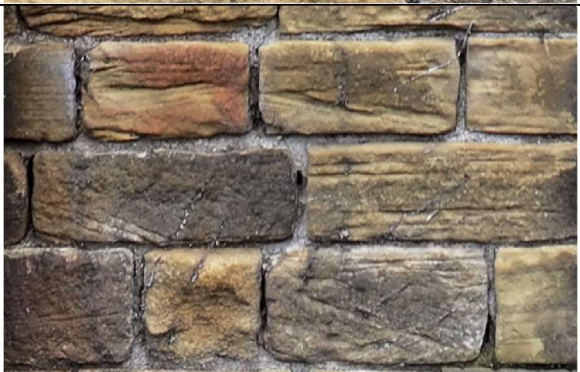
| <p>An example photo showing areas of missing/washed-out mortar.</p> <p>These areas should be re-pointed in the next year.</p> <p>See our comments above on mortar.</p> | |

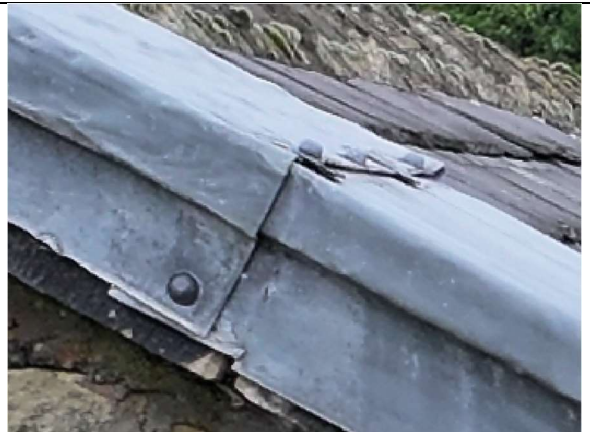
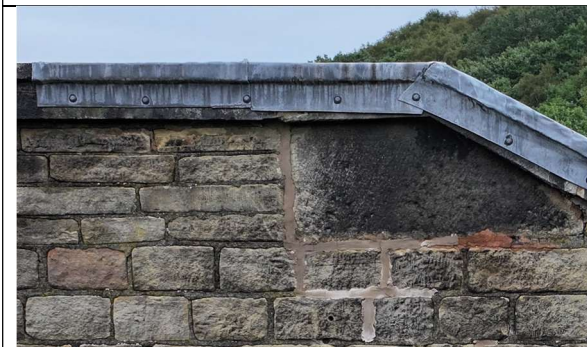
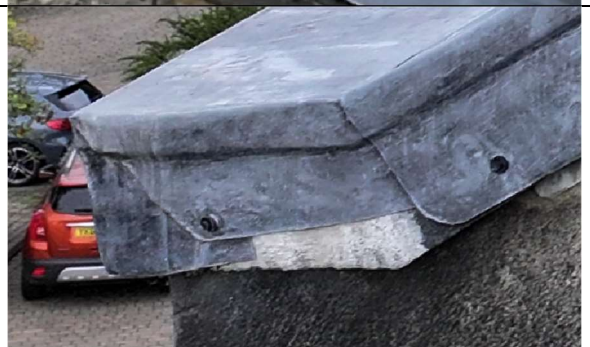
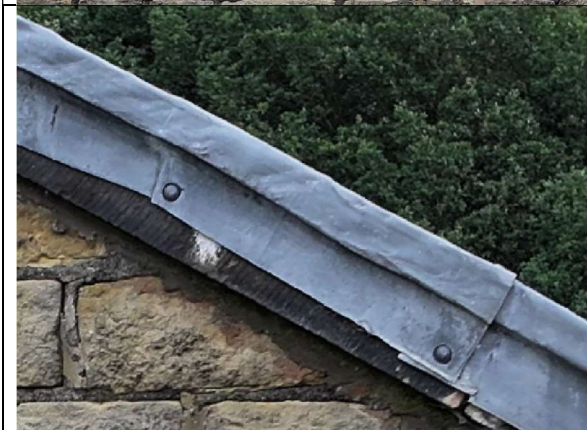
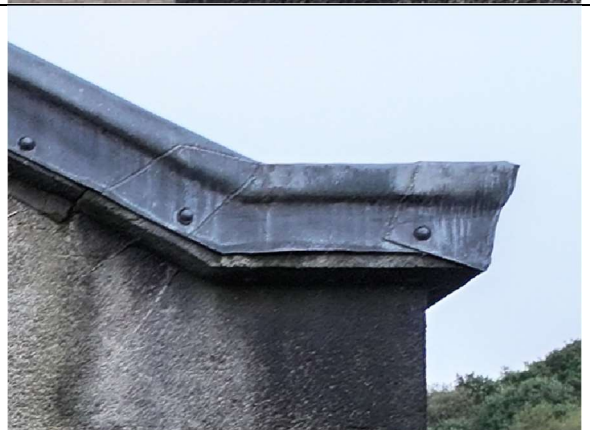
The original coping stones have been overlaid with concrete paving slabs and then partially dressed in lead.

Both of these details are incorrect and consideration should be given to removing these details and re-bedding the original coping stones on a suitably designed damp-proof course.
