Roof Inspection Report

5 Baldwin Terrace

Halifax

8th November 2023

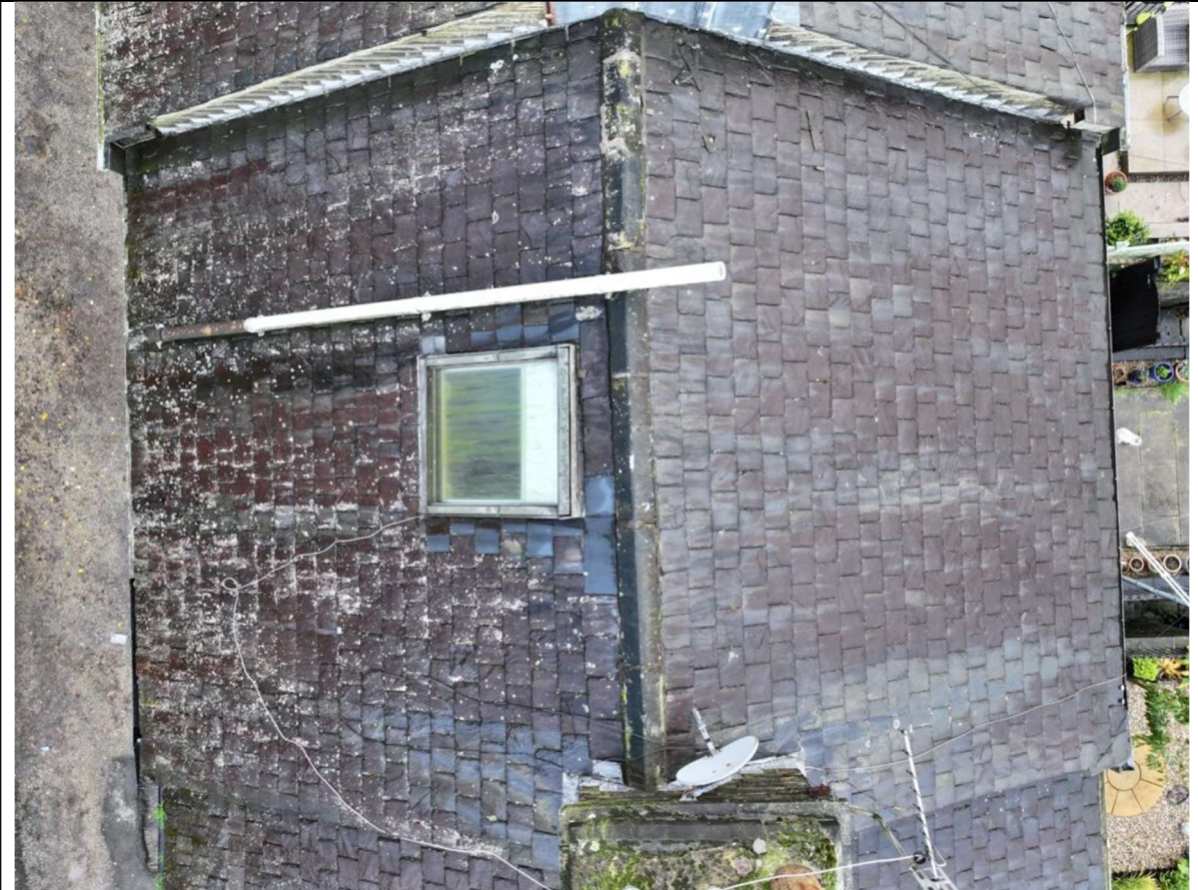
The main roof covering is natural slate.

Overhead photo of the roof covering, with the front of the property on the left-hand side of the photo.
