Roof Inspection Report
In respect of:

25th November 2022

Drone Inspection Report - Summary of Findings

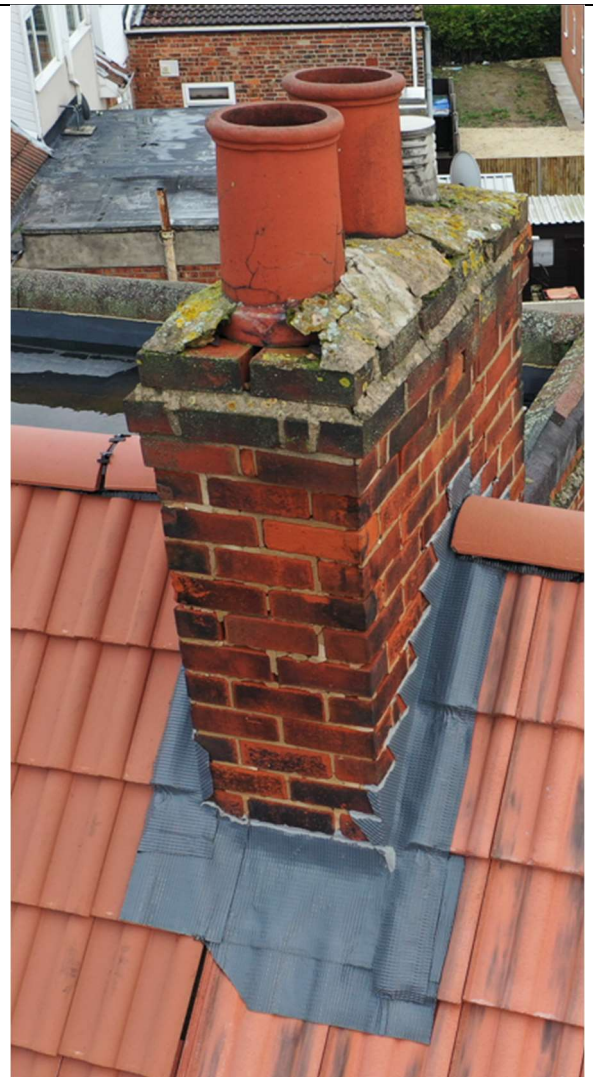
The original lead flashings have been replaced with a lead-replacement type

product. These products are inferior to lead and we do not recommend their use. The detail on the front pitch is poor and there is a section on the rear left-hand side that has not been replaced at all.

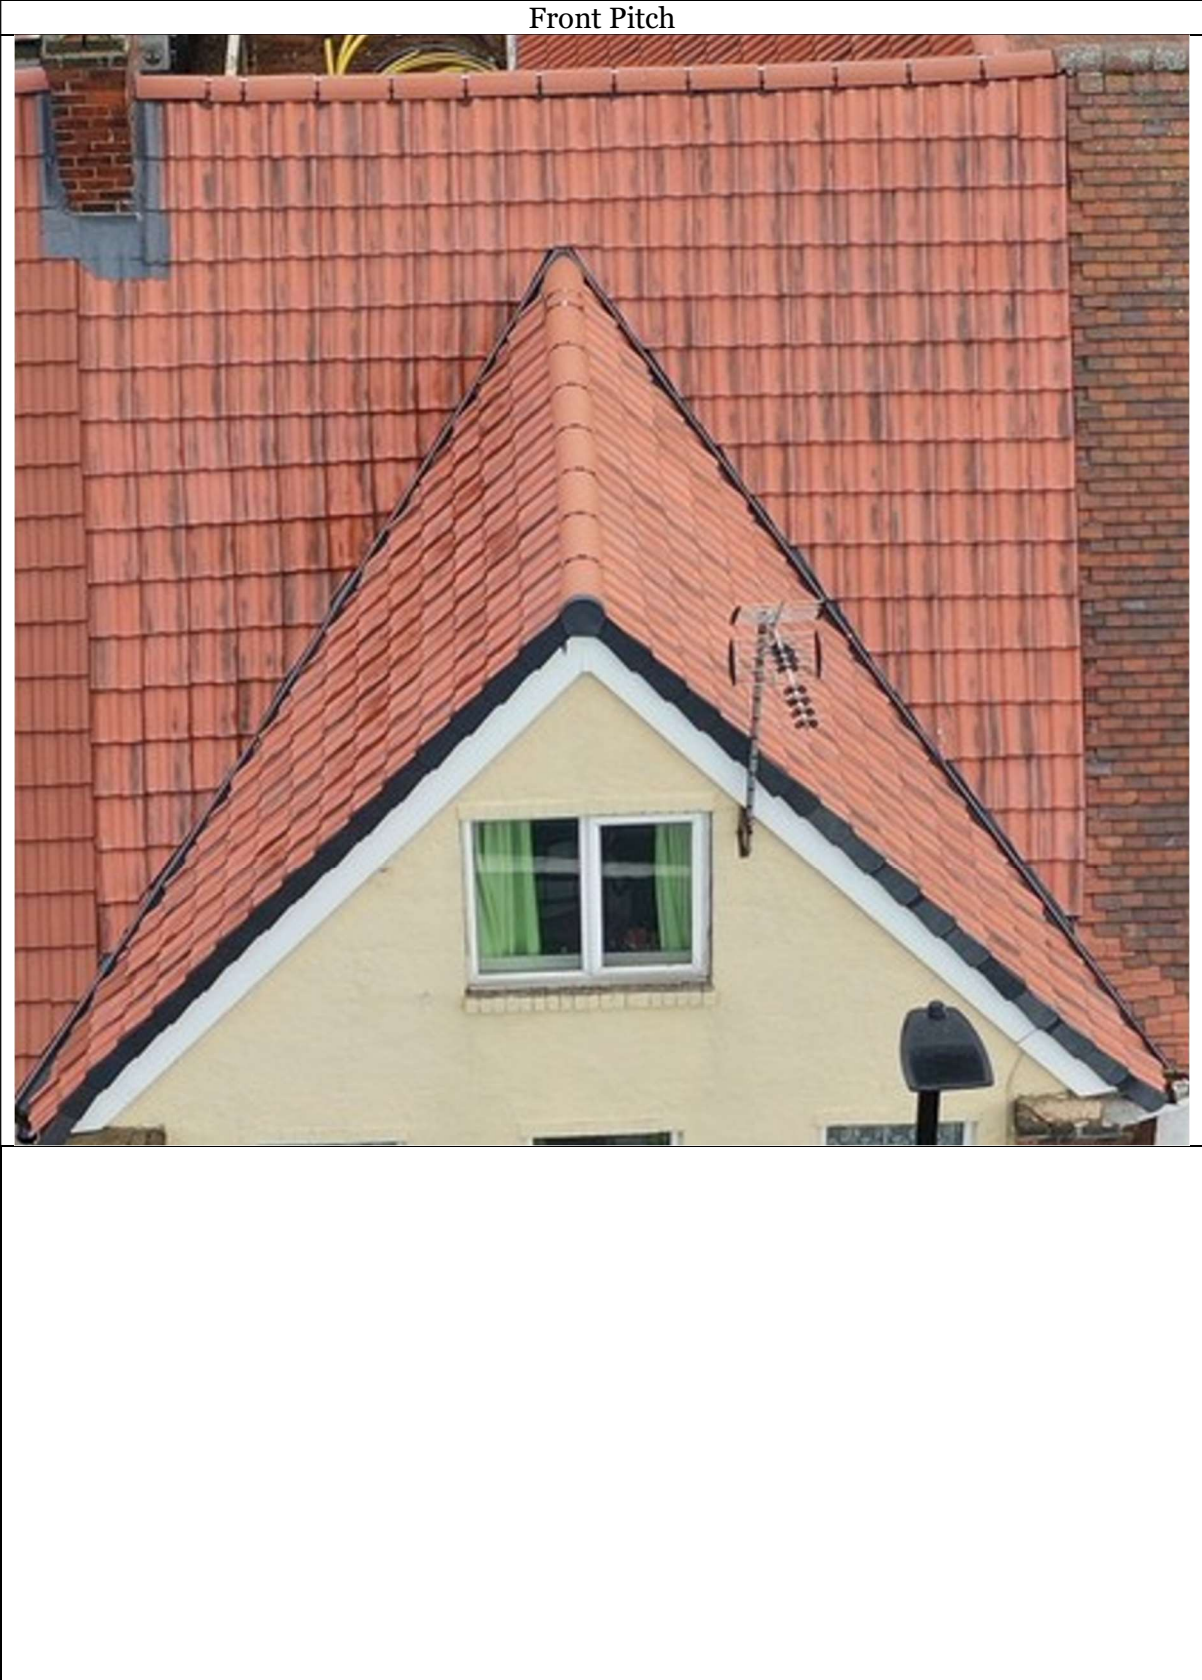
There should be a bonding gutter where the roof coverings meet on the left and right-hand abutments. We cannot see if one is present. On the right-hand abutment, all of the half-tiles are missing.

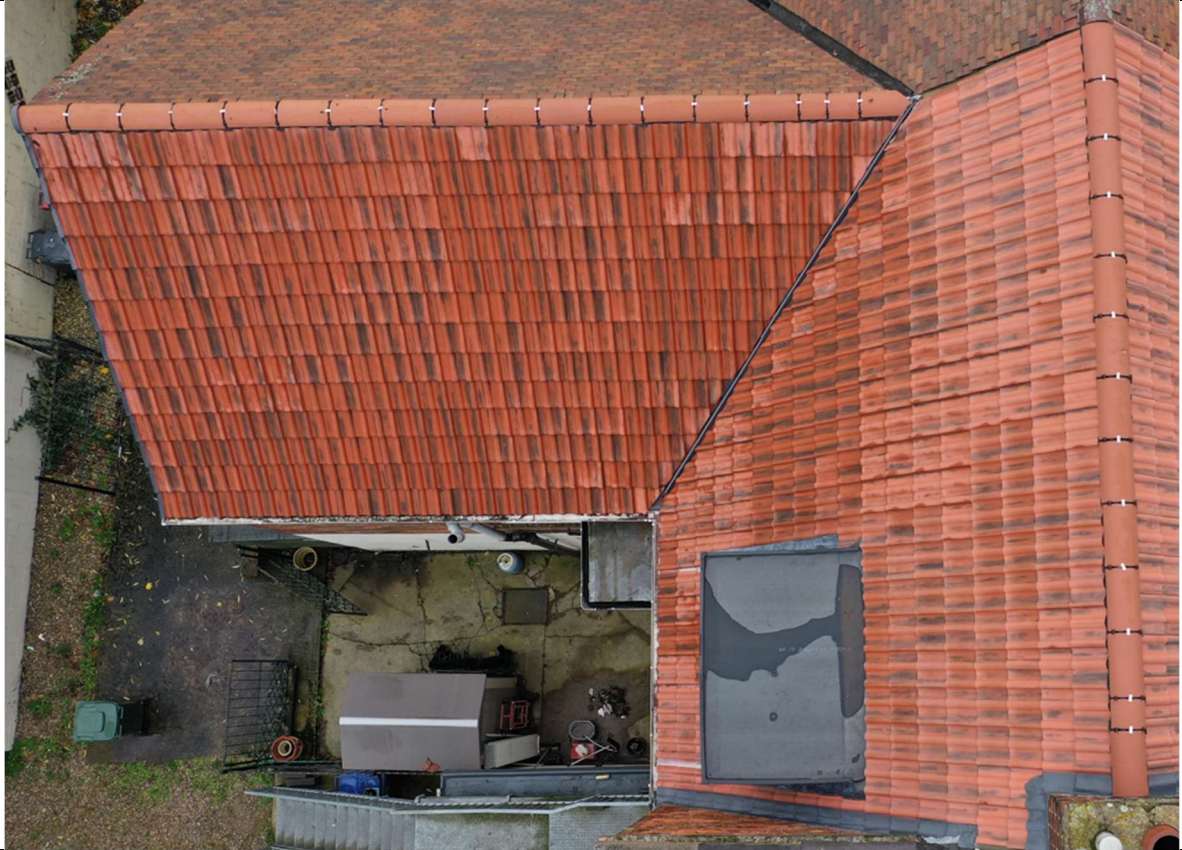
Abutment – lead flashing and soaker detail has been replaced with a single-piece cover flashing in lead replacement material. We do not recommend that lead be replaced with these inferior products. We cannot see if an abutment soaker has been used.
