ROOF INSPECTION REPORT

1 Cold Spring House
Haworth Road
Cullingworth
BD13 5EL

10 October 2024

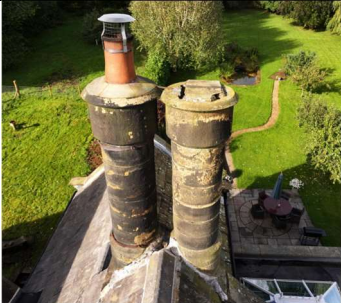
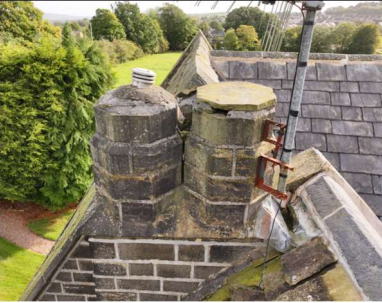
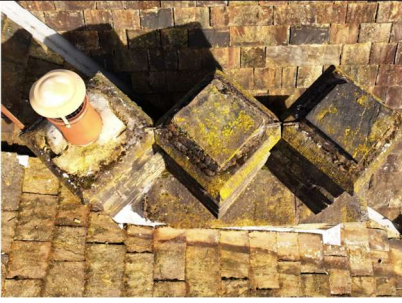
Rear stack	Front stack	Shared stack (front/southside)

To the flues, in areas the pointing is weathered and missing. Some isolated areas of pointing are missing to the main stack stonework, (Photo 0426) these should be repointed as soon as practical.

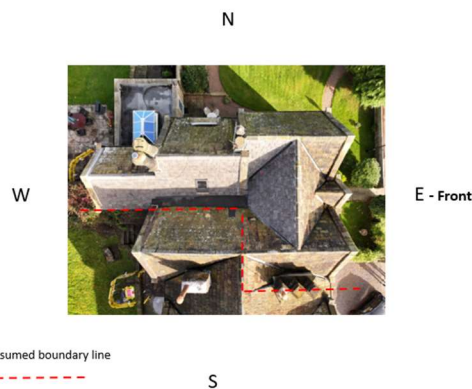
The redline on the above photo shows the assumed boundary line which was confirmed after the drone inspection, as a consequence the neighbouring roof covering are featured in the drone footage.

We believe the majority of coverings shown in photos 0374 – 0392 to be the neighbours roof coverings.
